Iowa Electric Light and Power Company

Subject: Duane Arnold Energy Center
Docket No: 50-331
Op. License DPR-49
Licensee Event Report #90-010, Rev.01

LICENSEE EVENT REPORT (LER)

TITLE (4): Control Rod Drive Insert/Withdraw Line Leakage and Indications at One Bundle Due to High Cycle Fatigue

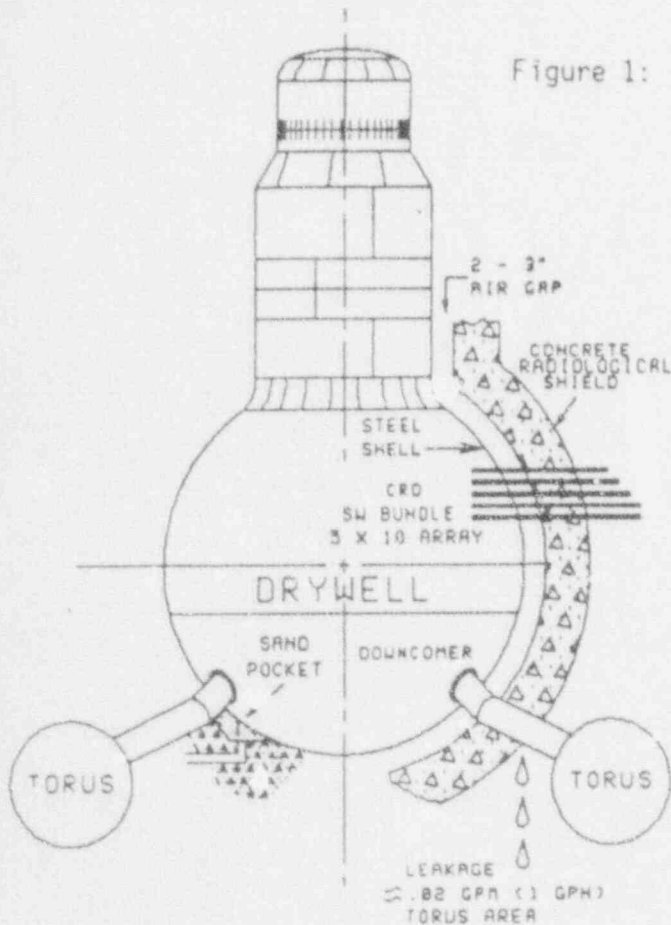
Figure 1:

During the past few years, with the reactor in various operational modes, small quantities of water have been observed dripping intermittently from a torus downcomer penetration in the southwest torus area. From the location of the downcomer, it appeared likely that the source of the water was in the air gap (annulus) region between the steel drywell shell and the outer, concrete radiological shield. (See Figure One). At one point the leakage was quantified at approximately one gallon per hour.

Drywell Shell, With Relative Location of Torus Downcomer and Southwest CRD Bundle

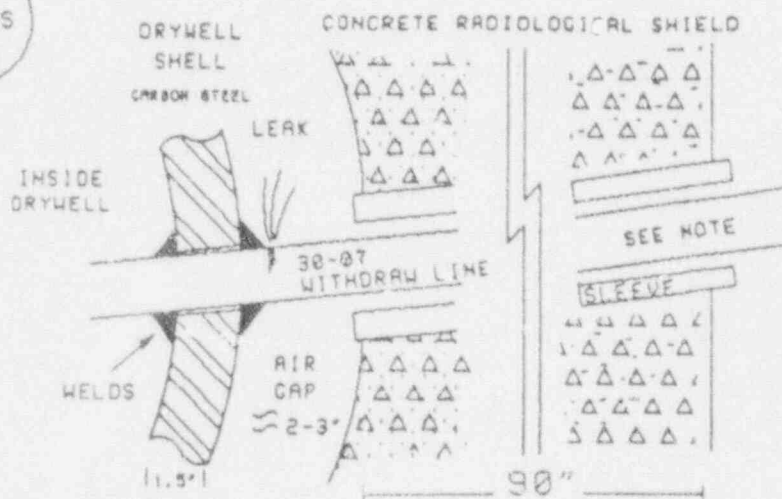
On May 19, 1990, a Control Rod Drive (CRD, EIIS Code AA) withdraw line with a small (pinhole) leak was found at penetration X-37C/X-38C. The leak in the pipe was at the toe of fillet weld between the pipe and the drywell shell. (See Figure Two). A second line at this penetration appeared to be weeping at a similar location. Penetration X-37C/X-38C is a bundle of fifty CRD insert and withdraw lines in the southwest quadrant of containment. (There are four CRD bundles in total, each located in a different quadrant). Upon inspection, roughly half of the southwest bundle lines were found to be visibly wet, and others had mineral streaks in evidence, indicating they had been wet in the past. Some corrosion and discoloration was in evidence on the pipes and drywell shell. Visual inspection within the air gap region of the other three CRD insert/withdraw line bundles saw no evidence of leakage, discoloration or notable corrosion. The dripping at the southwest torus downcomer penetration was noted at this time to be on the order of one gallon per hour.

All indications were circumferential in nature, in the pipes at the toe of the shell to pipe fillet weld, and from the outside diameter in. The indications were very fine and tight. (The withdraw line leak was not visible below 700 psig reactor pressure, and upon removal, its thru-wall crack could not be seen). A sampling of lines at the other three CRD bundle penetrations found no evidence of abnormal indications, indicating the problem was specific to the southwest CRD bundle.

30-07 WITHDRAW LINE

LEAKAGE OBSERVED AT POWER

Figure 2: Close-up Perspective of Leaking Southwest Bundle CRD Withdraw Line

THRU-WALL INDICATION NOT VISIBLE UPON REMOVAL

As a corrective action for the extensive indications noted in the southwest CRD bundle, all lines in that bundle have been replaced at the penetration into the drywell. A sleeve has been welded to the CRD pipe and then attached to the drywell shell plate, utilizing a partial penetration groove weld with a cover fillet. This new design provides increased flexibility for thermal transients without sacrificing the carrying capacity needed for mechanical loads. Enhanced leakage monitoring is also under review.
