In the Matter of DUKE POWER COMPANY, <u>et al</u>. (Catawba Nuclear Station,

Units 1 and 2)

TESTIMONY OF G. WAYNE HALLMAN, RUSSELL P. MUSCHICK, S. ROBERT WARD, JEFFERY A. GORMAN, CLIFFORD A. WELLS, LEE A. SWANGER, SIMON K. CHEN, JESSE O. BARBOUR, J. MALCOLM CURTIS, AND ROBERT C. GAMBERG RELATING TO PROBLEMS ENCOUNTERED IN THE CATAWBA DIESEL GENERATOR QUALIFICATION PROGRAM.

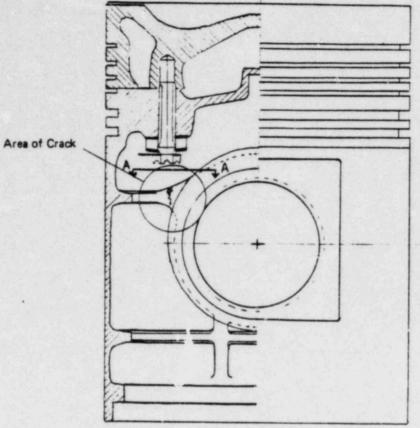
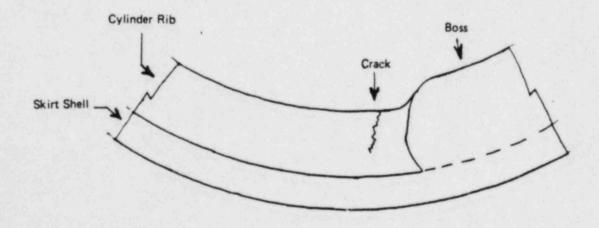
FIGURE 2-1 CRACKED TYPE AN PISTON SKIRT

Four of the Catawba 1A diesel piston skirts (Type AN) cracked at the reinforcing rib to wrist pin boss fillet. This cracking was found during the inspections following the extended operation test run which lasted more than 800 hours, and included over 660 hours at and above 225 psi BMEP (or 7000 KW). The largest crack observed which was the only one to penetrate the skirt wall, reached a vertical length of 3 inches. None of these cracks affected operability or startability. This concern is a category 3 item. (CHW, LAS, SKC)

The cracking of the AN skirts at Catawba, in the fillets between the reinforcing rib and wrist pin bosses, was attributed to high-cycle fatigue. Because the replacement AE skirts have a significantly increased cross section and a gradual taper in the reinforcing ribs, the stress level is substantially lower than in the Type AN skirts. As measured by experimental stress analysis, the stress in AN skirts is two times that in AE skirts. In other words, there is a 50% reduction in stress level from the original AN skirts to the replacement AE skirts.

Elevation view of skirt

View A-A Detail of crack initiation

The type AN Catawba 1A and 1B diesel piston skirts have been replaced with improved Type AE skirts even though the uncracked AN skirts have been qualified for unlimited operation at full load (225 BMEP). This was done because of schedule constraints associated with analyses of the original AN skirts. We believe that the AE piston skirt is a superior design

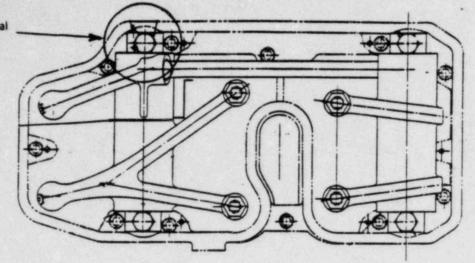
FIGURE 2-2 CRACKED SUBCOVER CASTINGS

- Two other problems of lesser consequence were noted as follows:
 - Five subcover castings (three on 1A and two on 1B) were found to have cracks in an intake rocker arm pedestal. These cracks did not affect diesel startability or operability and are not service related, but rather were caused by installation errors by Duke Power personnel. The affected castings have been replaced and installation procedures improved to prevent recurrence.
 - Four Catawba cylinder heads (one on diesel 1A and three on 1B) experienced small jacket water leaks into the fuel injector cavity. Metallographic examinations of the head removed from the 1A diesel -34-

A. Plan view of subcover

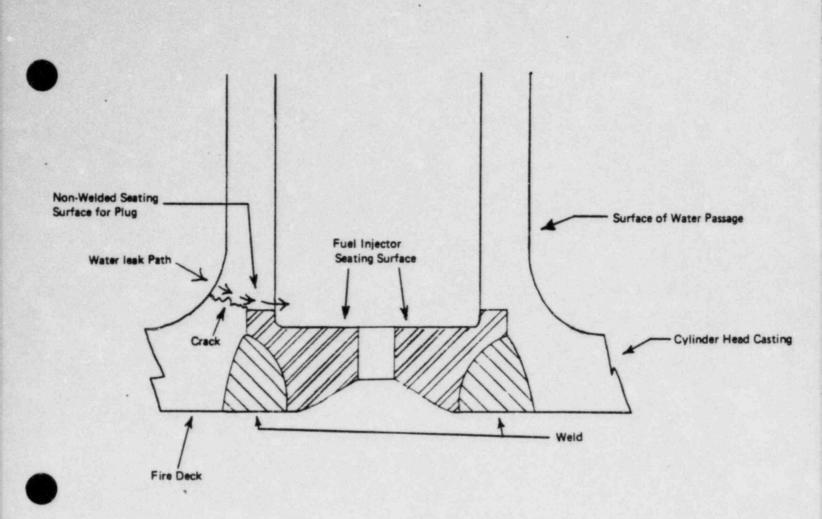
FIGURE 2-3 CRACK IN CYLINDER HEAD

indicated that the leak was due to a fatigue crack emanating from a welded plug used to repair the casting. All heads with this type of repair are being replaced. It should be noted that the problem did not affect diesel corrability since the water leaks to the exterior of the cylinder head and not into the cylinder. One cylinder head on 1P experienced a crack in the overlaid weld area of the valve seat area. There was no leakage through this crack and, thus, no effect on diesel operability.

External jacket water leakage was due to use of welded-in plugs to repair castings at the fuel injector nozzle port in the fire deck. Fatigue cracks from these plugs resulted in jacket water leaks to the outside of the cylinder head. (CHW, LAS)

All Catawba cylinder heads have been visually inspected to determine if any have welded-in repair plugs. All heads with welded-in repair plugs are being replaced with heads without welded-in repair plugs to prevent further external jacket water leaks. (RPM, SRW, JAG)
