# NORTHEAST UTILITIES

Reference: Facility Operating License No. NPF-49  
Docket No. 50-423  
Licensee Event Report 91-018-01

LICENSEE EVENT REPORT (LER)

TITLE (4)  
Both Supplemental Leak Collection and Release System Trains Inoperable Due to Design Deficiency

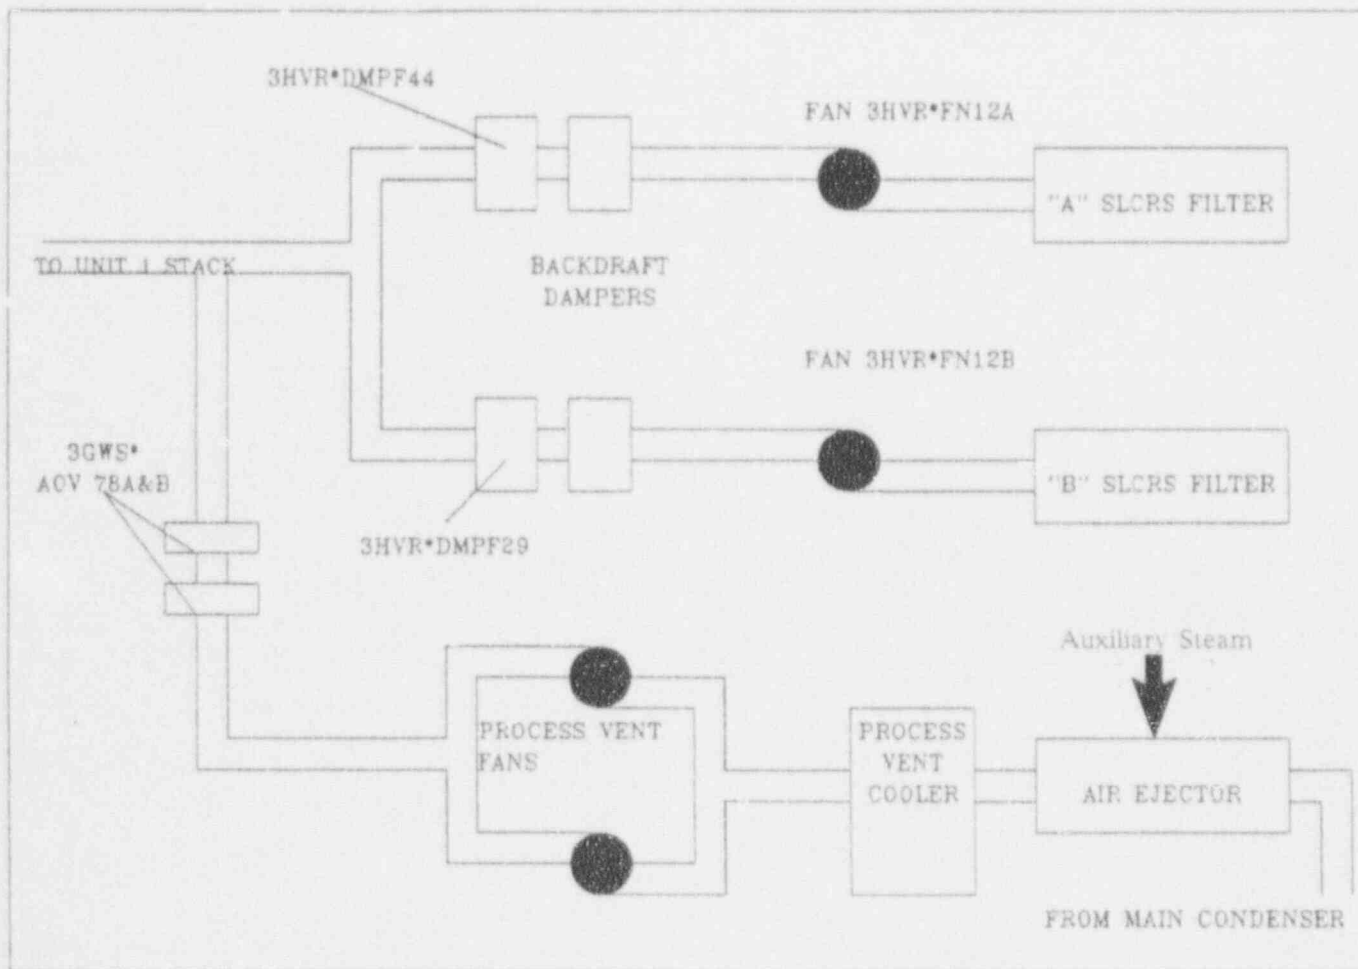
## SLCRS - WASTE GAS CROSS TIE

The Gaseous Waste System is designed to transfer gasses or vapors from several systems throughout the plant, including the Steam Jet Air Ejector (SJAE), to the Unit 1 gaseous effluent discharge stack. Any hot gasses are cooled by the process vent cooler, located in a common suction line for the process vent fans. The process vent fans discharge through two dampers, which close on a safety injection signal, to the SLCRS discharge header (reference attached figure). The reactor and turbine trip on June 9, 1991, resulted in a loss of non-vital electrical power for 29 minutes. Among the equipment out of service during this event were the circulating water pumps and the reactor plant chill water pumps. The circulating water pumps provide cooling water to the condenser. The chill water pumps provide cooling to the process vent cooler. The resultant high condenser pressure, loss of condensate cooling to the air ejectors, and continued auxiliary steam flow to the air ejector system is postulated to have increased pressure in the piping that connects to the waste gas system to as high as 10-12 psig. With no cooling to quench the steam being sent to the process vent cooler, it is postulated that steam flowed from the condenser through the waste gas system and into the common SLCRS/ waste gas discharge duct. The temperature of the steam was potentially as high as 260 degrees Fahrenheit. The steam is postulated to have melted the links for 3HVR\*DMPF44 and 3HVR\*DMPF29 which resulted in the closure of the fire dampers.

The root cause for closure of both 3HVR\*DMPF44 and 3HVR\*DMPF29 is design deficiency. The SLCRS system was not properly designed to operate following a loss of non-vital power.

As a long term corrective action, the design of the SLCRS system and connections to the waste gas system has been reviewed. The fusible links in dampers 3HVR'DMPF29 and 44 have been changed to ones with setpoints of 285 degrees Fahrenheit to prevent the SLCRS from becoming inoperable on a loss of non-vital power. These modifications were made prior to plant startup on February 4, 1992.
