PPAIRIE ISLAND NUCLEAR GENERATING PLANT
Docket Nos. 50-282 License Nos. DPR-42
50-306 DPR-60

Design Basis Reconstitution Effort Identified a
Condition Outside 10 CFR Part 50 Appendix R Requirements

FACILITY NAME (1) **Prairie Island Nuclear Generating Plant Unit 1** DOCKET NUMBER (2) **05000282** PAGE (3) **1 OF 6**

TITLE (4) **Design Basis Reconstitution Effort Identified a Condition Outside 10 CFR Part 50 Appendix R Requirements**

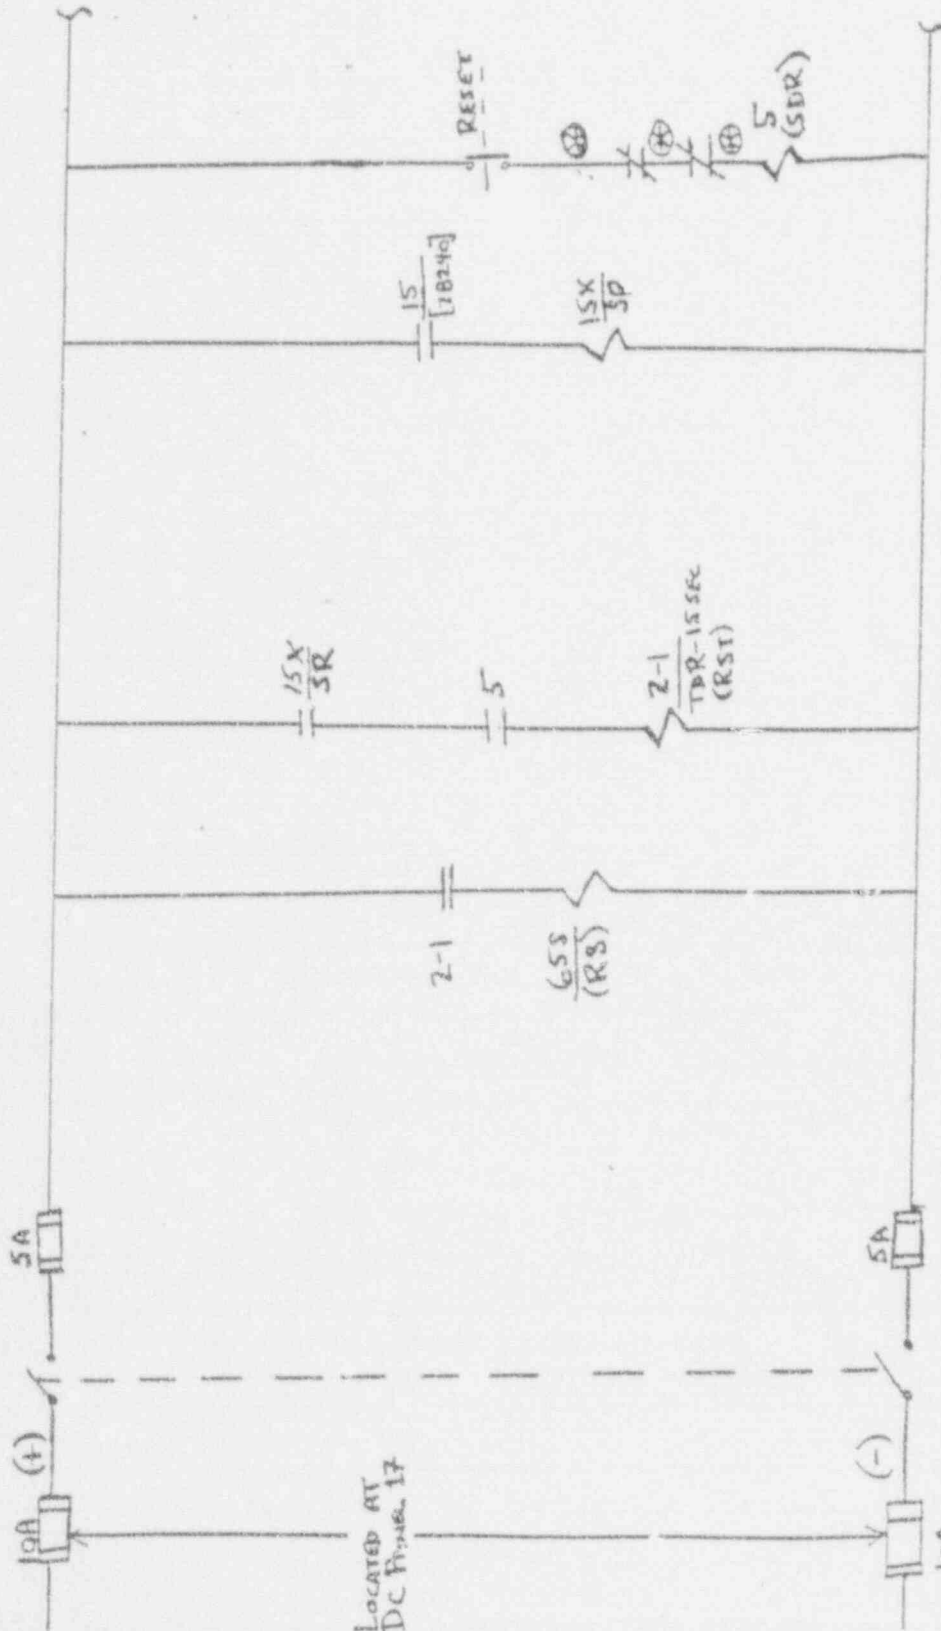
A hot short (positive wire) may be postulated to occur during a Relay Room fire that would continuously energize the shutdown Relay for No. 12 Diesel-Driven Cooling Water Pump. The result of that would be that the pump would not start.

As previously discussed, an operator is required to verify that No. 12 Diesel-Driven Cooling Water Pump is operating in this scenario. If the pump is not operating, the operator would start the pump manually per the procedure. A hot short (positive wire) may be postulated to occur during Relay Room fire in one of the locations identified on the attached diagram, continuously energizing the Shutdown Relay (5). When Relay 5 is continuously energized, the circuitry will shut off the engine fuel (i.e., shut down the diesel) whenever the engine speed is greater than 400 rpm. When diesel speed is greater than 400 rpm, contact 15/[28240] is closed energizing relay 15X/SR. This energizes the 2-1/TDR-15 sec relay which closes a contact to energize the fuel rack solenoid, resulting in a loss of fuel supply to the diesel. Relay 2-1 will remain energized for 15 seconds after the shutdown signal is received, allowing the diesel engine to coast down.

At less than 400 rpm, contact 15/[28240] is open de-energizing relay 15X/SR, and after 2-1/TDR-15 de-energizes, the fuel supply to the diesel engine is on-line and air start solenoid valves open. The engine would then attempt to start; however, upon reaching 400 RPM, the engine would again shut down. This could continue until the air supply is exhausted.

The basic cause of this event stems from a potential circuit failure mode that was not recognized during development and implementation of the Appendix R program.

⊗ WIRES OF CONCEPT; LOCATED IN RELAY ROOM

A temporary procedure was issued to provide instructions for the operator to remove the fuses (e.g., the 10 amp fuses shown on the attached figure) at the appropriate DC Panel for No. 12 Diesel-Driven Cooling Water Pump Control Panel. (If an auto-start signal were to be initiated, an overcranking relay would prevent depletion of the starting air inventory prior to removal of the fuses.) A fuse puller is staged at the appropriate DC panel. The procedure already provides instructions for manually starting No. 12 Diesel-Driven Cooling Water Pump (if necessary). An in-line switch is available in the circuit; however, it is installed for maintenance purposes only. It is considered easier and more convenient for the operator to remove the fuses.

1. The Control Room evacuation procedure will be revised to include the actions identified in the temporary procedure regarding fuse removal. This is considered satisfactory based on the following:
 - a. The fuse panel is readily accessible,
 - b. The fuses are clearly identified in the panel,
 - c. The fuse panel has sufficient space to permit ready/easy access for pulling fuses,
 - d. Emergency lighting is available for the fuse panel (actions are being added to the emergency lighting surveillance procedure to periodically verify the adequacy of this lighting),
 - e. A fuse puller is staged at the fuse panel,
