**NUREG/CR-3591  
Volume 2  
ORNL/NSIC-217/V2**

**Precursors to Potential Severe  
Core Damage Accidents: 1980-1981**

**A Status Report**

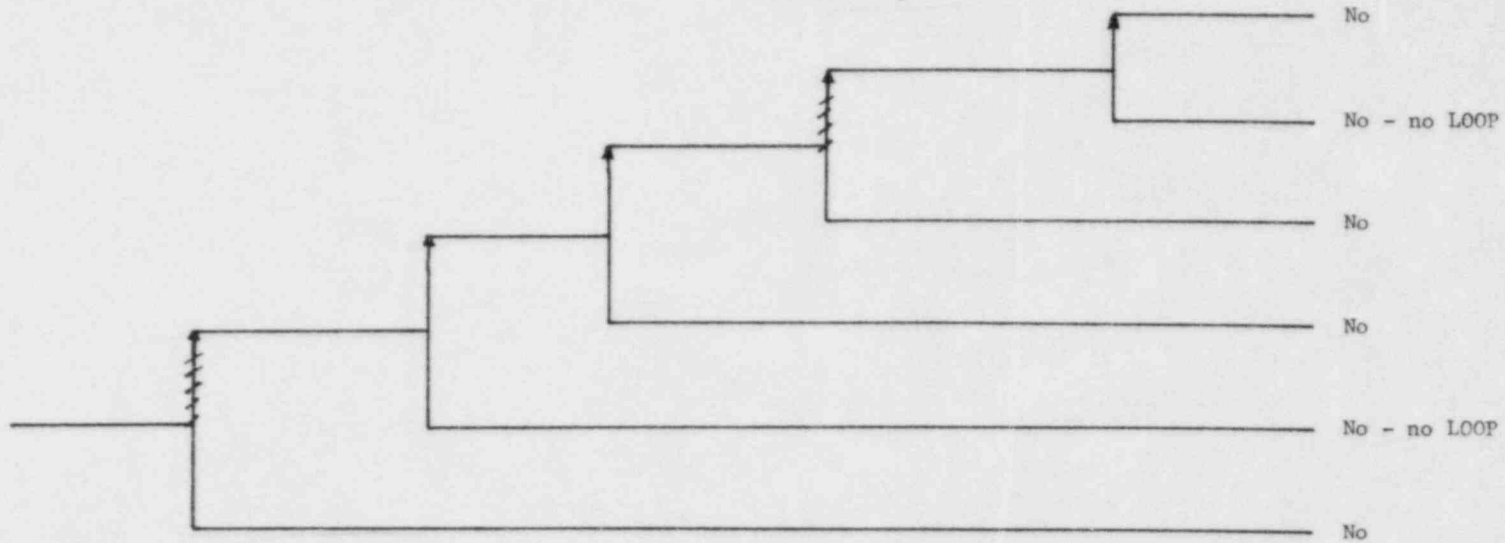
NSIC 154674 - Actual Occurrence for Emergency Power System Unavailable at Calvert Cliffs 2

1. With Unit 1 in cold shutdown and Unit 2 at 100% power, safety injection was inadvertently initiated on Unit 1 during surveillance testing, a result of a missed step in the surveillance procedure.
2. Unit 1 SI components actuated, including all three diesel generators.
3. SIAS was reset and the diesel generators shut down.
4. All SIAS actuation modules did not reset, because either individual modules did not reset or because a technician at the ESFAS cabinets interfered with the control room operator when he reset SIAS.
5. Both unit DGs continued to receive a false start signal which caused a start failure alarm.
6. This rendered the DGs inoperable in the event of another SIAS.

The operators manually reset the ESFAS actuation modules and diesel generator start failure relays at the respective local panels and restored the DGs to service.

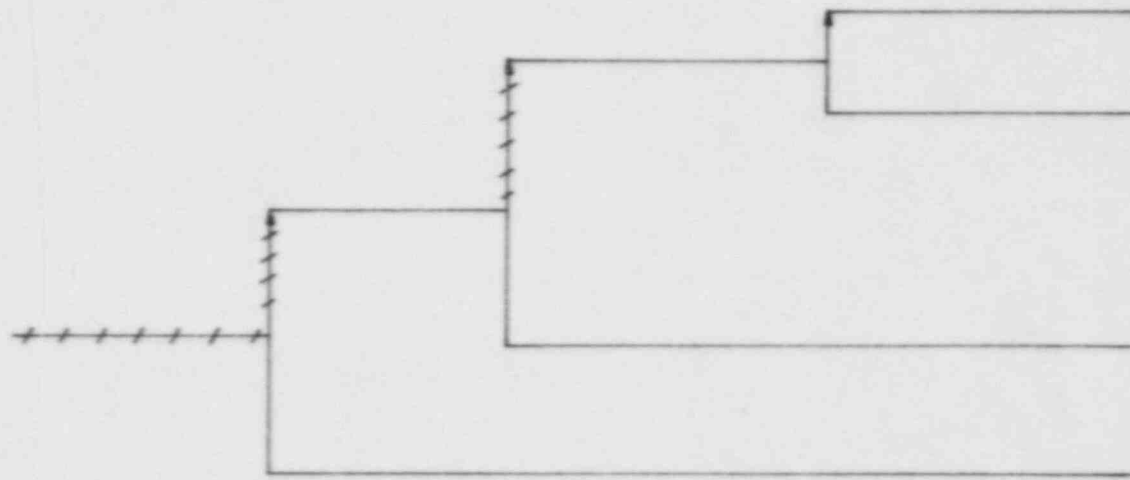
1. With the reactor at full power and south saltwater cooling (SWC) pump G-13B in operation, G-13B shaft failed due to excessive vibration from worn bearings.

2. This resulted in low flow and low discharge pressure alarms in the control room and auto start of north SWC pumps G-13A.
3. North pump G-13A discharge valve failed to open due to an O-ring. Failure caused by desiccant in the instrument air lines. This resulted in no flow from either pump.

4. Auxiliary saltwater cooling pump G-13C was manually started from the control room but failed to develop sufficient flow because of insufficient prime, and the pump was shut down.

North SWC pump valve POV-5 was opened and the north SWC pump placed in service. The auxiliary SWC pump surveillance testing was increased from once per week to daily during low tide conditions.

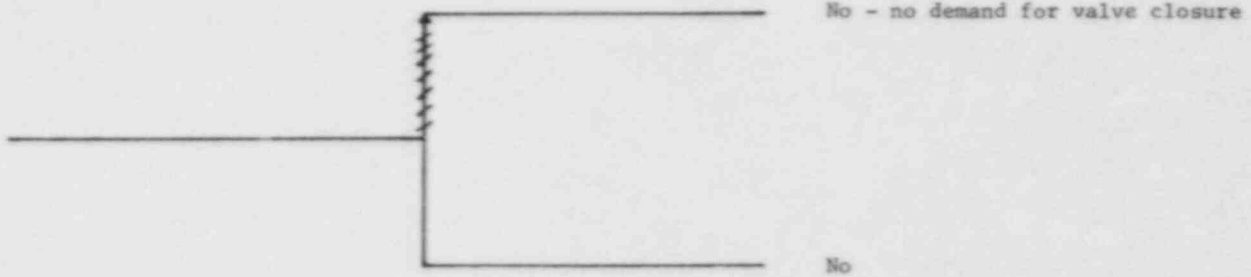
NSIC 156204 - Actual Occurrence for Failure of MSIVs to Close on Demand at Trojan

1. With the reactor in hot standby, three of four MSIVs failed to close on demand during the annual surveillance test due to sticking valve stems.
2. The plant was taken to cold shutdown.

The short-term corrective action was to loosen the valve stem packings and cycle the valves. Permanent corrective action was still being investigated at the time the report was written.

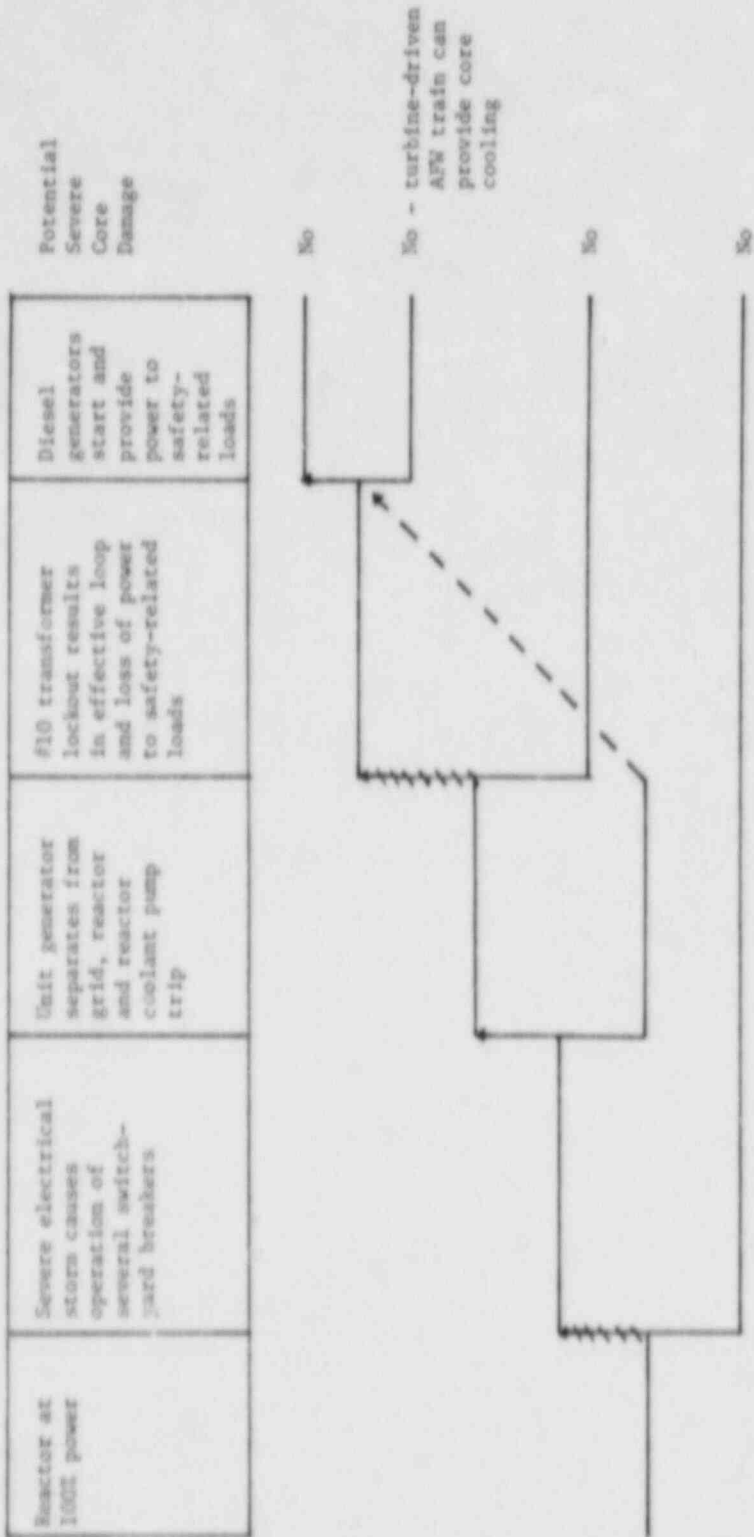
NSIC 158228 - Actual Occurrence for Loss of Offsite Power at Prairie Island 2

1. With Unit 2 at 100% power a severe electrical storm caused operation of several breakers in the substation.
2. The unit generator separated from the grid and the reactor and reactor coolant pumps tripped.
3. About 8 minutes later, the 345/161/13.8 kV No. 10 transformer locked out.
4. The diesel generators started and provided power to safety-related loads.

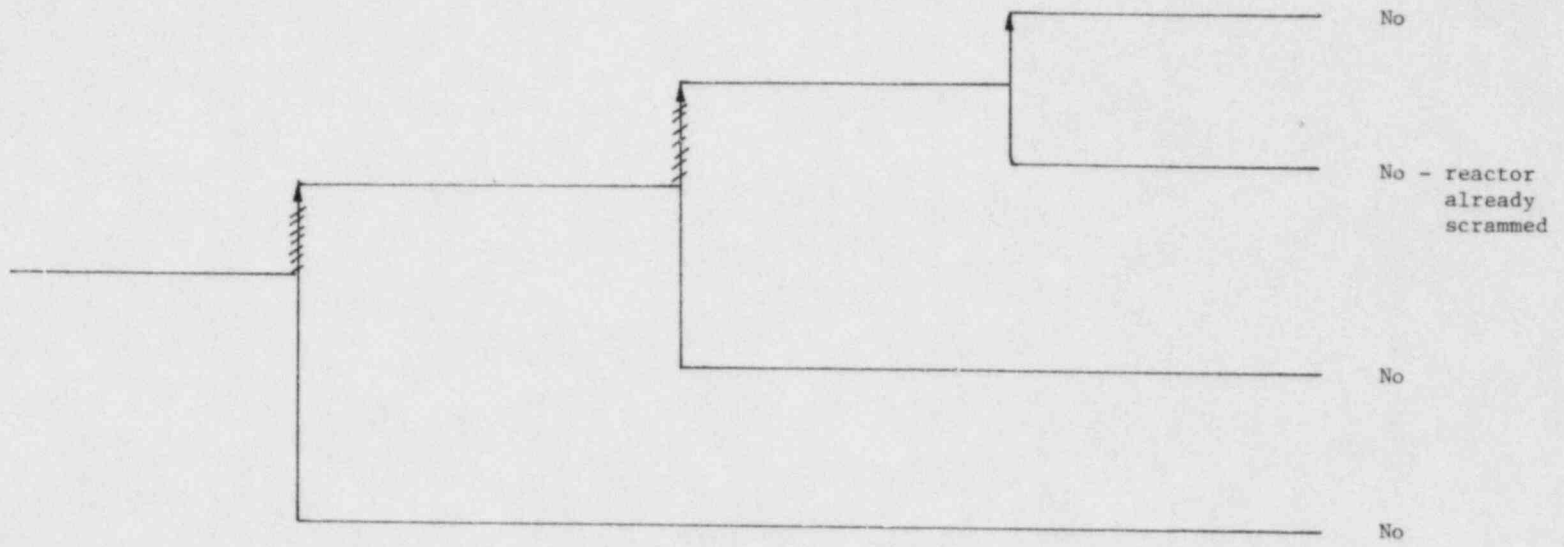
NSIC 158229 - Actual Occurrence of the Scram Discharge Volume Fails to Drain and Alarms Clear at Dresden 3

4. Ultrasonic test, however, showed that the 4-inch piping of the west SDV was still 80% full.
5. The ball check valve (vacuum breaker) on the west SDV alternate vent path was found to be stuck closed.

6. The cause for the failure of west side SDV drainage is believed to be due to unavailability of the normal vent path combined with unavailability of the alternate vent path. Both SDVs are normally vented via a common header that is piped to a vented tank, the RBEDT (reactor building equipment drain tank). [At the time of this event the level in the RBEDT was reported to be above normal, such that the SDV vent header was emersed and could not be vented. The east SDV would also have been prevented from draining if its alternate vent path was not functioning (i.e., if its ball check valve was stuck closed).]
