Beaver Valley Power Station, Unit No. 1
Docket No. 50-334, License No. DPR-66
LER 91-026-01

LER 91-026-01, 10 CFR 50.73.a.2.i.B, "Potentially Inoperable Charging Pump Due to Missing Nuts on High Speed Coupling."

TITLE (4)
Potentially Inoperable Charging Pump Due to Missing Nuts on High Speed Coupling

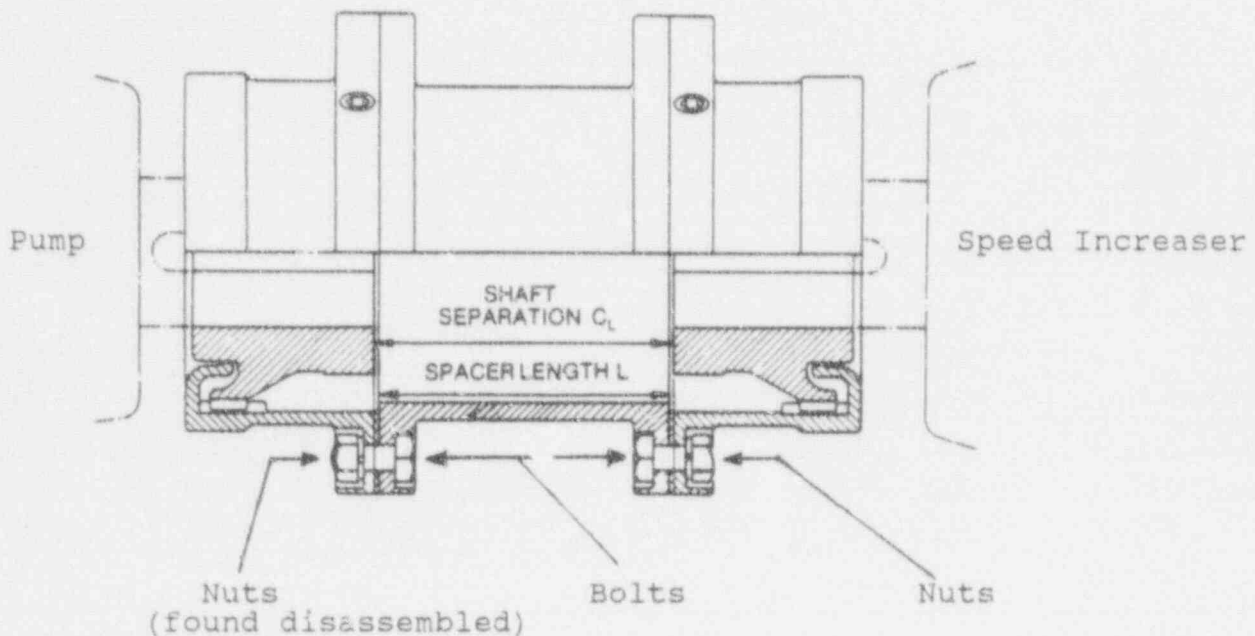
Figure 1

On 7/26/91 station mechanics were performing a lubrication preventive maintenance procedure (PMP-1/2-7CH-P-1A/21A-B-C-1M) on the "B" charging pump. When the coupling guard was removed, they noticed that all ten nuts for the pump side spool piece coupling were not attached to the bolts but were lying in the bottom of the coupling guard. The nuts and bolts on the speed increaser side of the spool piece coupling were in the correct configuration.

Improper installation of the coupling was due to inadequate work instructions. The procedure to reassemble the speed increaser to pump coupling directed the bolts and nuts be installed hand tight then the bolts were to be torqued. The coupling has a spacer and is bolted on both ends (Figure 1). However, the procedure does not specifically address torquing the bolts on each end of the coupling. This maintenance activity extended over several shifts and it is believed, but could not be verified, that only the bolts on the speed increaser half of the coupling were torqued. This would have resulted in the bolts on the pump half of the coupling being only hand tight and the coupling, as a whole, appearing to be properly assembled.

- 1) Following discovery of this condition and completion of the maintenance action, the nuts were installed on the bolts and torqued to specifications, applying torque to the nuts.
- 2) The other charging pump couplings were inspected and found to be satisfactory. Specified torque was verified on the coupling nuts.
- 3) All maintenance supervisors will review this incident.
- 4) The preventive maintenance procedures will be revised to contain a specific signoff for torquing the bolts on each coupling half.
- 5) The post-maintenance test sheet for the charging pump will be revised to include a step that has the coupling assembly verified as correct by the mechanic.
