Beaver Valley Power Station, Unit No. 2  
Docket No. 50-412, License No. NPF-73  
LER 92-004-00

LER 92-004-00, 10 CFR 50.73.a.2.v.D, "Diesel Generator Sequencing Relays Found Inoperable During Functional Testing".

TITLE (4)  
Diesel Generator Sequencing Relays Found Inoperable During Functional Testing

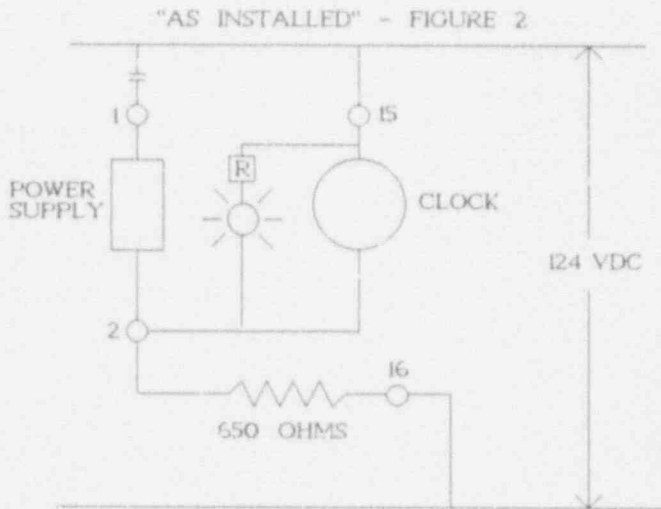
When these relays were installed during the last refueling outage, the relays' installation was modified to constantly energize the clock circuits in an effort to enhance the relays' time response (See figure 2). This was done by removing the "jumper" between terminals 1 and 15 and rewiring terminal 15 directly to a voltage source. However, this configuration resulted in the clock circuit being constantly energized at 112 VDC, which is not consistent with the tests used to qualify the relays.

The relay failures were due to improper design application. These relays were installed via a design change during the last refueling outage. They were designed for 24 VDC applications, but were installed in a configuration that caused the relay clock circuits to be constantly energized with 112 volts. The excessive constant voltage on the clock circuits caused high heat loads that resulted in relay failures. The relays are a sealed case configuration and the only means of heat dissipation is through radiative heat transfer. This design compounded the higher heat loads in the "as installed" configuration.

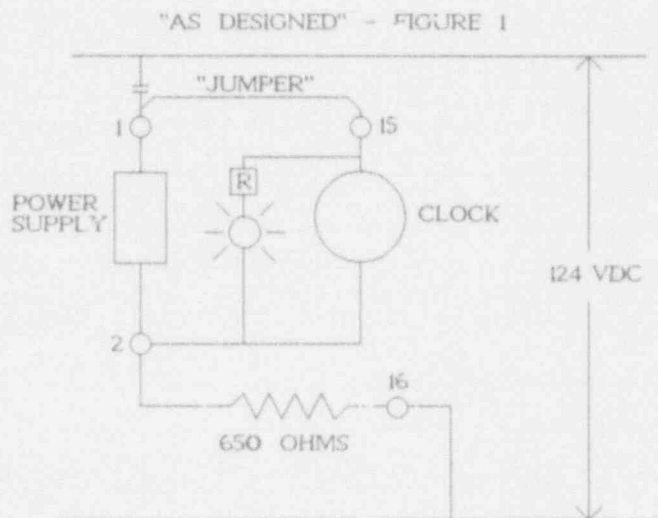
The relays have two separate internal circuits, a clock circuit and a power supply circuit. Both circuits are designed for 24 VDC operation. However, Beaver Valley's diesel generator sequencer operates on 124 VDC. For applications at this voltage, the manufacturer states a 650 Ohm series resistor can be installed to drop the voltage applied to the relay to 24 VDC. (See figure 1 for typical normal installation.)

The failed relays were replaced. The relay installations were returned to the original design (figure 1) so that the clock circuit and the power supply would energize simultaneously (which is consistent with the relay qualification test). Subsequent testing by plant relay personnel verified proper relay operations, including time response.
