U.S. NUCLEAR REGULATORY COMMISSION

Report Nos.: 95-23
95-23

Facility: Nine Mile Point, Units 1 and 2

Dates: September 3, to October 14, 1995

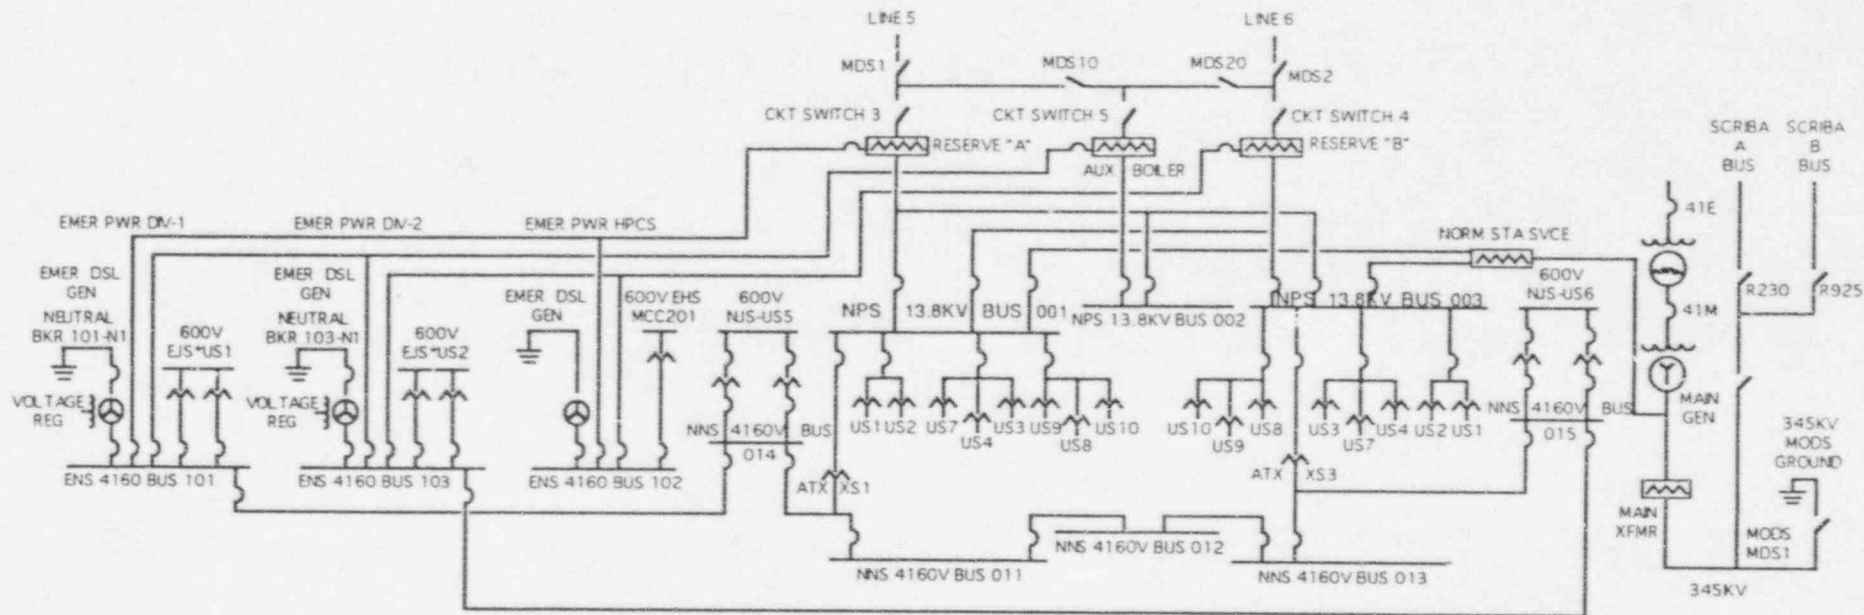
TITLE
Mimic of Electric Plant Control
Panel

The inspectors reviewed the actions taken by NMPC regarding the availability of offsite power to Unit 2. The unit experienced a partial loss of offsite power on September 6, 1995, at 2:20 p.m. This was the result of a ground fault occurring on phase "C" of the non-segregated bus which supplies power from the 13.8Kv secondary of reserve transformer 2RTX-XSR1B to the station service switchgear 2NPS-SWG003. A 4-hour event report was made to the NRC. NMPC initiated a Deviation/Event Report (DER 2-95-2538) to document the event, root cause(s) and corrective actions.

The ground fault occurred on phase "C" of the secondary side (13.8Kv) of transformer 2RTX-XSR1B, at a wall penetration transition piece where the non-segregated bus enters the south side of the normal switchgear building. The transition piece provides a fire and vapor barrier, and connects the aluminum bus bars on either side of the wall. The transition piece is bolted to the square aluminum bus bars; and consists of two flat copper pieces, each covered with a bakelite sleeve and supported at mid-length by a ceramic feed through bushing. NMPC replaced all of the phase transition pieces for both reserve transformers, based on early signs of degradation.
