Detroit
Edison

April 29, 1992
NRC-92-0049

Subject: Response to NRC Request for Information Concerning Low
Pressure Turbine Blade Failures and Disc Inspections

Attachment 1
Responses to NRC Questions and Discussion
of
Turbine Blade Failures

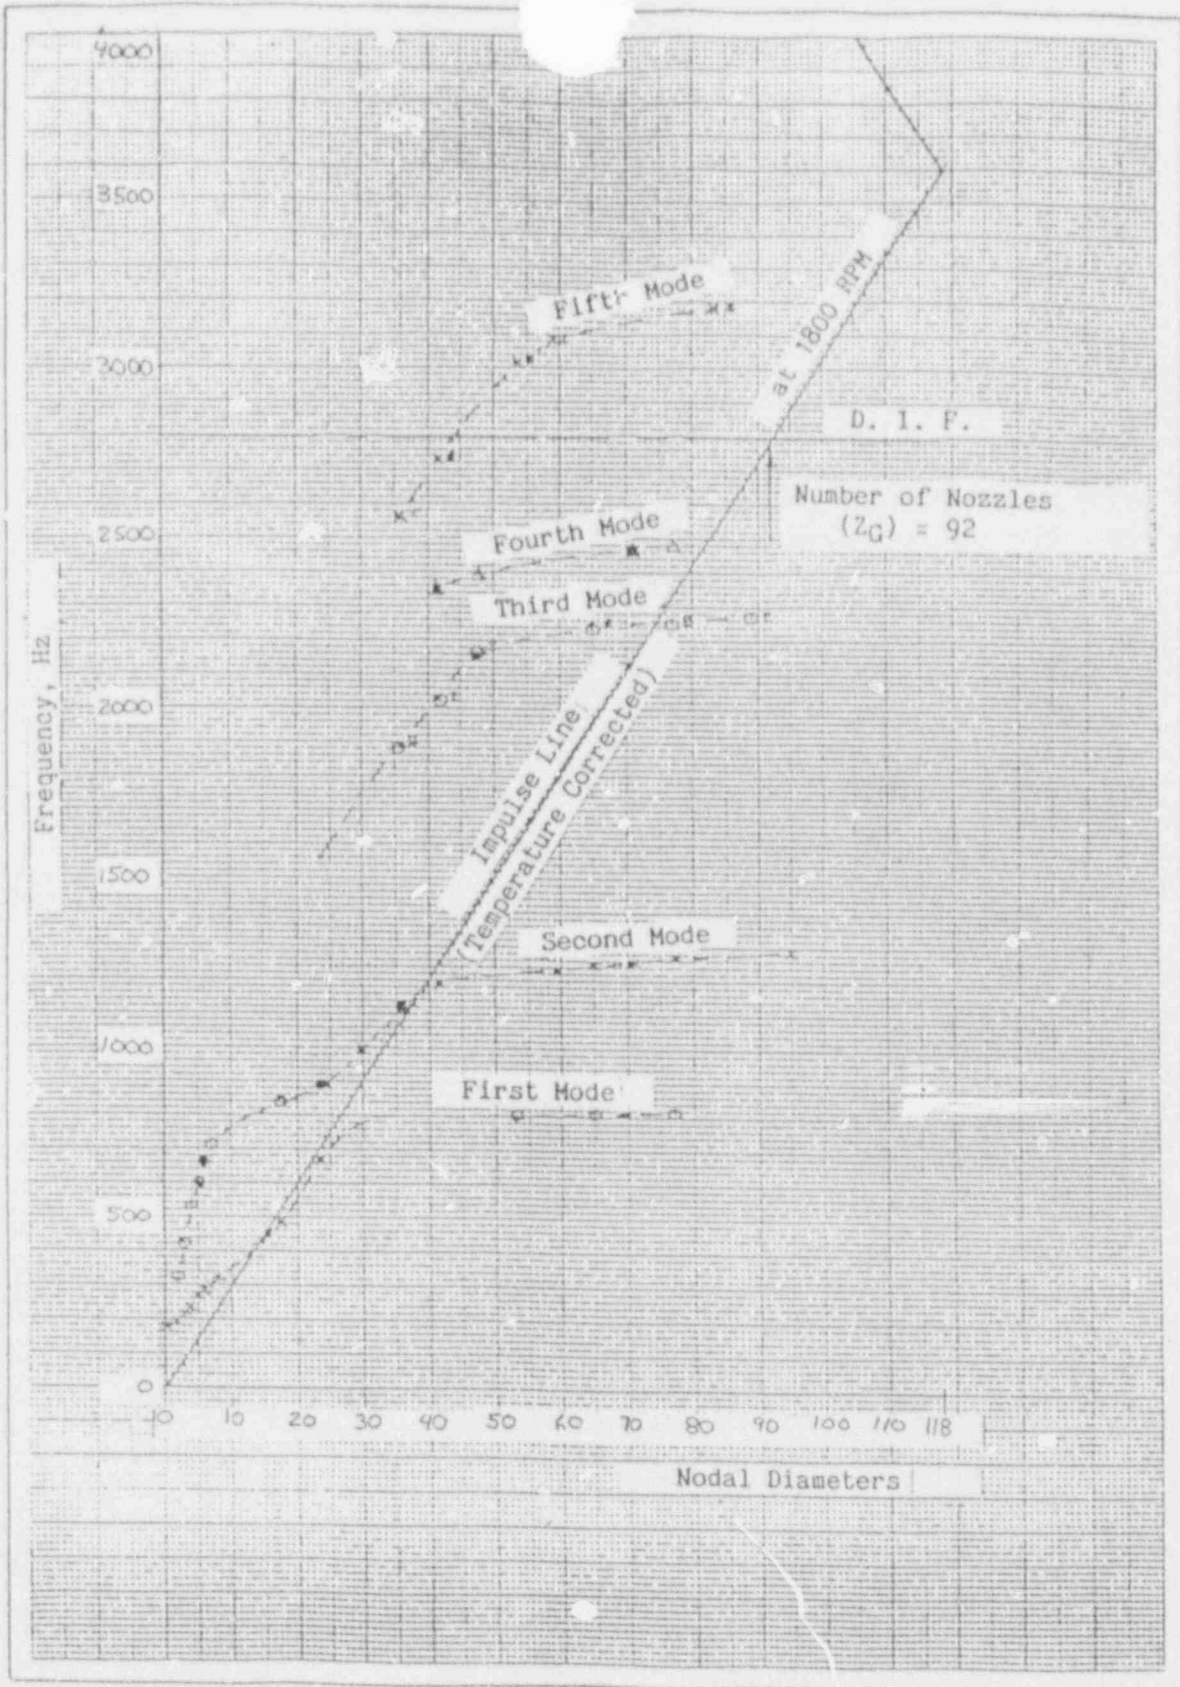
FIGURE 1

ENRICO FERMI SET 2: LP2 TURBINE END: STAGE 5
RESULTS OF VIBRATION TESTS ON STATIONARY ROTOR
ORIGINAL DESIGN

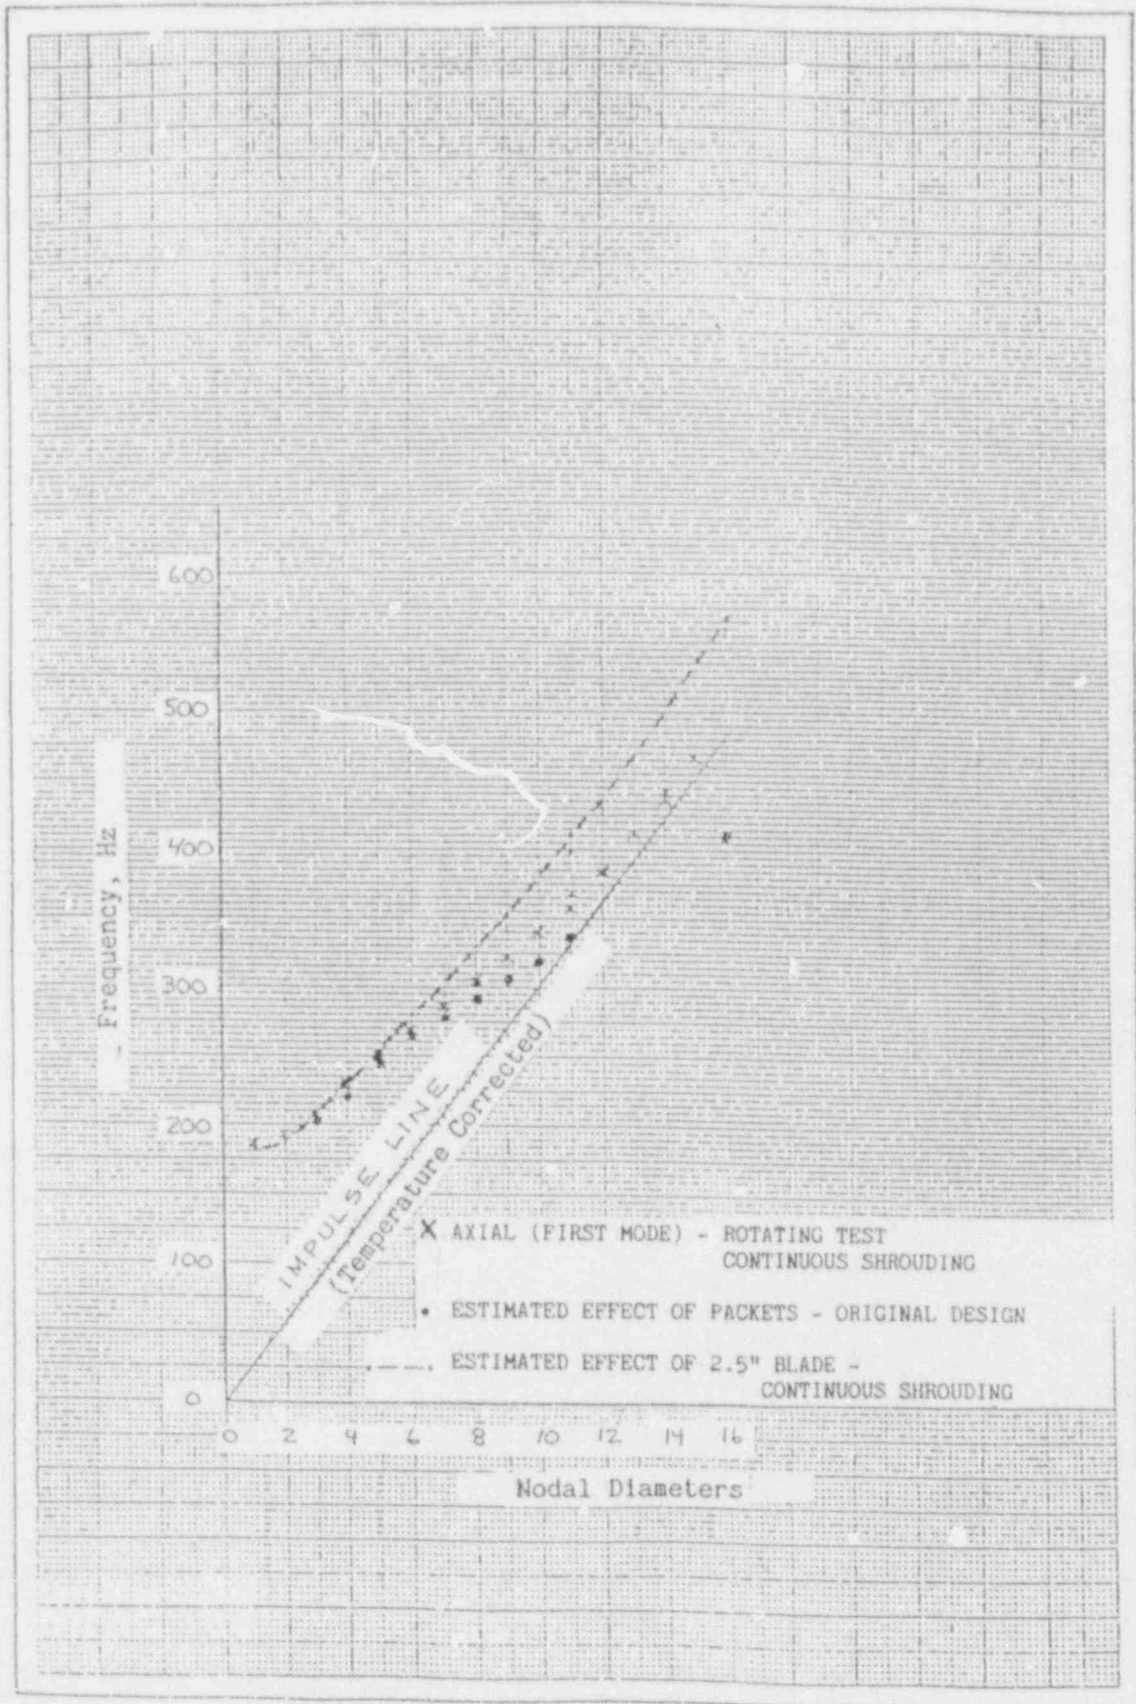
FIGURE 2

PREDICTED VIBRATION CHARACTERISTICS AT 1800 RPM

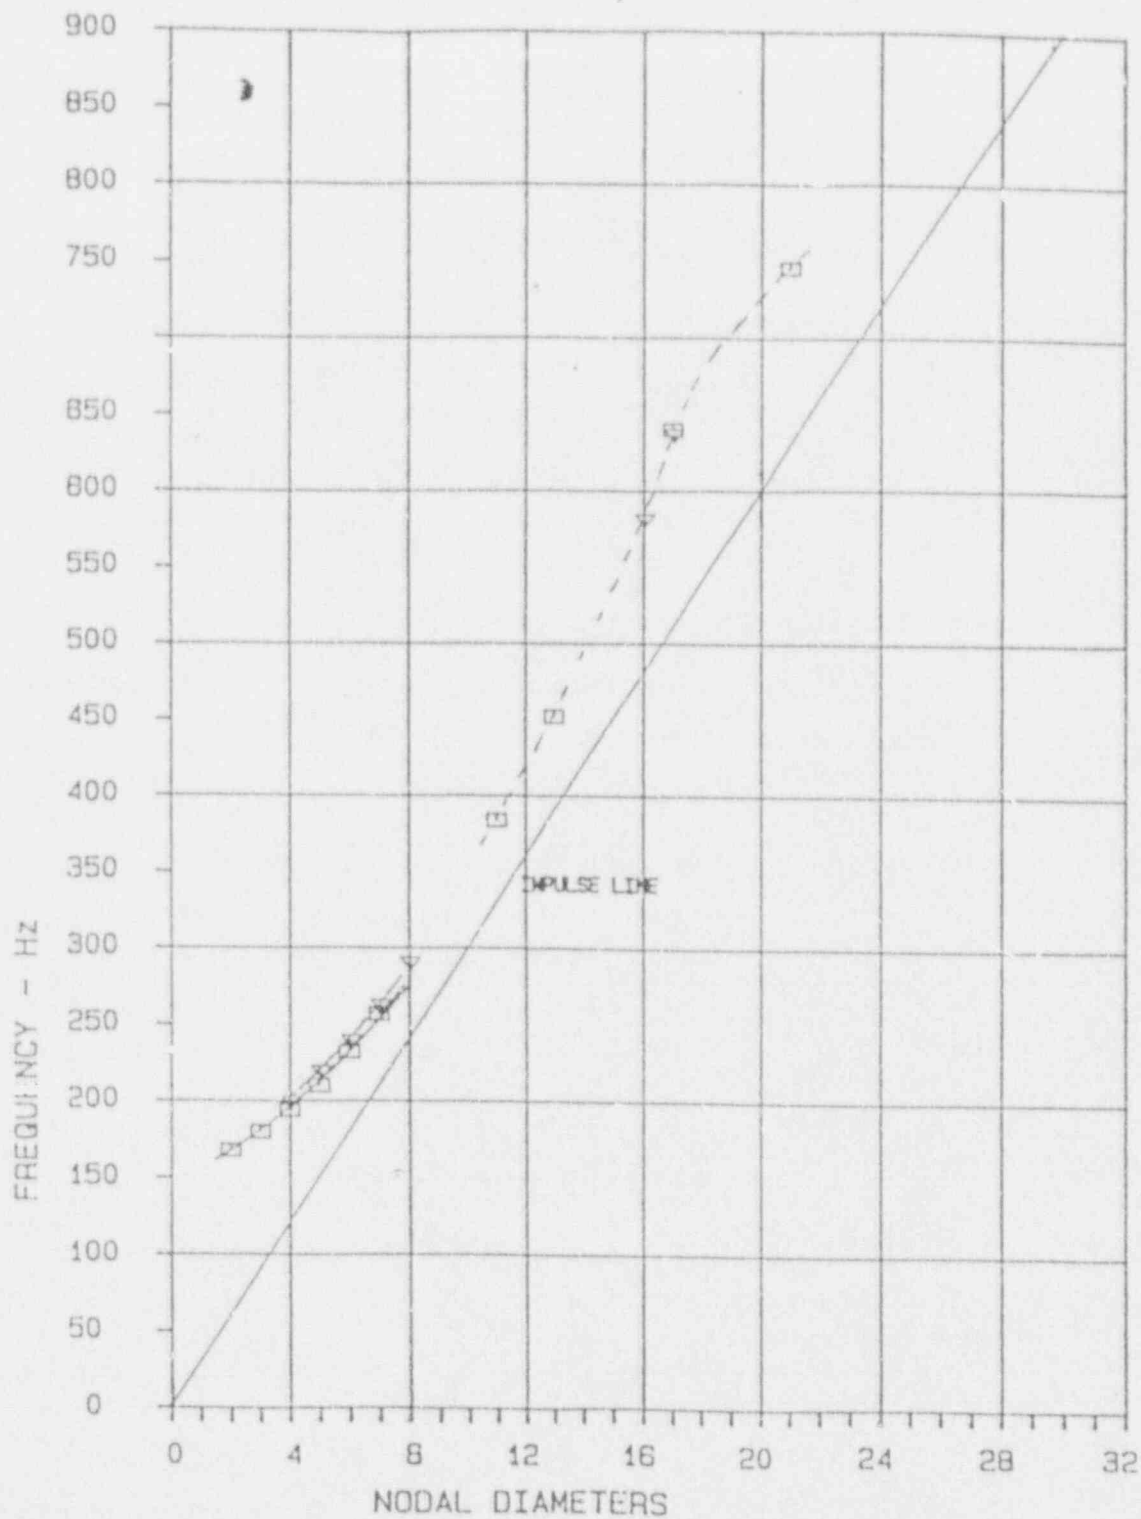
FIGURE 3

RESULTS OF VIBRATION TESTS ON STATIONARY ROTOR

CURRENT DESIGN
