U.S. NUCLEAR REGULATORY COMMISSION  
OFFICE OF NUCLEAR REACTOR REGULATION

NRC Inspection Report: 50-361/95-201  
and 50-362/95-201 (FINAL)

Facility Name: San Onofre Nuclear Generating Station, Units 2 and 3

Inspection Conducted: October 16-26, 1995 (Second Phase)

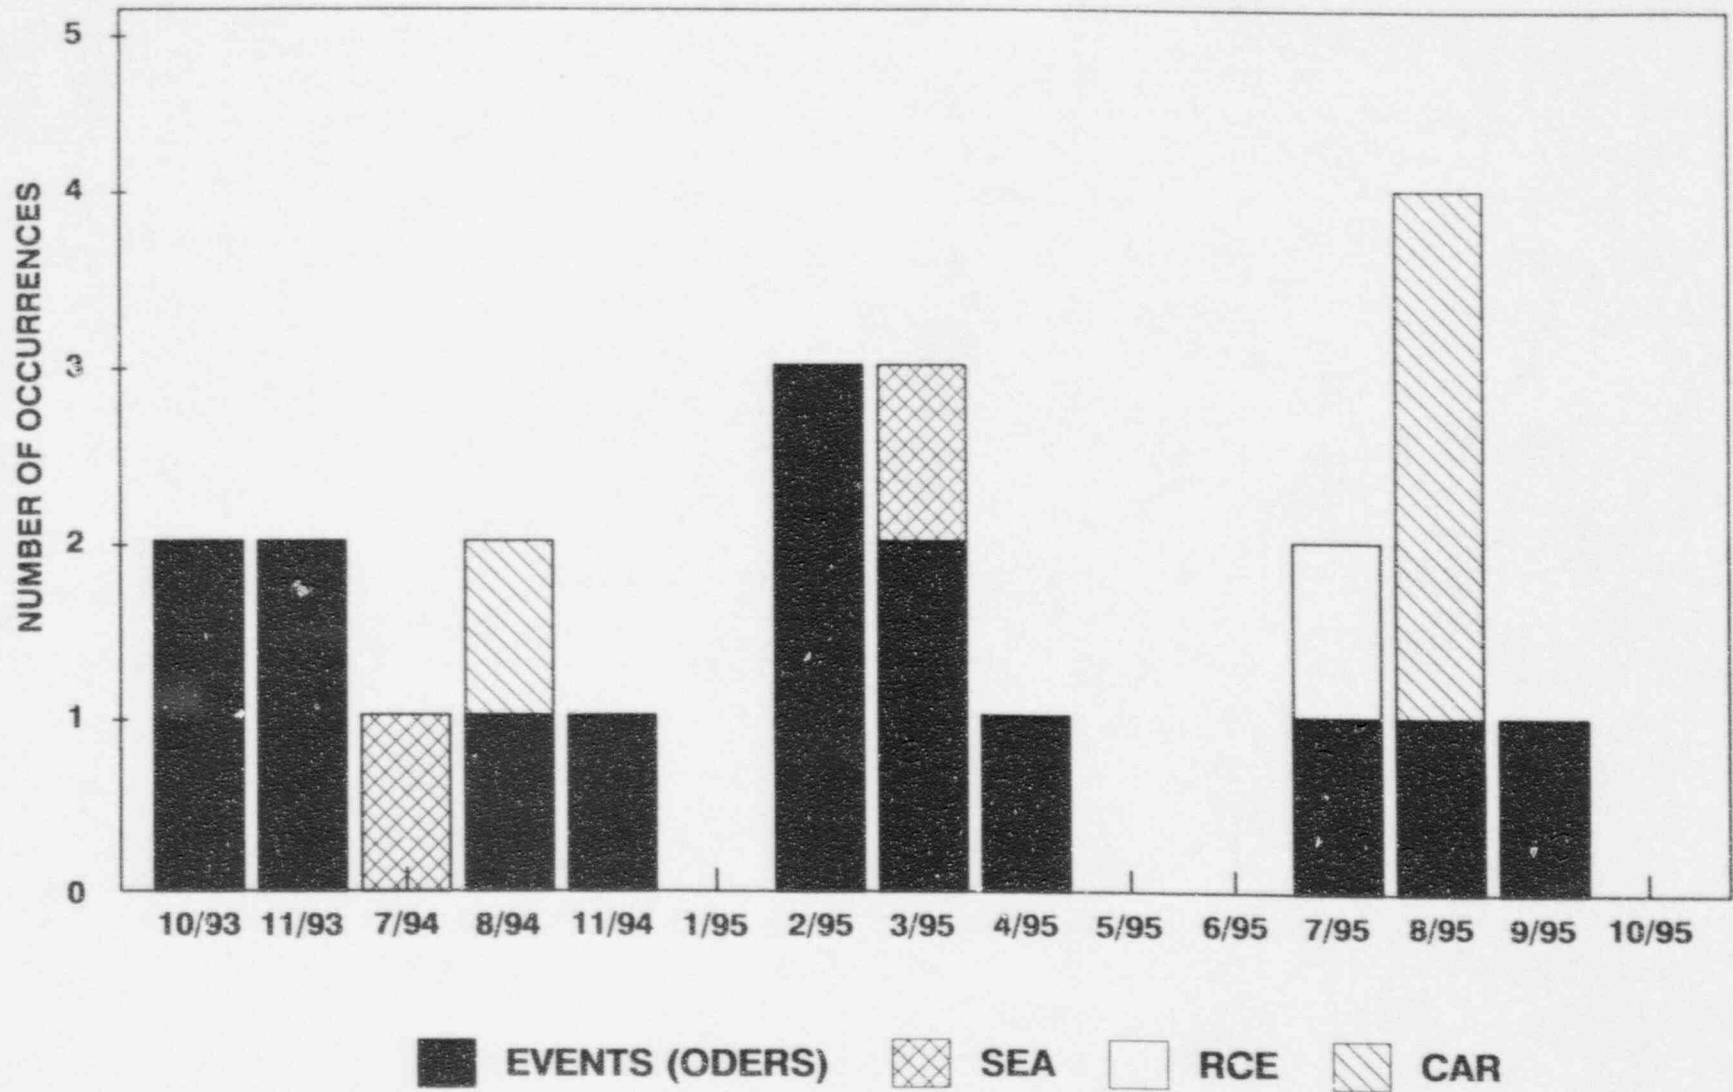
FIGURE 1

Figure 1 depicts 15 operational events that occurred over a two year time period from October 1993 to September 1995. In response to these events, the Nuclear Oversight Division's Safety Engineering Group issued two Safety Engineering Assessments and one Root Cause Evaluation. The Quality Assurance Group also issued four CARs. Problems with operator performance were also identified in CAR-013-94 - Operations Degraded Performance, issued in August 1994. These corrective action requests, evaluations, and assessments provided
