2.790 MATERIAL
Withhold From Public Disclosure
METALLURGICAL ANALYSIS
of
FERMI 2 LP3 EIGHTH STAGE
TURBINE BLADING

Report No. 94V70 - 13
June 20, 1994

Subject: **Metallurgical Examination of Fermi-2 Low Pressure
Seventh Stage Turbine Blading**
Technical & Engineering Services Report 94V70-22

Subject: Metallurgical Analysis of Fermi-2 Low Pressure
Seventh and Eighth Stage Turbine Blading
Technical & Engineering Services Report 94V70-30

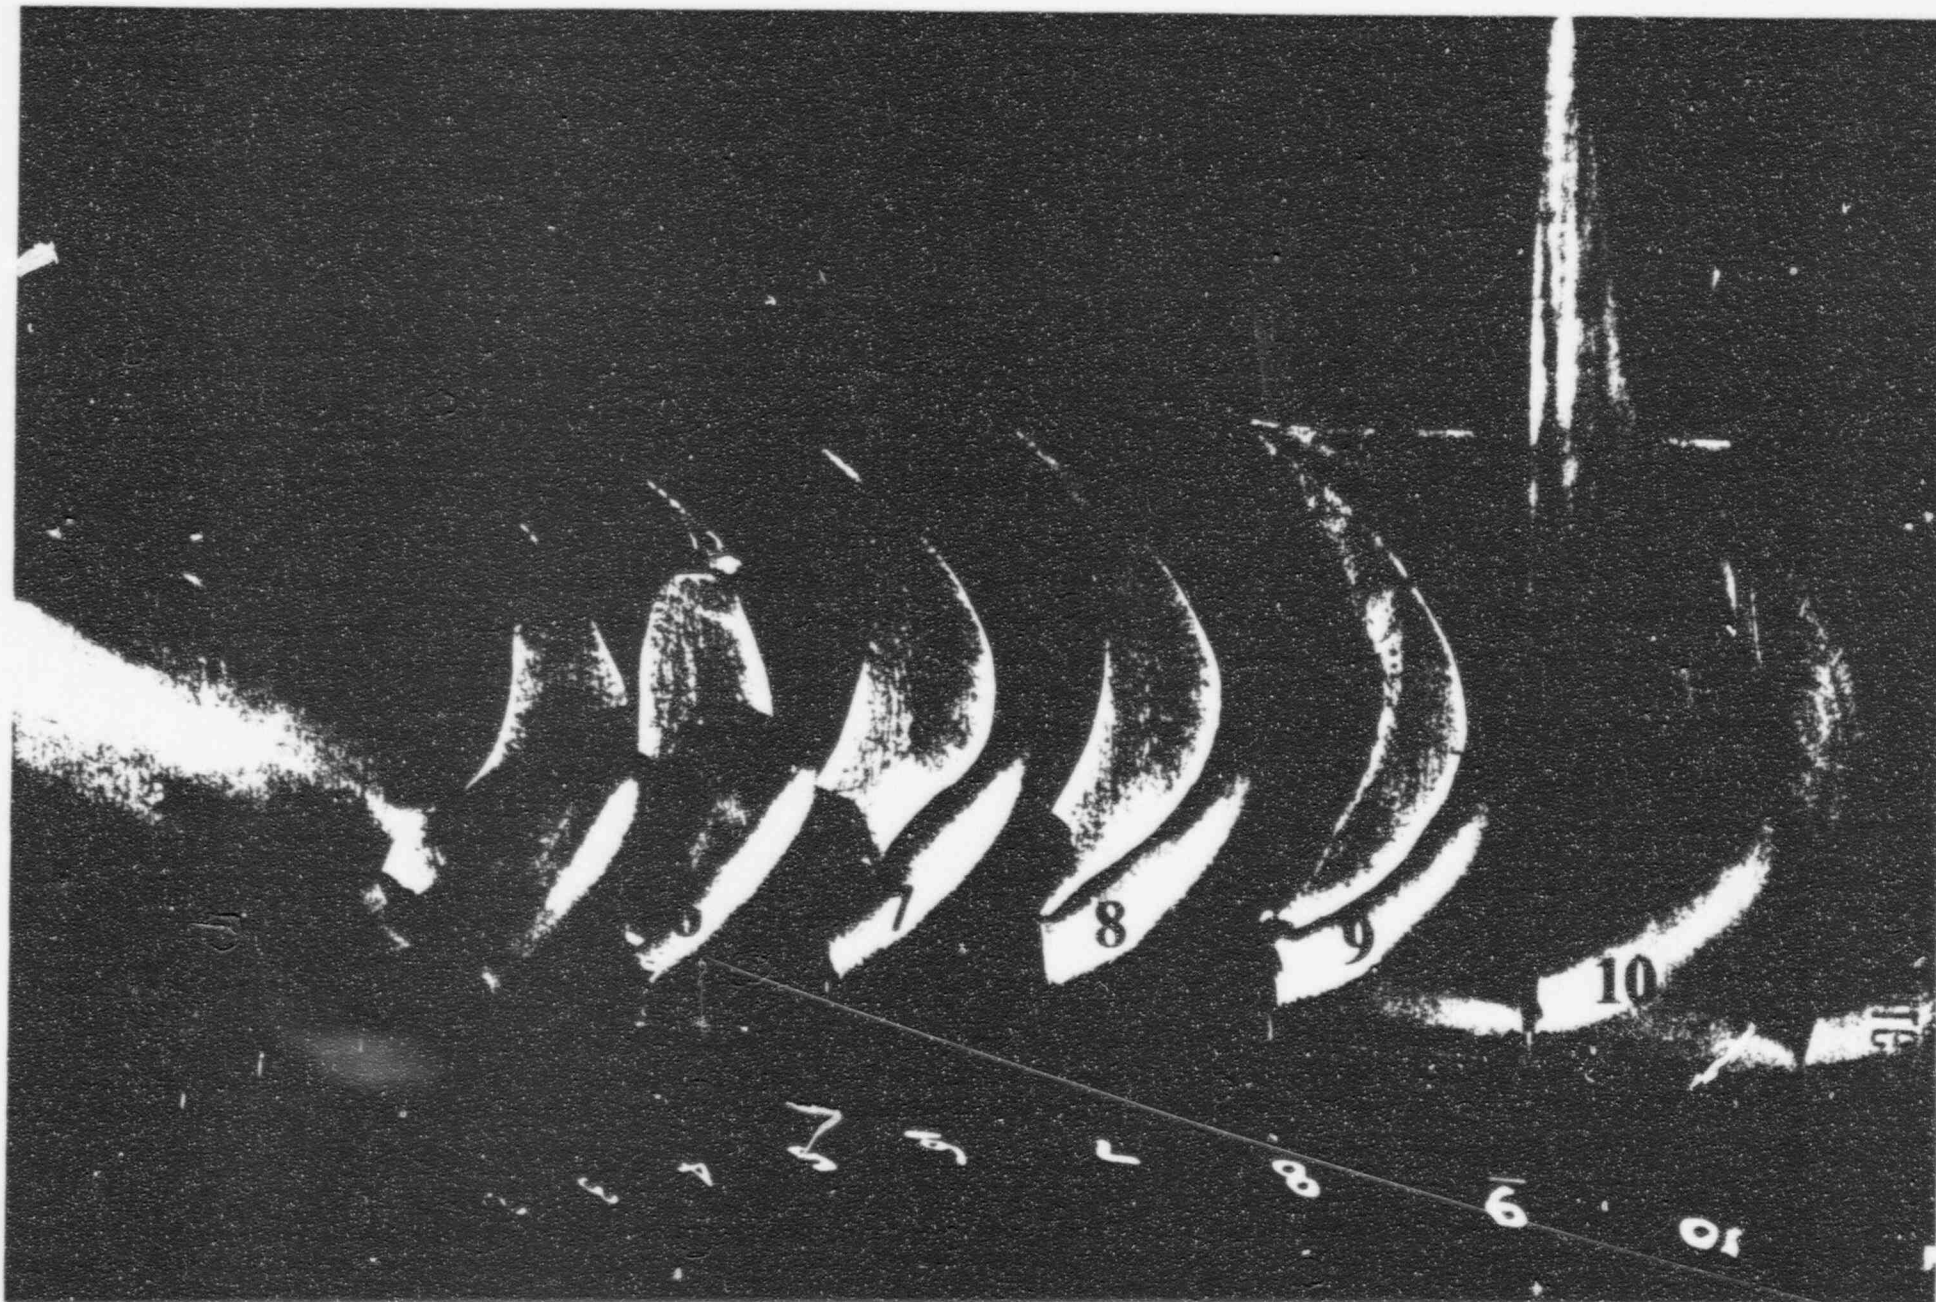
Figure 1 Stage 8 of L.P. No. 3 Turbine showing failed blade sections

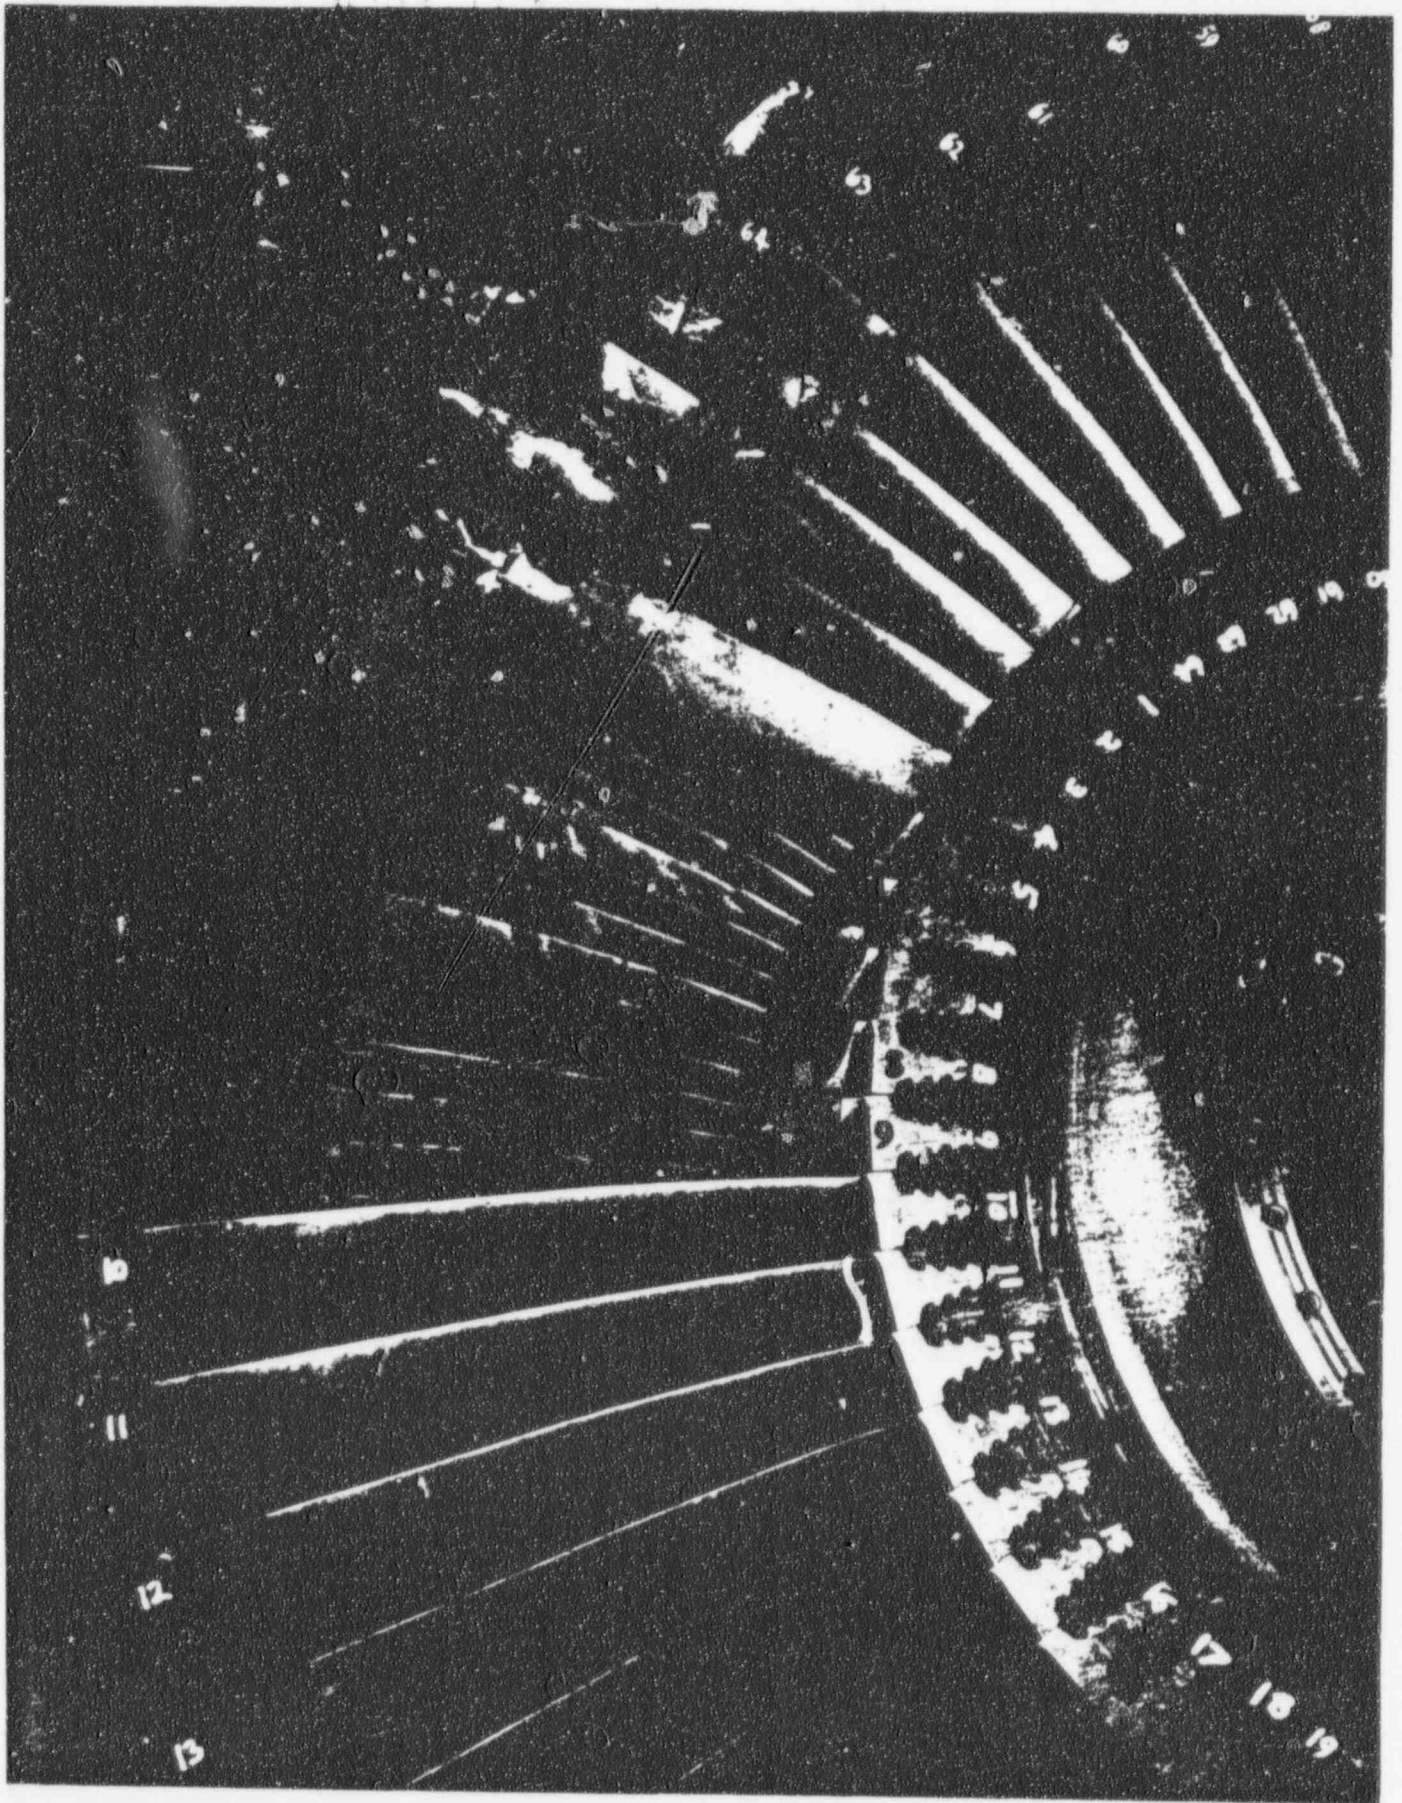
Figure 2 Failure area of L.P. No. 3 showing fractured and damaged blading.

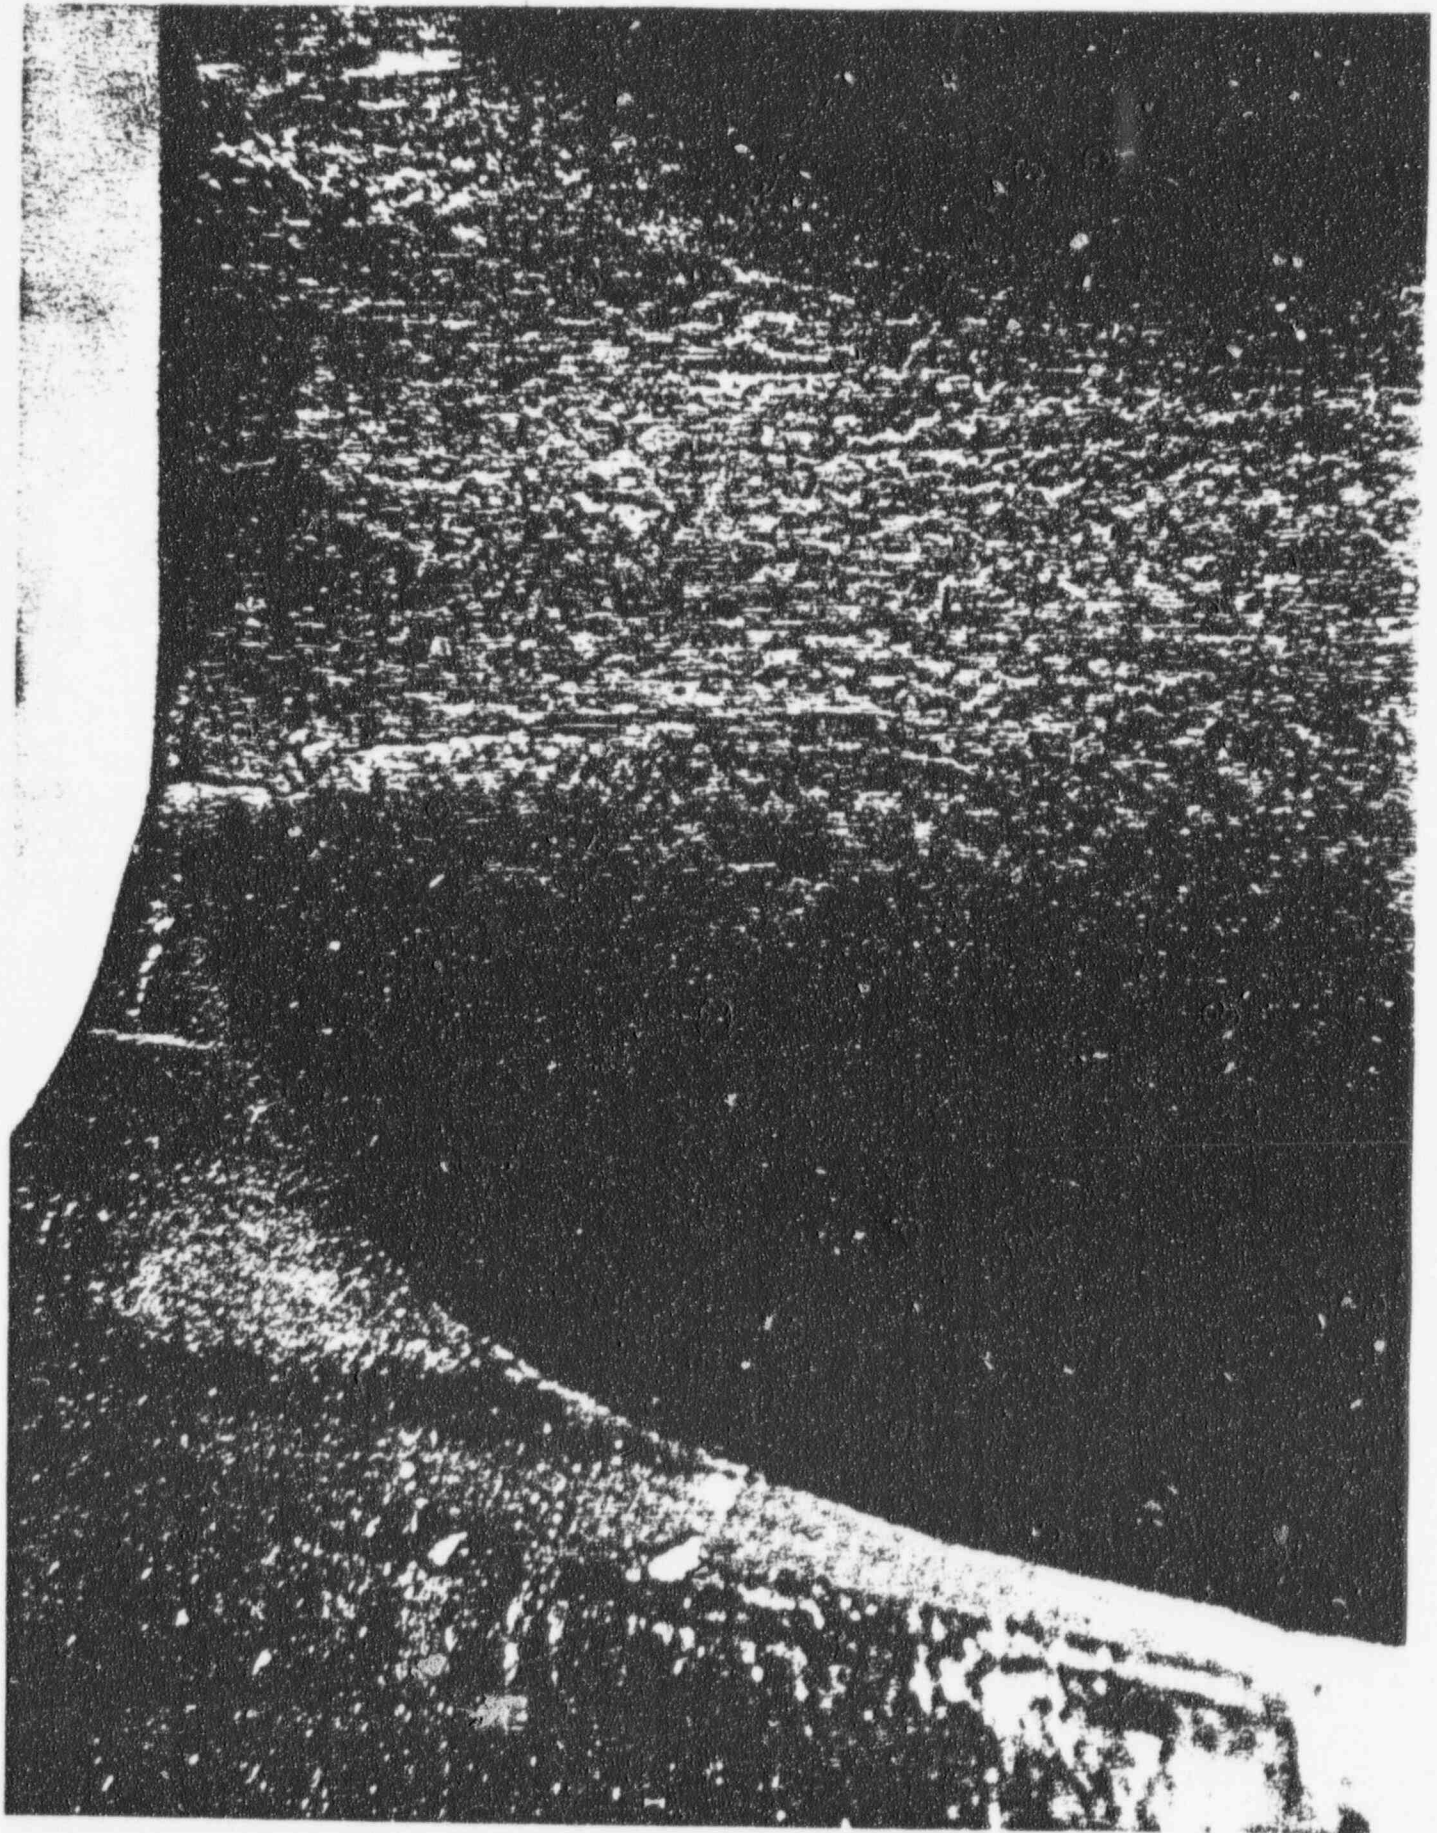
Figure 3 Trailing edge crack in Blade 3.

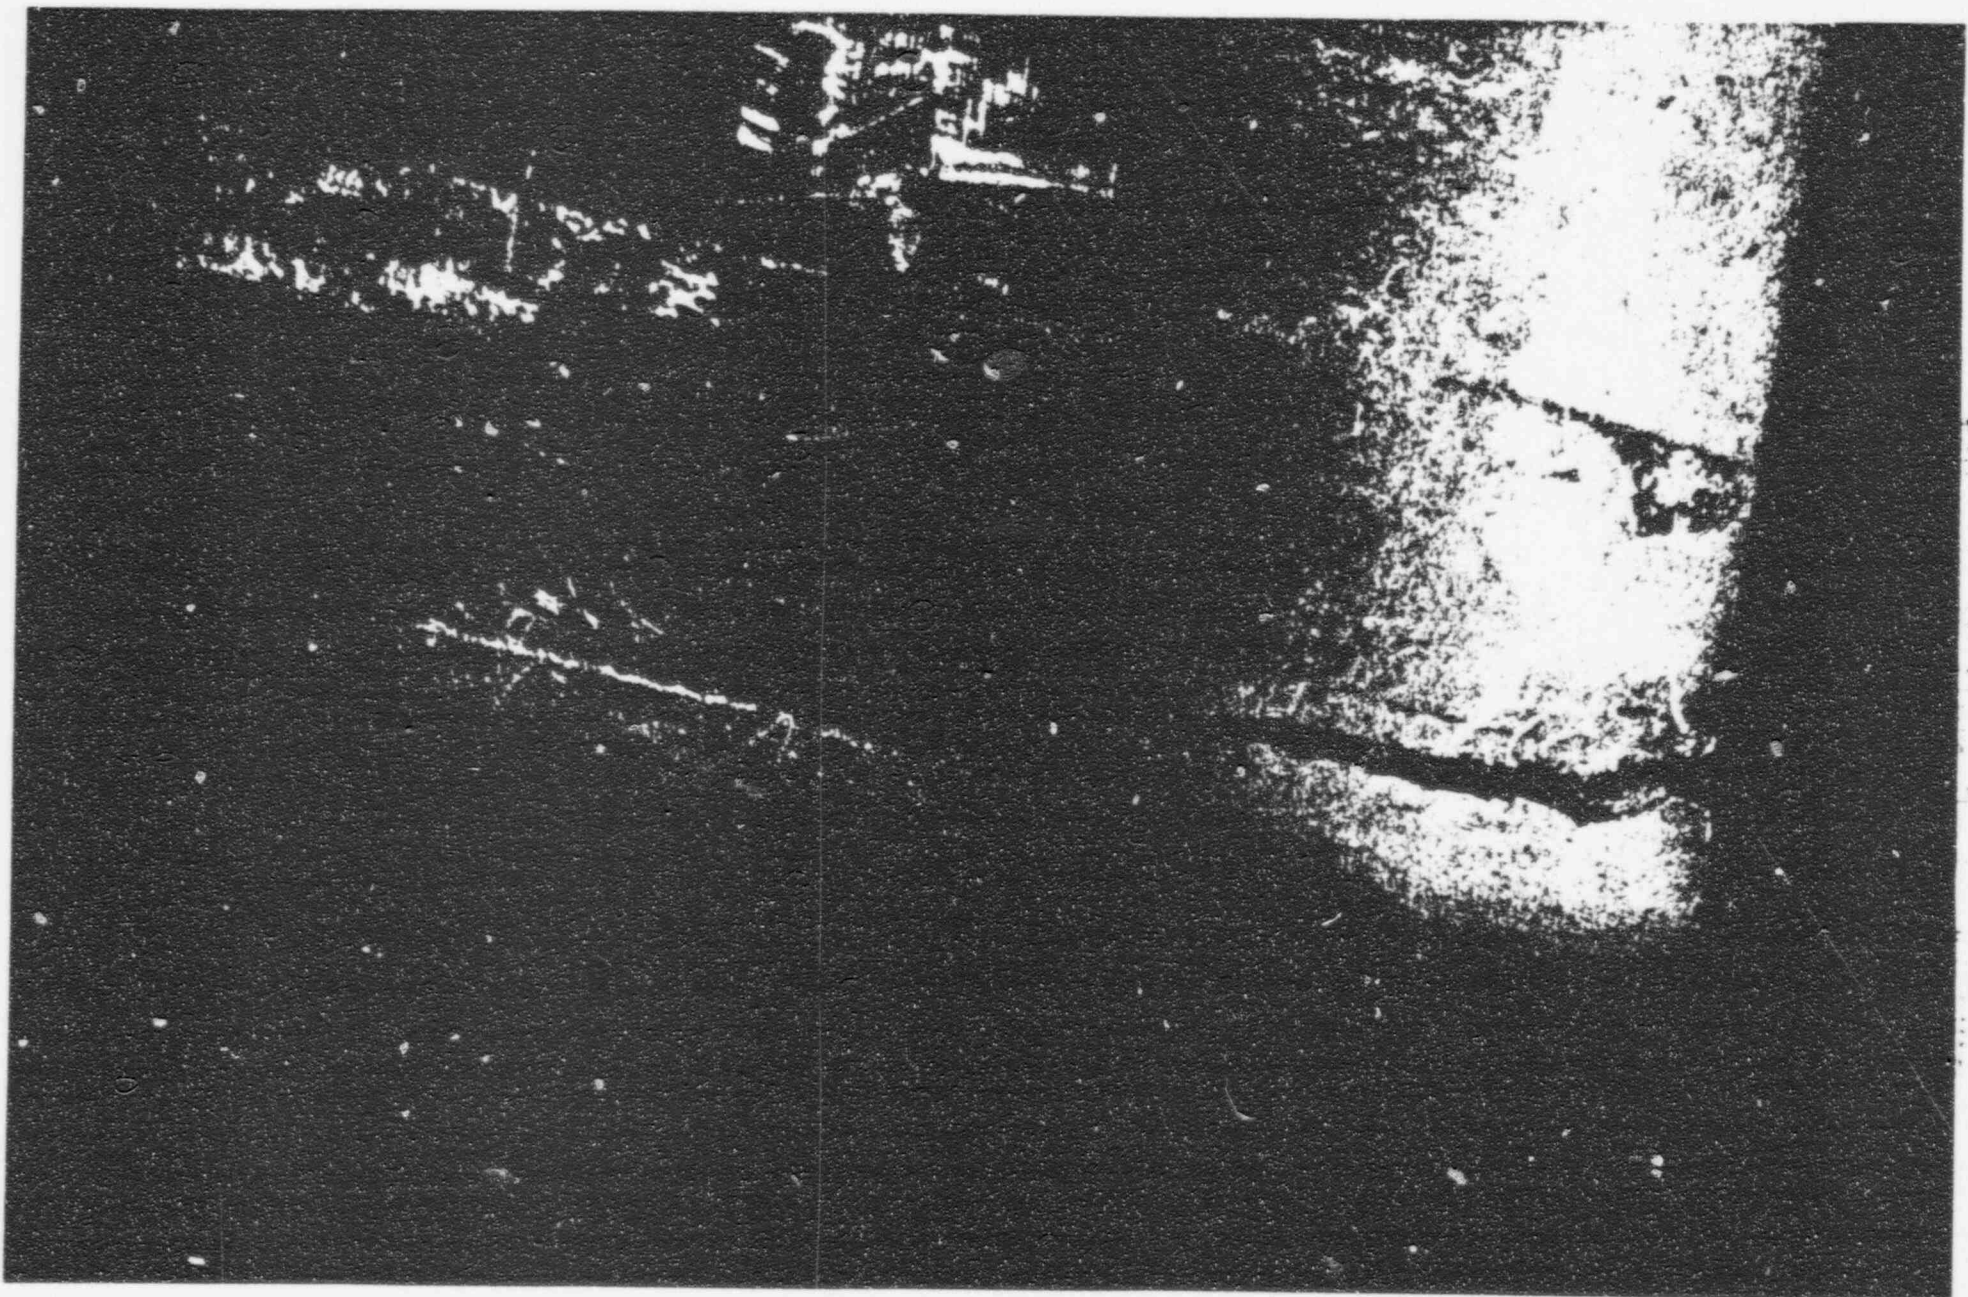
Figure 4 Trailing edge crack in Blade 1.

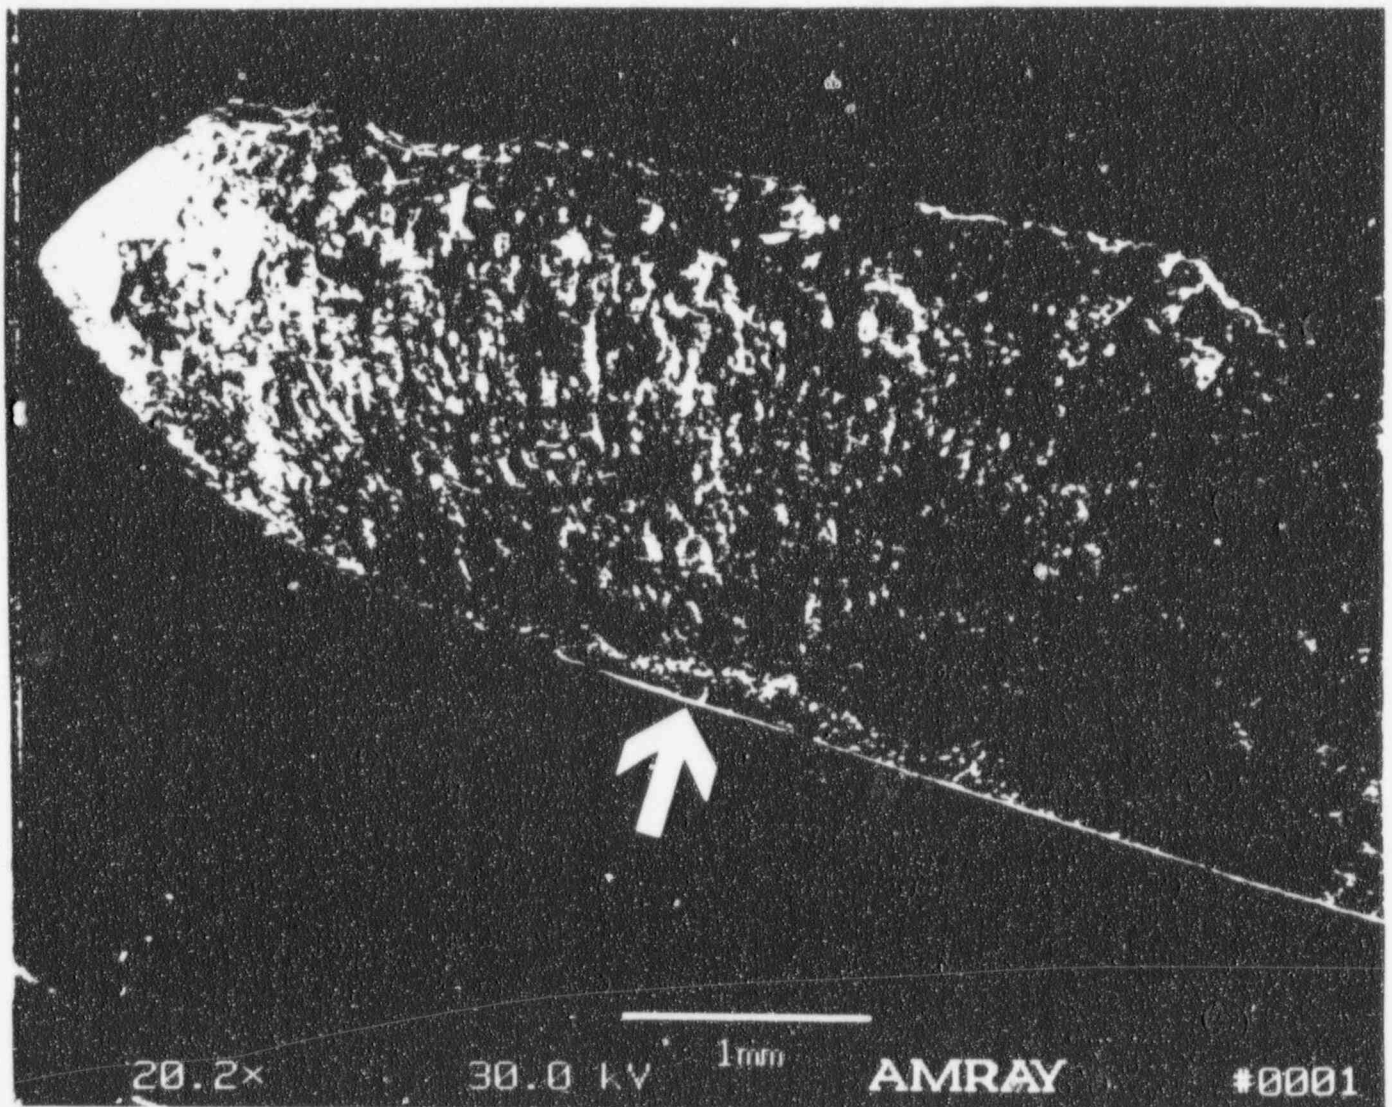
X Initial visual examination of Blade 9 indicated a thin trailing edge and a sharp "V" edge (Figure 5, Page 13) as opposed to the rounded and thicker edge on other blades (Figure 6, Page 14). A thickness survey of other blades as shown in Table 1, Page 15 shows an obvious trailing edge thickness problem in Blade 9. As a further check of the trailing edge problem, a dimensional survey was made of two blades (4 and 9) for a 3.5 inch distance from the trailing edge. A plot of the cross sections and integration of the areas revealed Blade 4 to have 28 percent more cross sectional area over the 3.5 inch distance. The reduced thickness is obviously not confined to the very edge of the blade. This reduced cross section would produce a higher stress in Blade 9 for the same blade load. In addition, a forging or machining condition at the failure elevation above the platform was also noted on nearly all blades. A pronounced gradual dip in the concave surface up to 0.040 inches deep was found to extend across the full section of the blade. However, there was no evidence of any cracking associated with this condition. A cursory review of turbine blade records noted the reference to a manufacturing problem, the accidental thinning of the trailing edge, which was designated as Deviation T52 (Merz and McClellan - Design Review - 46" Long Prototype Last Stage Blade, 22 June 1973). Further details on the problem were not readily retrievable.

Figure 5 Thinned and pointed trailing edge, and fatigue crack initiation (arrow) in Blade 9.

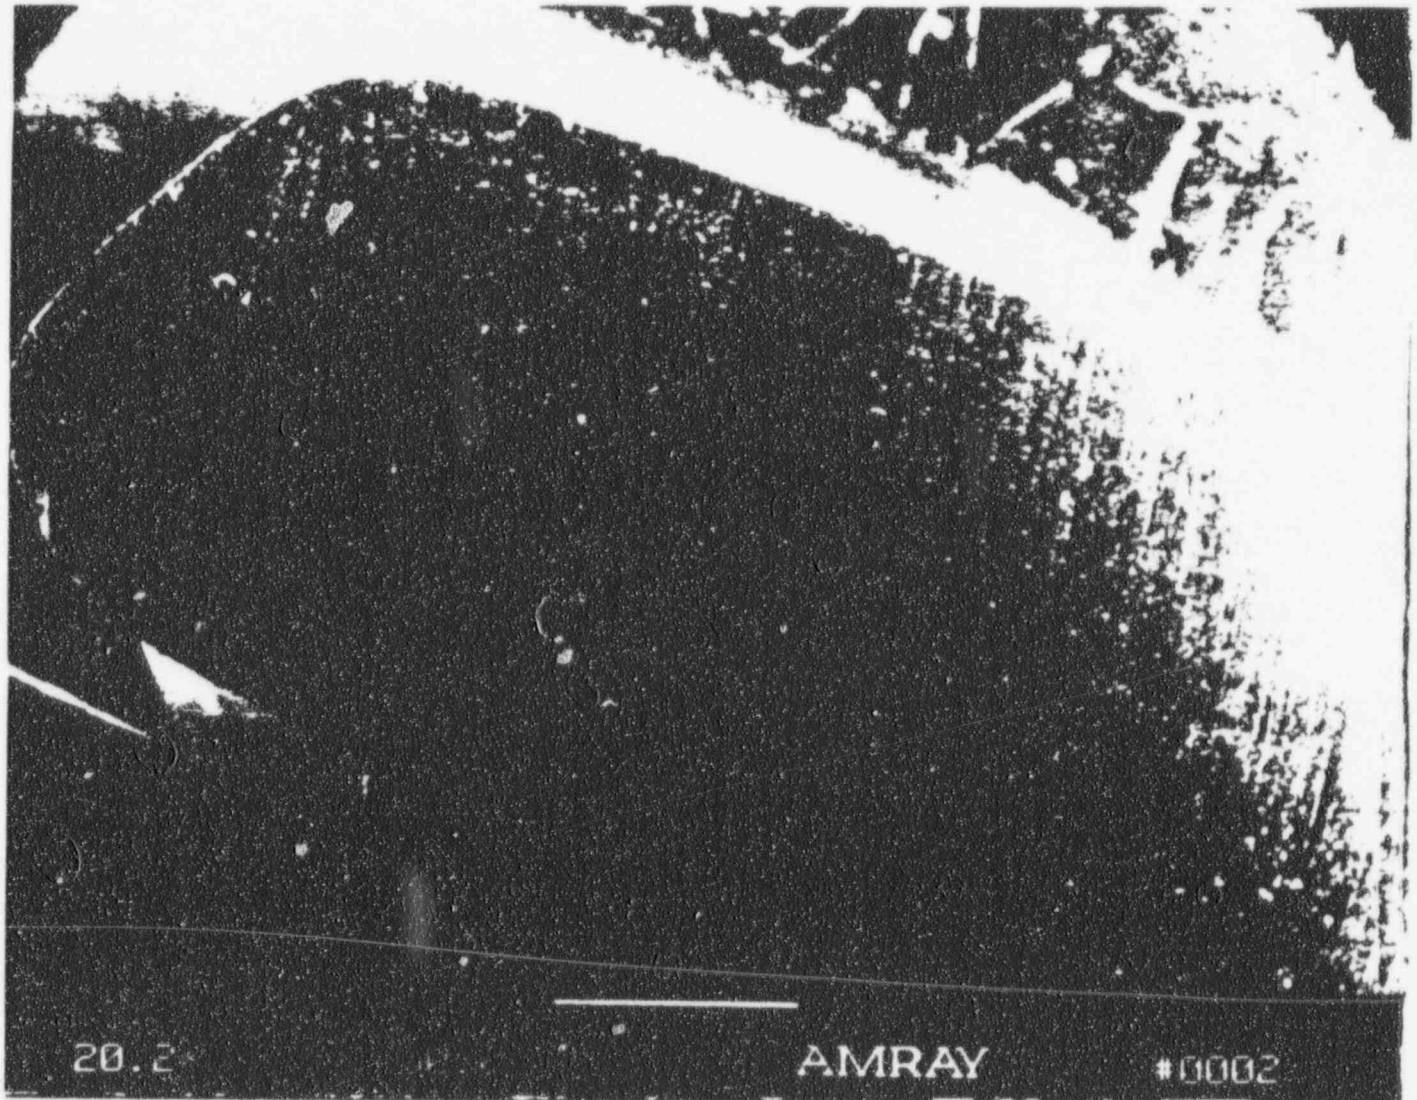
Figure 6 Cross section of Blade 4 at failure reference location showing normal rounded edge and increased thickness.
Mag. 20.2 x

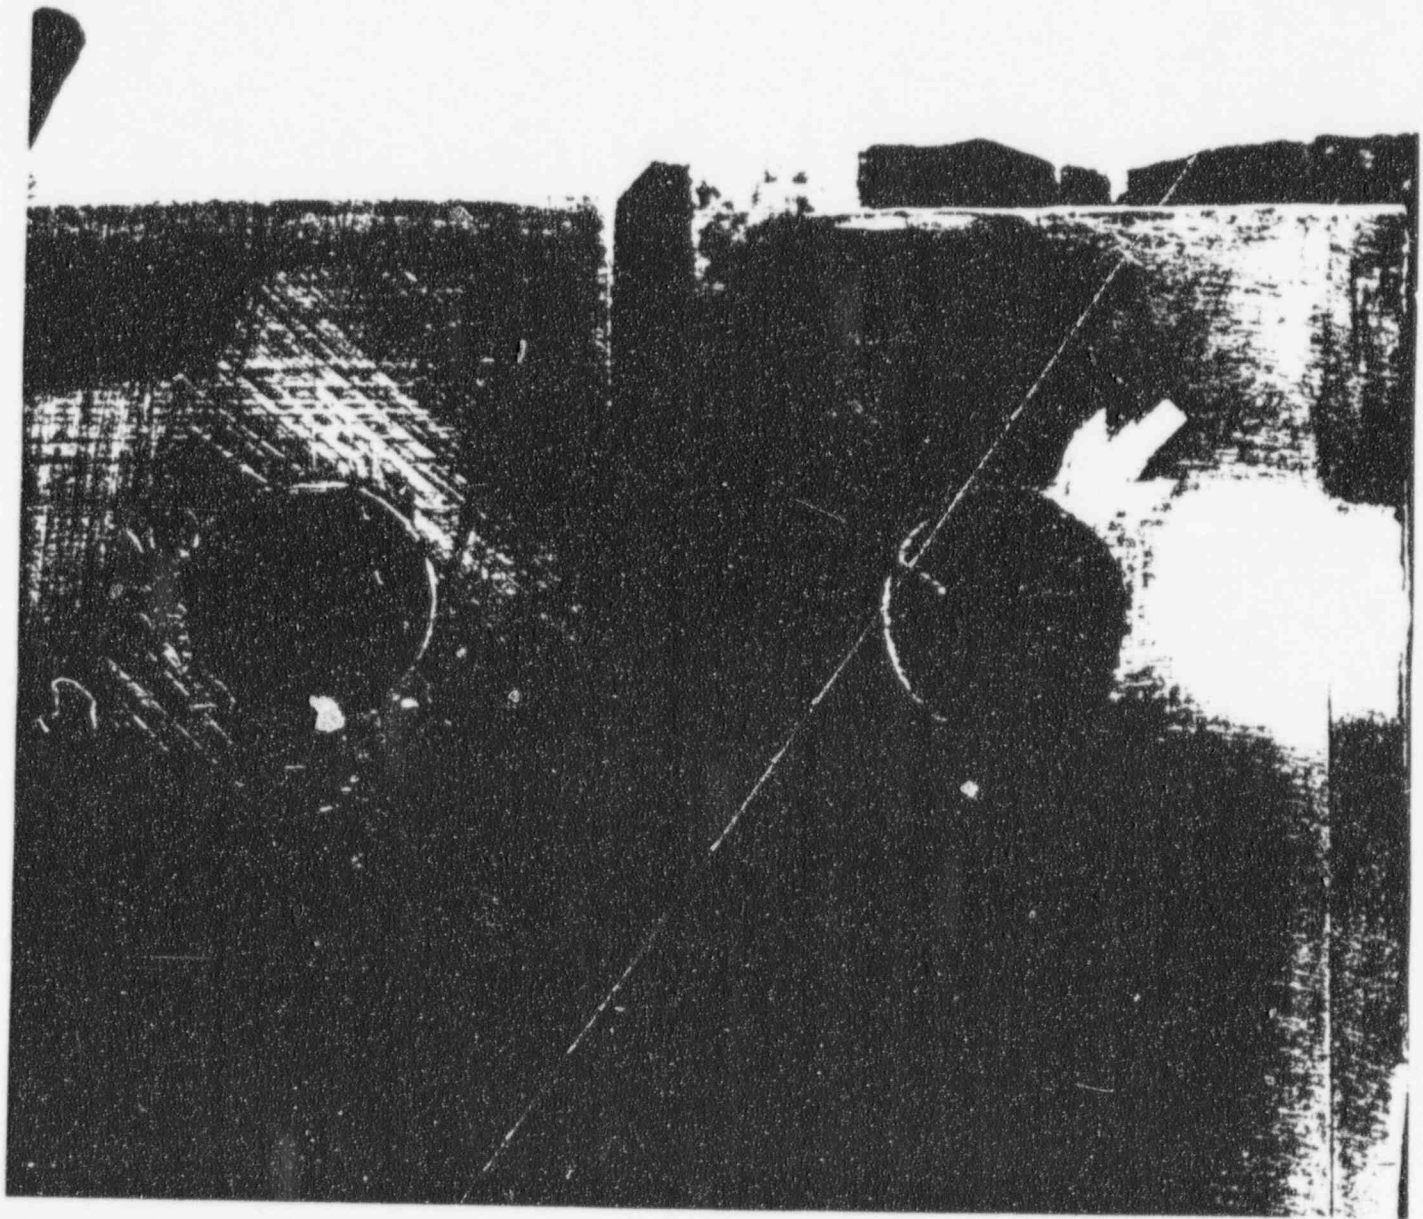
X Evidence of fatigue cycling in Blade 9 during turning gear operation was apparent from the indentations on the blade platform where contact was made with Blade 8. Reportedly the manufacturer originally used spacer pins ("packer pins") to close the gap when excessive clearance existed. Figure 7, Page 16, shows the contact surfaces of Blade 8 to Blade 9. A seven mil indentation in Blade 9 indicates a loose condition. This could be influential during turning gear operation in amplifying the trailing edge stress condition. Laboratory strain gauging and testing of a sample blade or Finite Element Analysis would assist in determining the magnitude of this stress cycle. While the installation of "ripple springs" in RF01 would minimize subsequent movement, it would not remove fatigue damage accumulated during many hours on turning gear.

Figure 7 Platform contact between Blades 8 and 9 shows indentation in Blade 9 from "packer pin".

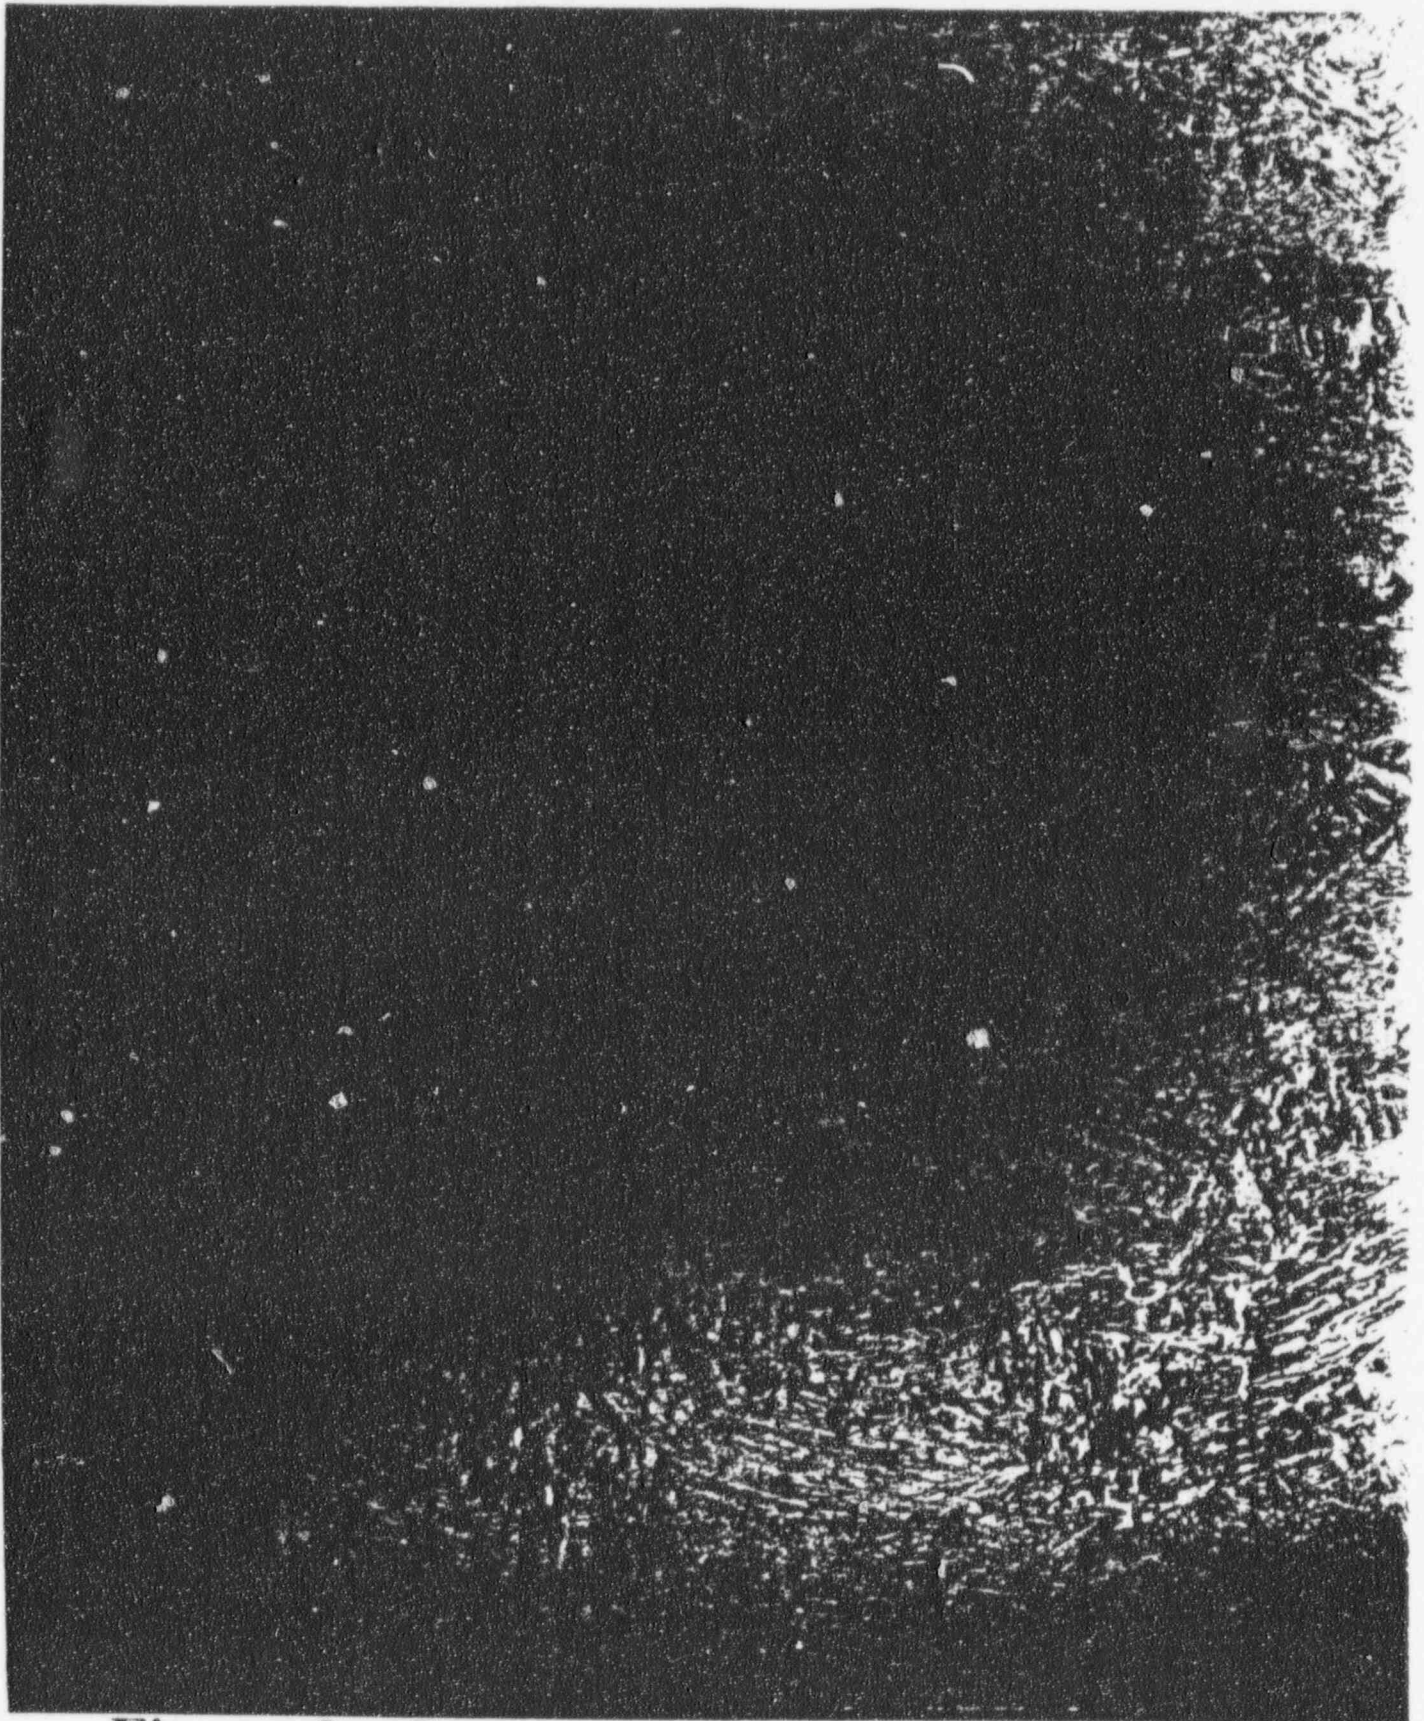
X Many of the blades, particularly on the concave surface, exhibited grinding and/or tool marks running in an undesirable direction transverse to the blade. Surface conditions such as these act as stress raisers and may lead to the initiation of fatigue cracks. Good finishing practices include the removal of such marks.

Figure 8 Concave surface of the blade exhibits tool marks up to ~~0.003~~ inches deep.

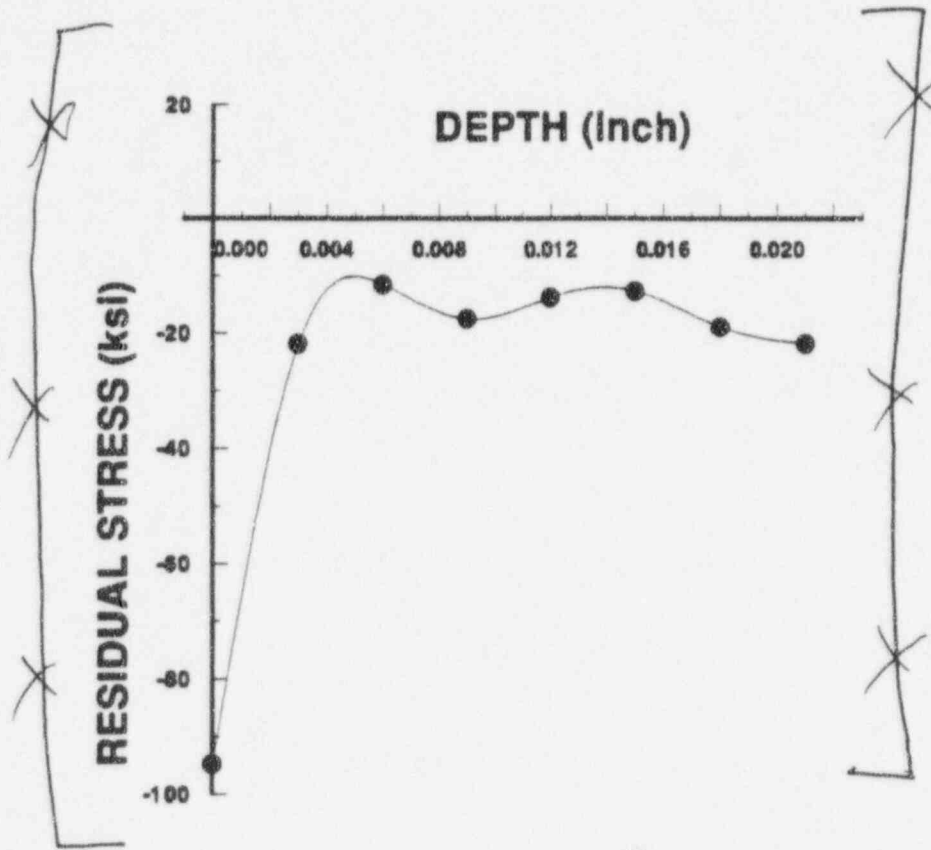
Residual stress measurements on Blades 10, 48, and 60 were performed by TEC in Knoxville, TN. Their analysis shows significant residual compressive stress at the surface for locations comparable to the initiation site on Blade 9. Values of -67 to -94 ksi at the surface decaying to -2.7 ksi at 15 mils below the surface have been reported. A plot of residual stress found in Blade 48 is shown in Figure 10, Page 22. These results must be related to the Finite Element Analysis work to establish the overall significance. Reference data cannot be obtained from Blade 9 and assumptions must be made in view of the thin trailing edge. If the trailing edge condition were introduced after final heat treatment the residual stress pattern could be totally different.

FIGURE 10 - Residual Stress Profile for Blade 48 at Failure Initiation Point.

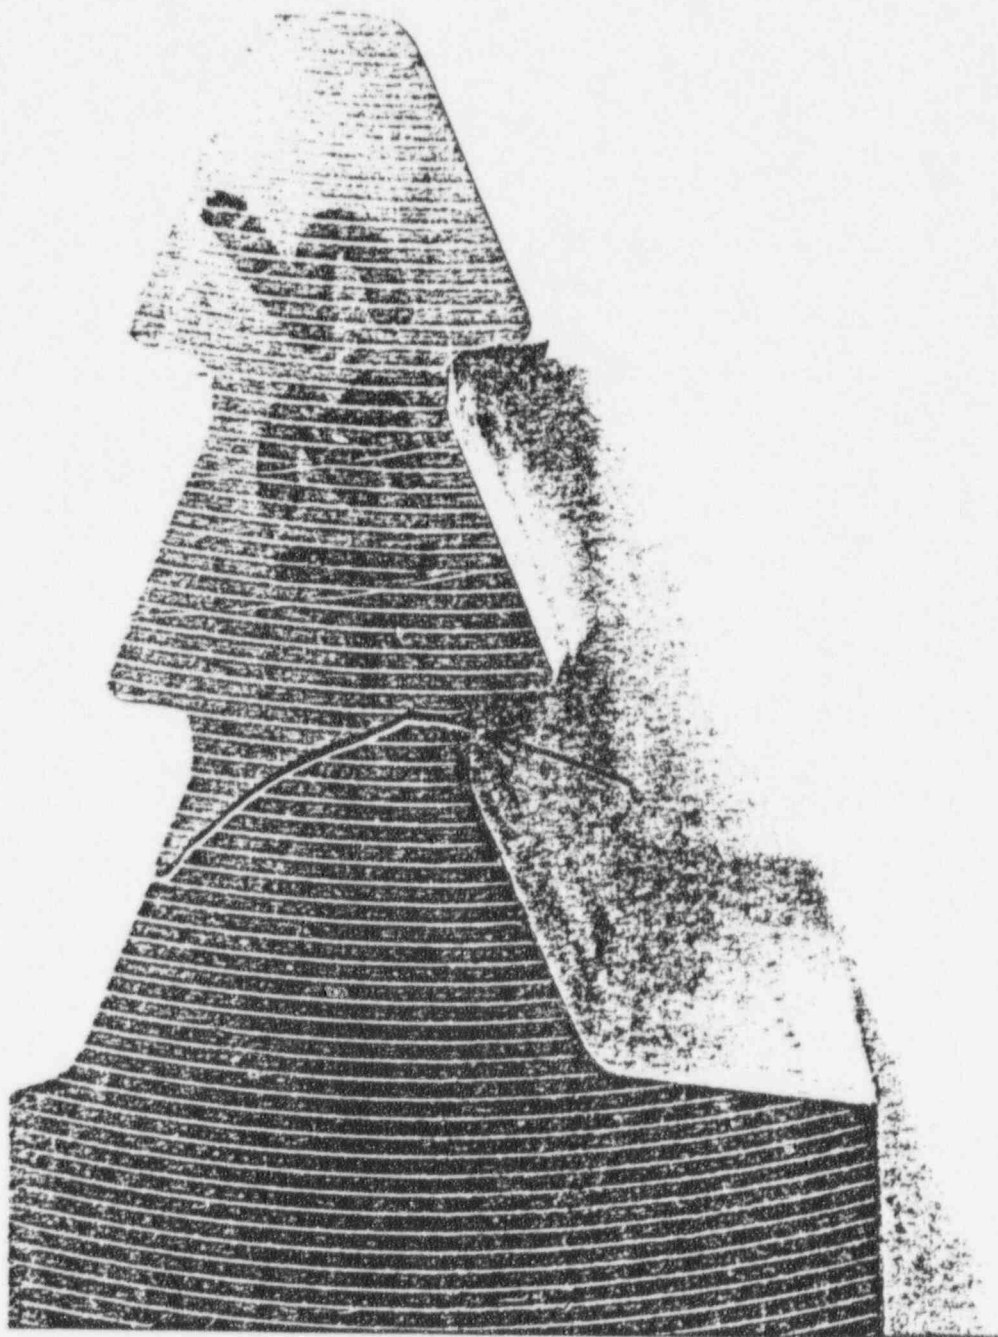
Figure 1 Typical root section of seventh stage blade showing crack initiation location (arrow).
Approx 2X

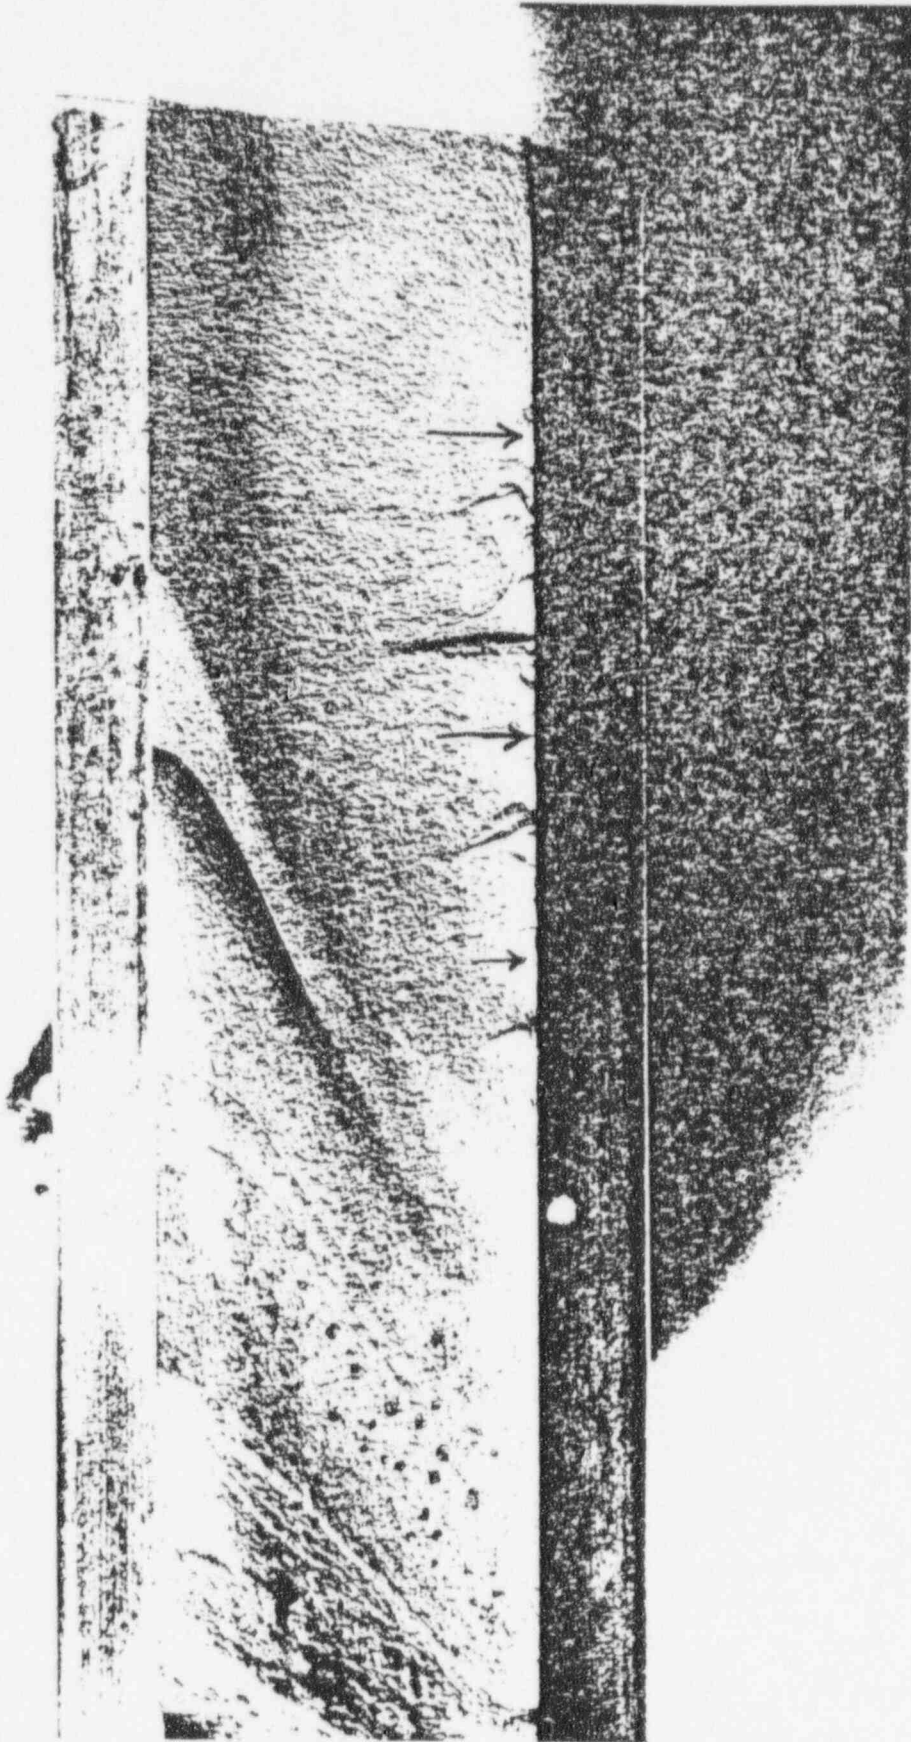
Figure 2 Crack surface of Blade No. 62 showing high cycle fatigue. Initiation sites are indicated by arrows.
