2.790 MATERIAL
Withhold From Public Disclosure
METALLURGICAL ANALYSIS
of
FERMI 2 LP3 EIGHTH STAGE
TURBINE BLADING

Report No. 94V70 - 13
June 20, 1994

Subject: **Metallurgical Examination of Fermi-2 Low Pressure
Seventh Stage Turbine Blading**
Technical & Engineering Services Report 94V70-22

Subject: Metallurgical Analysis of Fermi-2 Low Pressure
Seventh and Eighth Stage Turbine Blading
Technical & Engineering Services Report 94V70-30

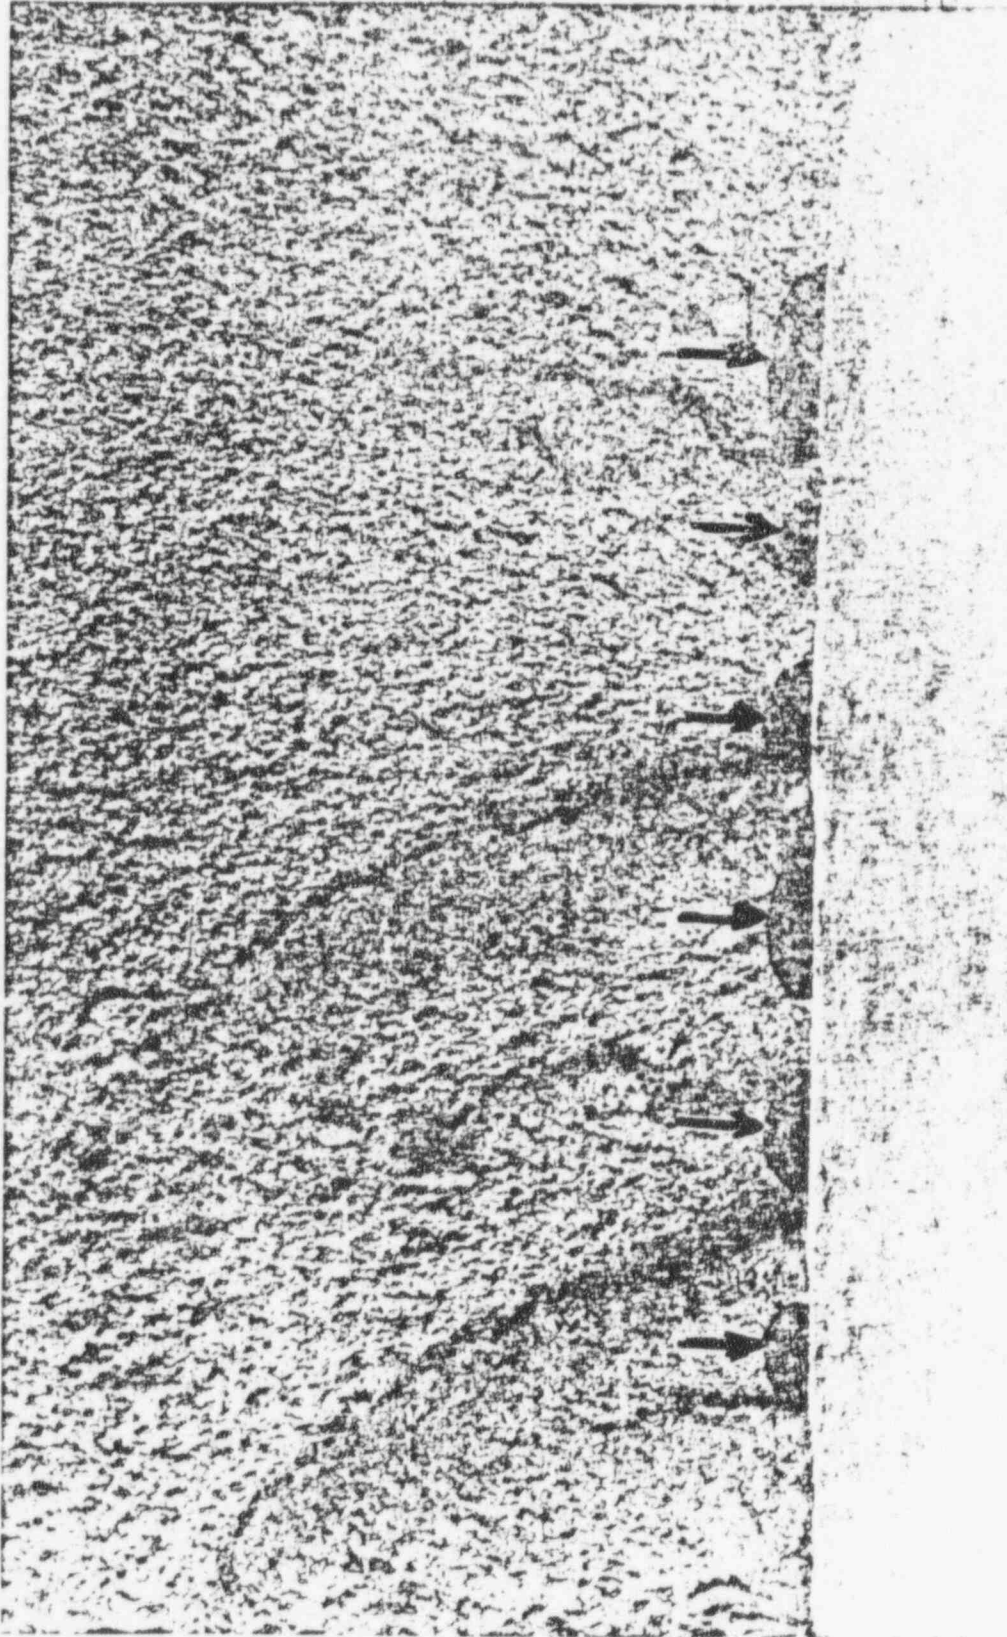
Figure 4 Crack surface of Blade No. 116 showing multiple fatigue crack initiation sites (arrows).
