Interim Status Report
Independent Root Cause Analysis Assessment
of the Detroit Edison
Fermi 2 Turbine - Generator Event
on December 25, 1993

July 26, 1994

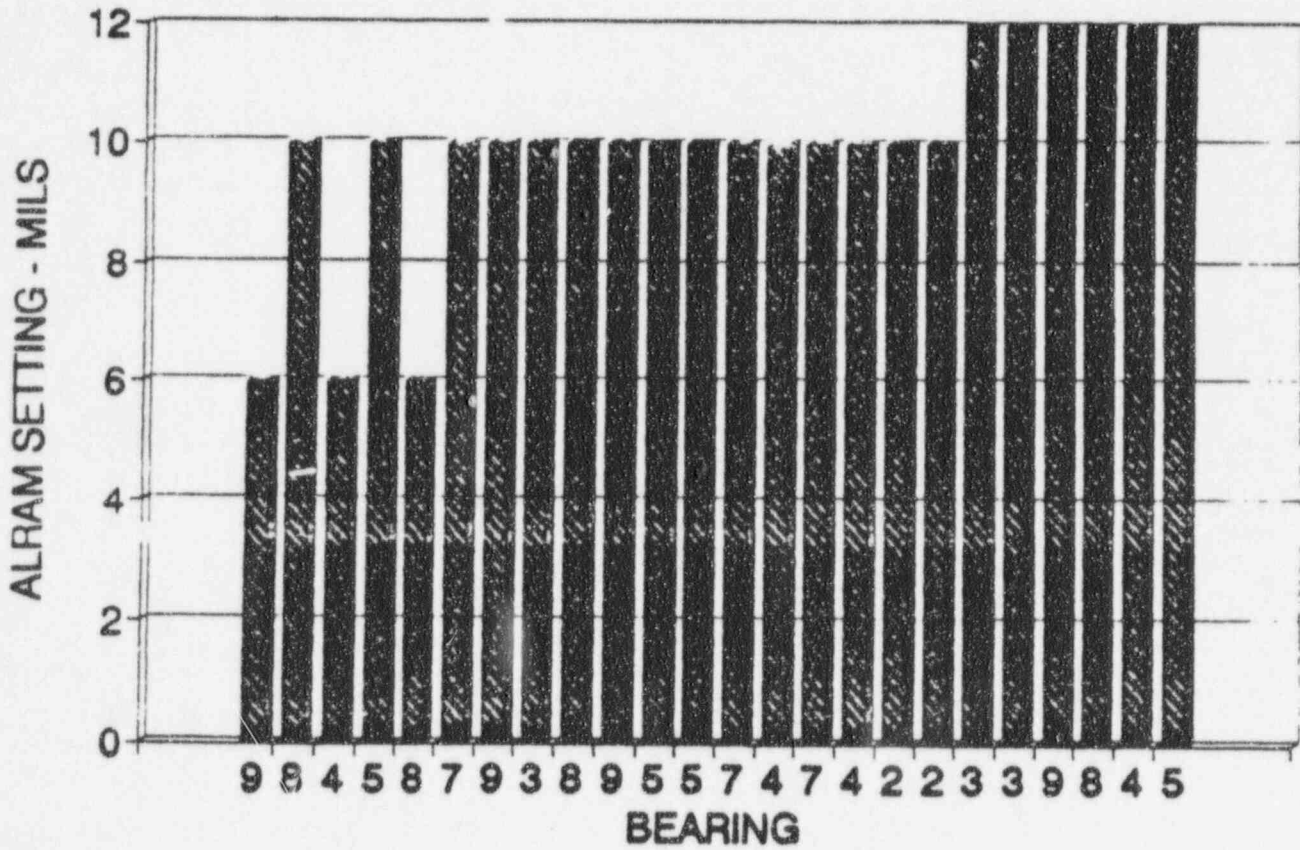
SHAFT VIBRATION ALARMS IN ORDER OF OCCURANCE

47.738	0.841	BRG 1 RUN UP ON PED AT 5 MIL
47.739		BRG 1 ON LOAD ON PED AT 5 MIL
47.682		BRG 3 ON LOAD ON SHAFT AT 10 MIL
47.871		BRG 9 HI VIB ON SHAFT AT 10 MIL
47.956		BRG 10 HI HI ON PED AT 4 MIL
47.975		BRG 11 HI HI ON PED AT 4 MIL
48.073		BRG 1 HI HI ON PED AT 4 MIL
48.084		BRG 8 HI HI ON SHAFT AT 12 MIL
48.125		BRG 4 HI HI ON SHAFT AT 12 MIL
48.156		BRG 5 HI HI ON SHAFT AT 12 MIL
48.165		BRG 7 HI HI ON SHAFT AT 12 MIL
48.19		BRG 2 HI HI ON SHAFT AT 12 MIL
48.247		BRG 3 HI HI ON SHAFT AT 12 MIL
