PEACH BOTTOM ATOMIC POWER STATION

SUBJECT: Licensee Event Report
Peach Bottom Atomic Power Station - Unit 2

Reference:	Docket No. 50-277
Report Number:	2-92-006
Revision Number:	00
Event Date:	04/07/92
Report Date:	05/07/92
Facility:	Peach Bottom Atomic Power Station RD 1, Box 208, Delta, PA 17314

TITLE (4) **Manual Scram and Primary Containment Isolation System Group II/III Isolations Following a Condensate Vent Line Failure**

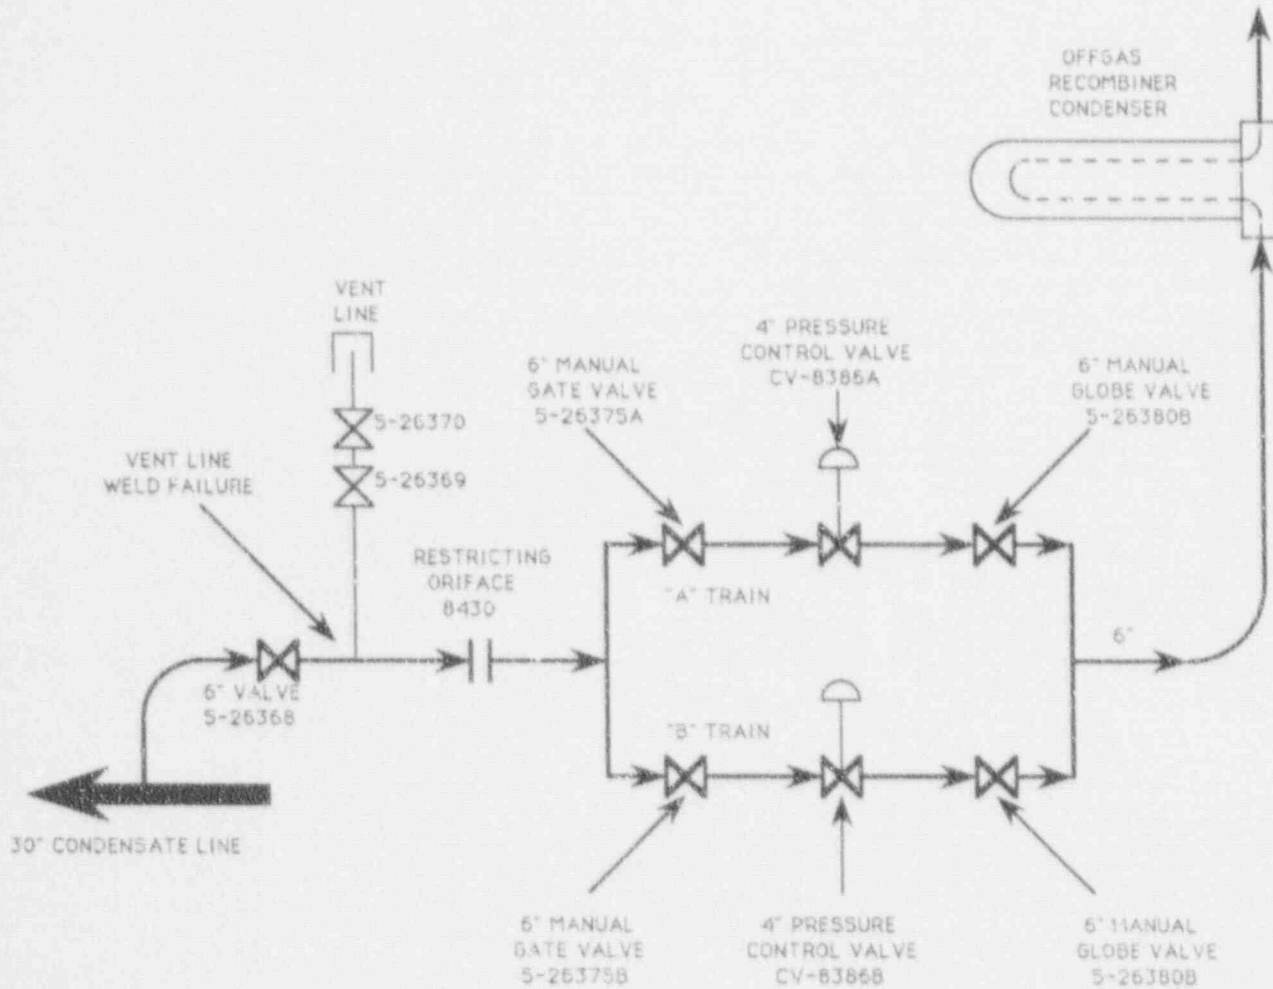
The cause of the event has been determined to be the failure of a one inch vent line weld (See Attached Drawing) on a six inch condensate line. The leak could not be isolated at power without removal of the Off Gas Recombiner system from service. Therefore, power reduction was commenced and a manual scram was initiated.

Metallurgical analysis showed that the weld failure was the result of metal fatigue due to high frequency vibration. During normal system operation prior to 1990, the pressure controller sensing lines experienced pressure pulsations as the condensate cooling water system inlet pressure was reduced from as high as 700 psig down to 120 psig by a pressure control valve and by throttling the Manual Globe Valve. These pulsations caused several failures of pressure controllers. Prior to the 1990 operating procedure revision which reduced the system vibrations, pressure controller valve linkage failures were identified on the both Unit 2 and 3 pressure controllers (only one train was used during normal operation). The system operating procedures were revised in 1990 such that both pressure control valves are throttled to approximately 75% open. Both trains are now placed inservice at the same time to reduce system vibration. The 6" manual globe valves directly downstream of the pressure control valves are now manually throttled to control the inlet pressure of condensate cooling water to the Off Gas Recombiner Condenser. In addition, condensate from the failed connection entered the Normal Waste Drains since the drains were not plugged.

Following the event, the scram and PCIS Group II/III isolation logics were reset. Affected systems were restored to appropriate conditions as necessary. In addition, the actual activity released through the Normal Waste Drains was verified to be well below the limits specified in the Tech Specs. Subsequently, the failed one inch weld and other unrelated components were repaired.

Both trains are now placed inservice at the same time to reduce system vibration. The 6" manual globe valves directly downstream of the pressure control valves are now manually throttled to control the inlet pressure of condensate cooling water to the Off Gas Recombiner Condenser.

An evaluation is being performed on similar drain and vent line configurations in this high vibration area on both units.
