VERMONT YANKEE NUCLEAR POWER CORPORATION

January 4, 1996
BVY 96-02

REFERENCE: Operating License DPR-28
Docket No. 50-271
Reportable Occurrence No. LER 95-021

On 12/8/95 at 1114 an automatic plant shutdown occurred. The plant shutdown was the result of a turbine trip caused by high reactor water level due to a failure of the "A" Feedwater Regulating Valve (FCV-6-12A). Power had been reduced to 79% and FCV-6-12A had been pinned in manual due to problems with the valve oscillation. When FCV-6-12A was placed in manual the tapered pin used to couple the manual operator to the valve stem could not be fully inserted. Due to asbestos contamination concerns in the area the operators were ordered out of the area until cleanup could be completed. Vibration of FCV-6-12A subsequently caused the tapered pin to come out allowing the valve to open. The failure of the FCV-6-12A operator was due to an unthreading of the connection between the upper and middle operator shafts. The torque on the connection is thought to have been disturbed during a prior maintenance activity and vibration during operation resulted in the two shafts becoming disconnected. The valve was repaired and retested satisfac

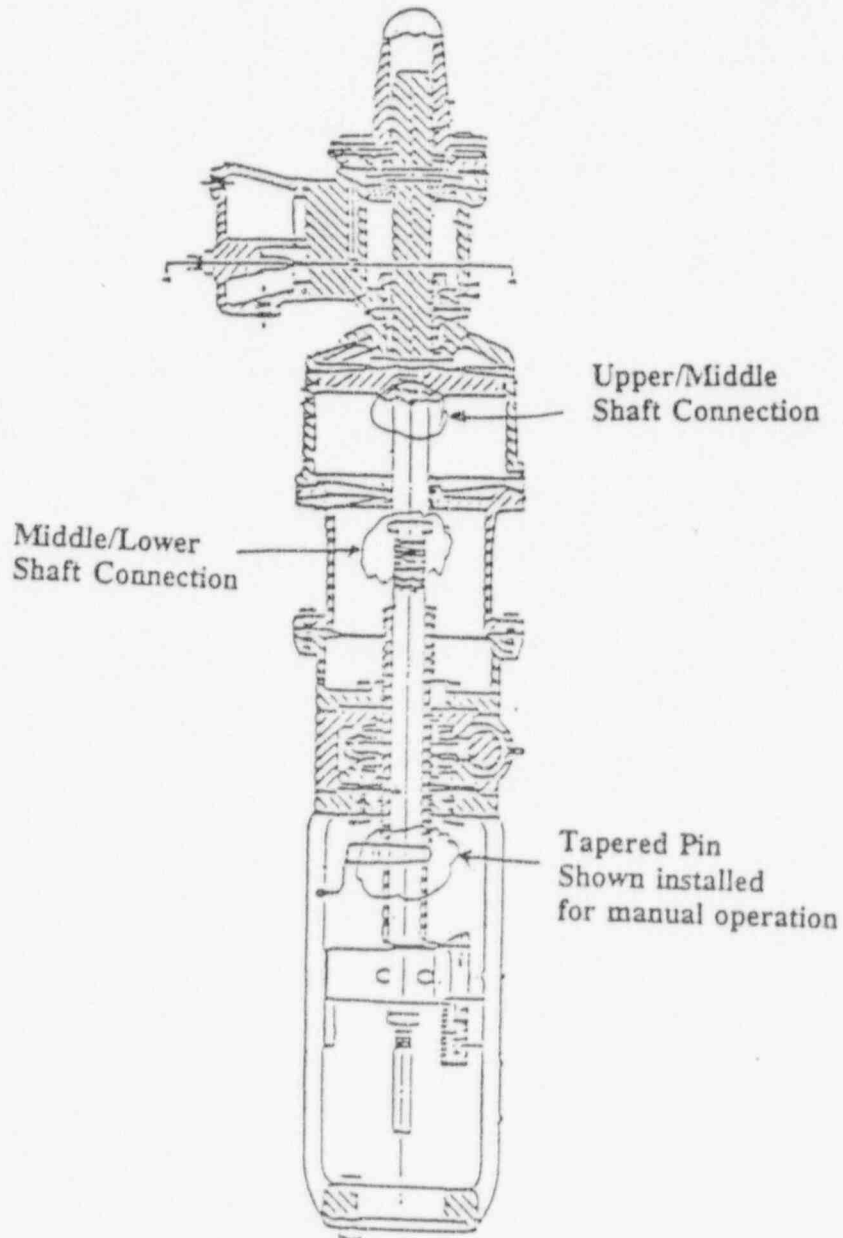
Figure 1

The cause of the failure of FCV-6-12A is thought to have resulted from a prior maintenance activity. FCV-6-12A was worked on twice during the 1995 refueling outage. The first time was to perform an overhaul of the valve operator. The second maintenance activity was to address air leakage in the lower portion of the operator. This activity required the valve operator to be partially disassembled. During the disassembly some reverse torque was applied to the connection between the upper and middle shafts. Since the maintenance activity did not require disassembly of this connection the torque was not rechecked when the operator was reassembled.

After the plant was fully shutdown the operator for FCV-6-12A was disassembled to determine the cause of the valve malfunction. Upon disassembly it was found that the threaded connection between the upper and lower shafts (Figure 1 and 2)) had come unscrewed. This effectively disconnected the valve operator from the valve disk such that the operator would only limit open travel of the valve disk. The operator for FCV-6-12A had been overhauled during the 1995 refueling outage. A recent vendor bulletin dealing with assembly of the middle and upper operator shafts had been received in 1994. The vendor bulletin noted instances of the connection between the upper and middle shafts coming loose and recommended use of a thread sealant on the shaft threads and torquing the shaft connection to 100 ft-lbs. The torque requirement was incorporated into the work order for the operator overhaul. The valve manufacturer was contacted about the recommendation to use thread sealant on the threads. The manufacturer stated that the use of a thread sealant was not a requirement and its use was subsequently not incorporated into the valve work. At the completion of the overhaul the post maintenance testing revealed an air leak in the lower portion of the operator. The operator was partially disassembled to address this air leak. During the disassembly the shafts were disconnected between the middle and lower shafts (Figure 1). During the disassembly some torque was applied to the connection between the upper and middle shafts however, as the maintenance activity did not require disassembly of this connection, the torque was not rechecked when the operator was reassembled.

- Cleanup of the asbestos contamination in the feedwater pump room was completed.
- The operator for FCV-6-12A was repaired and retested to insure proper operation. Thread sealant was installed on the threaded connection and the connection was torqued to 100 ft-lbs.
- The operator on FCV-6-12B was inspected to the extent possible without operator disassembly to ensure a similar problem did not exist with it. No problems were noted during the inspection.
- The feedwater piping and associated hangers were inspected to ensure that no damage had been created by the piping movement. No damage was identified.

- The plant procedure for overhaul of the operators on FCV-6-12A/B (OP 5353) is being revised to incorporate the use of thread sealant on the threaded connection of the upper and middle operator shafts and that the shaft connection be torqued to a minimum of 100 ft-lbs. Expected completion date is March 1996.

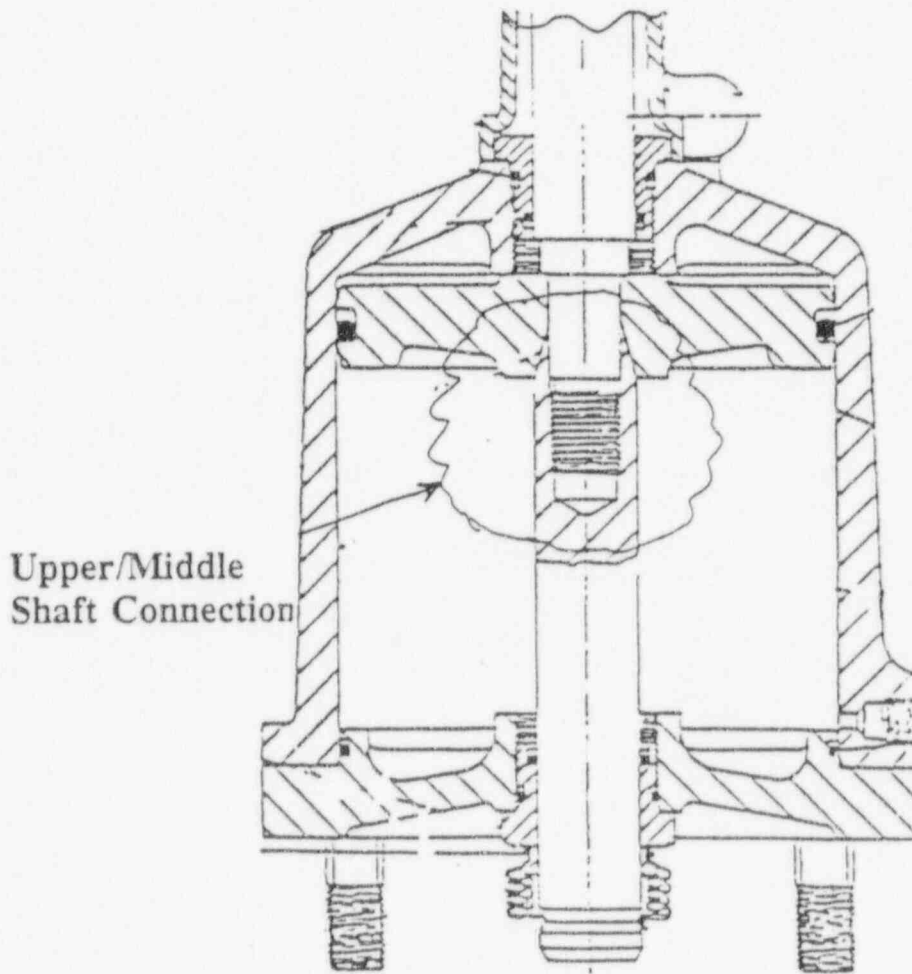
Figure 2

Upper/Middle
Shaft Connection
