# **1995 Annual Inspection of the Burrell, Pennsylvania, UMTRA Project Vicinity Property Disposal Site**

**December 1995**

**U.S. Department of Energy  
Grand Junction Projects Office  
Grand Junction, Colorado**

**Prepared by  
Rust Geotech  
Under DOE Contract No. DE-AC04-86ID12584  
U.S. Department of Energy  
Grand Junction Projects Office  
Grand Junction, Colorado**

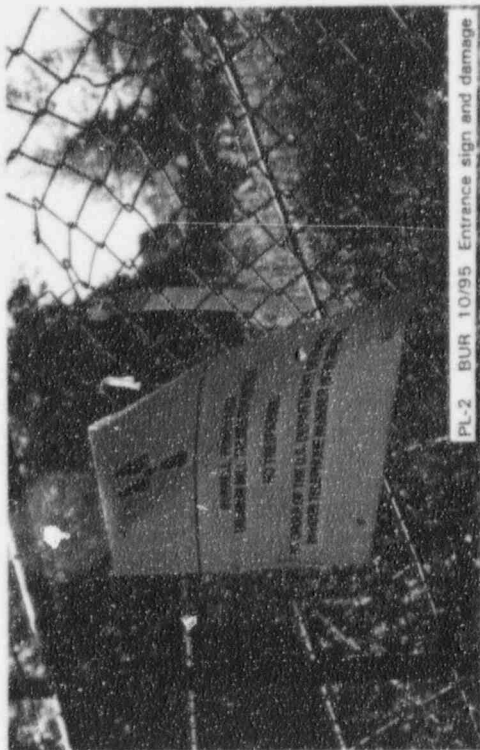
The entrance gate is functional and in good condition, except for some minor damage to the chain link fence fabric where the entrance sign is attached to the gate (PL-2). The entrance sign, designated on Plate 1 by an "E," has been damaged by an attempt to pull the sign off the entrance gate. Damage of the sign (still attached to the gate) consists of a bend on the right side. Additionally, the bolt in the upper right corner was pulled through the sign as the sign separated from the aluminum strap attaching it to the gate (PL-2). The sign is repairable and should be straightened and re-attached to the entrance gate before or during the 1996 site inspection; at the same time, the minor damage to the chain link fence fabric of the entrance gate should be repaired.

1. The entrance sign has been damaged (bent) in an attempt to pull it off the entrance gate, which also incurred minor damage to the chain link fabric. (See page 4.)

PL-2 BUR 10/95 Entrance sign and damage

**Recommendation:** Repair the entrance sign and chain link fabric of the entrance gate.

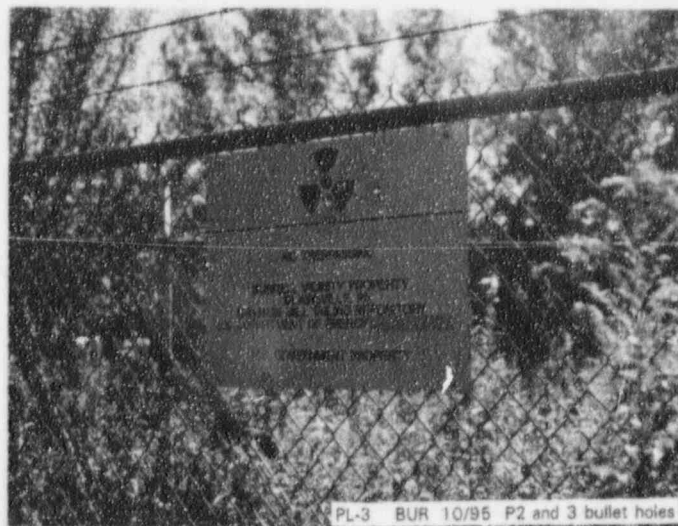
Damage to perimeter signs by rifle fire and shotgun blasts continues to be a problem; however, damage at this time is confined to the 7 signs along the north side of the site that face northward and can be seen from the Strangford dump area. Bullet damage to a typical sign (P2), which remains legible, is shown in PL-3. P4, which has sustained the worst damage from numerous bullet holes (PL-4), is partly illegible. The presence of bullet holes noted during this inspection in each of the seven north-facing perimeter signs is shown on Plate 1. Perimeter signs will continue to be monitored for damage and will be replaced when they become illegible.

PL-3 BUR 10/95 P2 and 3 bullet holes

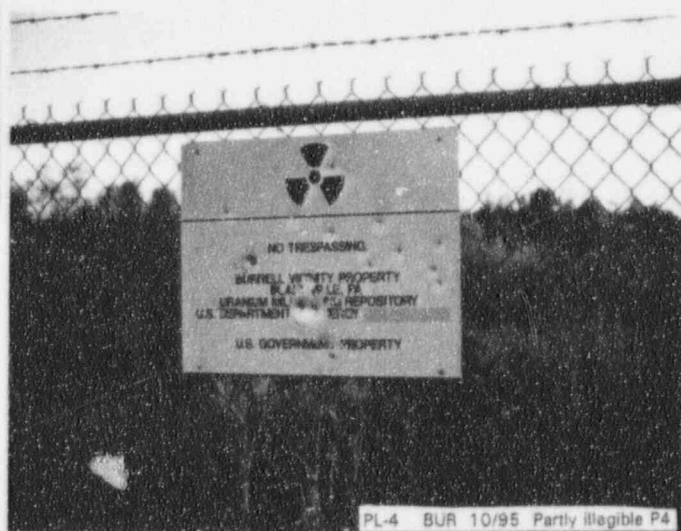
PL-4 BUR 10/95 Partly illegible P4

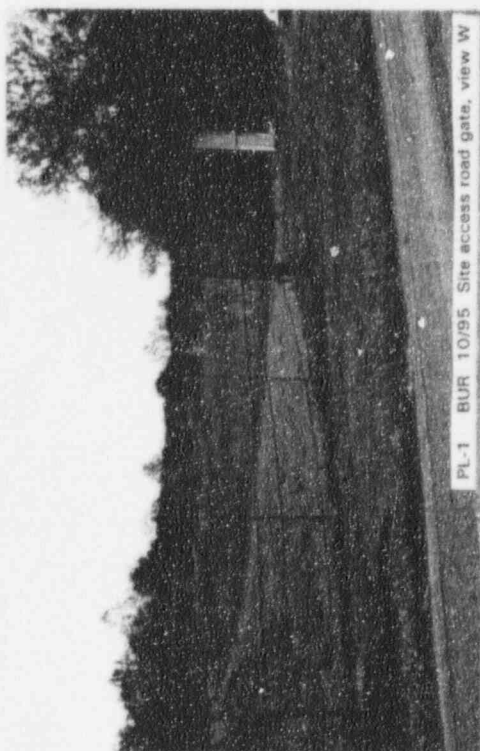
West of the gate, vegetation on the site access road has been mowed and for the first 300 feet, the road is covered by short grass (PL-1). Beyond this point, the gravel-surfaced access road is in good condition, contains no grass cover, parallels the ConRail Railroad tracks, and has been used by the public to access the Strangford dump. The condition of the site access road gate and the effectiveness of the adjacent chain link fence to prevent vehicle access should be noted during future inspections.

PL-1 BUR 10/95 Site access road gate, view W

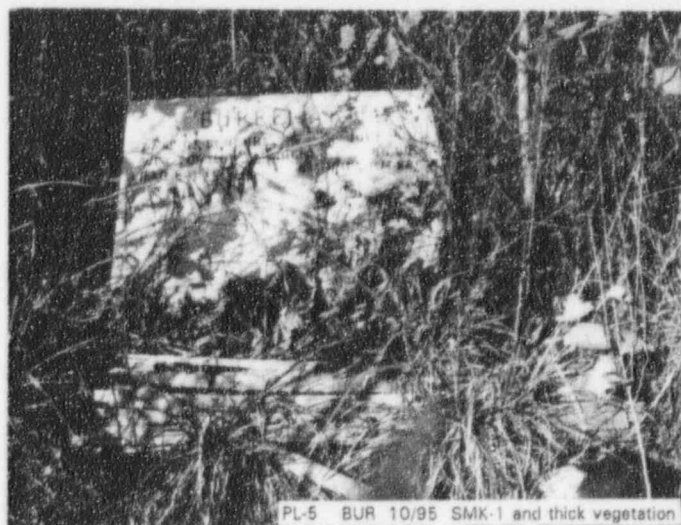
Only one site marker is present at this site. This marker, SMK-1, is near the entrance gate and is in excellent condition, although it is becoming increasingly covered by vegetation (PL-5). A second site marker at the crest of the disposal cell is necessary for the site to comply with Environmental Restoration Division—Uranium Mill Tailings Remedial Action (UMTRA) Project requirements (DOE 1992). The UMTRA Project Office has requested the GJPO to install the second site marker as soon as practicable. Installation of the second site marker is planned in 1996 if funds are available, and after specifications for the marker are reviewed.

PL-5 BUR 10/95 SMK-1 and thick vegetation

**Recommendation:** Install a second site marker on top of the disposal cell in 1996, if funds are available, and after specifications for the site marker are reviewed.

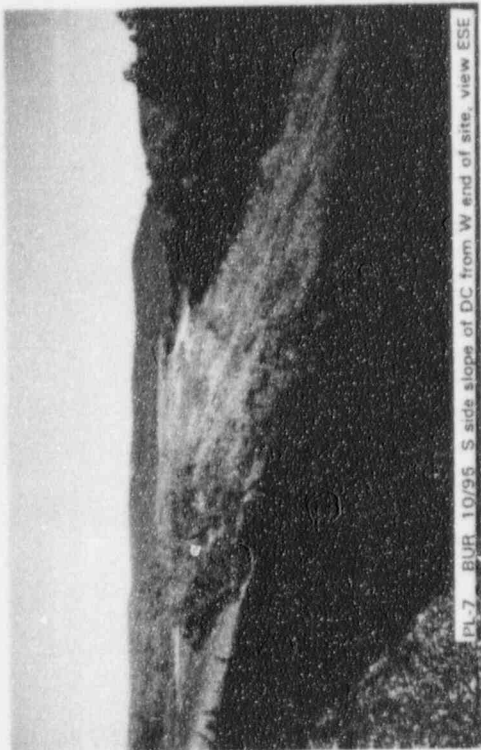
The south side slope of the disposal cell also hosts an increasing growth of herbaceous and woody vegetation (PL-7 through PL-9). Sycamore trees up to 15 feet tall, which represents a 3-year growth period since herbicide spray was applied, are present on this slope.

PL-7 BUR 10/95 S side slope of DC from W end of site, view ESE

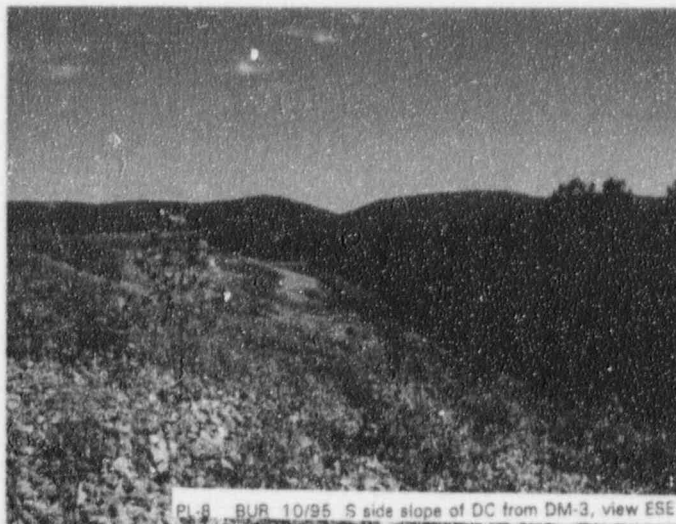
PL-8 BUR 10/95 S side slope of DC from DM-3, view ESE

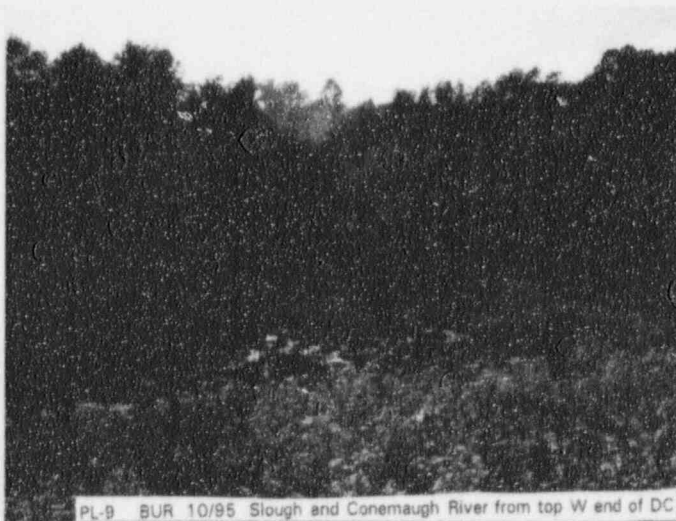
PL-9 BUR 10/95 Slough and Conemaugh River from top W end of DC

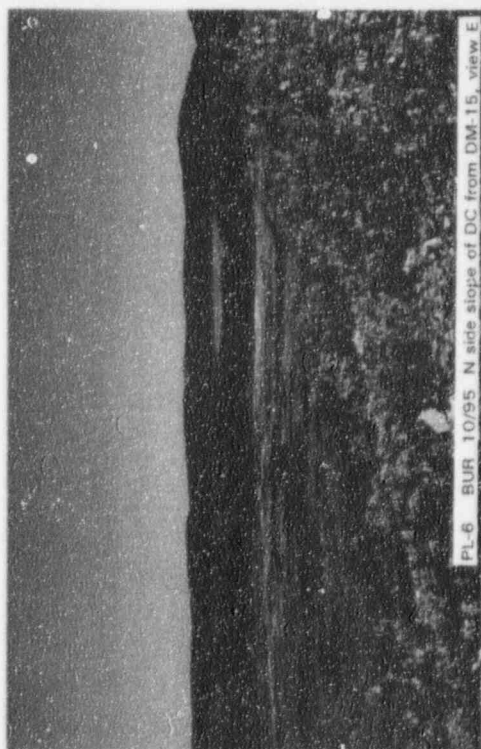
Prolific growth of herbaceous and woody vegetation occurs on the top and north side slope (PL-6) of the disposal cell. Since the spraying of the herbicides on woody plants and Japanese knotweed on the disposal cell in August 1992, this vegetation is becoming thicker and growth height is increasing. A special study is in progress, as a result of a recommendation in the 1994 inspection report (DOE 1994), to evaluate the effects of deep-rooted plants to the long-term performance of the disposal cell cover. If the study supports removal of deep-rooted species, herbicide spraying may be resumed, but long-term alternatives to spraying (such as establishment of a grass cover) should be considered. (No recommendation on vegetation management or control will be made until the special study is completed.)

PL-6 BUR 10/95 N side slope of DC from DM-15, view E

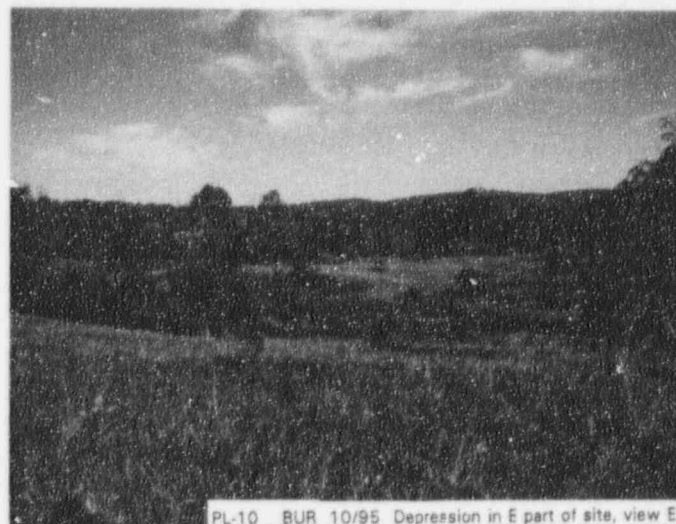
The large open area east of the disposal cell inside the security fence is covered mostly by thick grass and scattered trees and shrubs. A depression about 15 feet deep and 500 feet long is present in this area (PL-10). During wet periods, surface water collects in the depression, and if the depression filled with water, additional water would spill eastward to the nearby swale and drain south into the Conemaugh River. No water was present in the depression at the time of this inspection.

PL-10 BUR 10/95 Depression in E part of site, view E

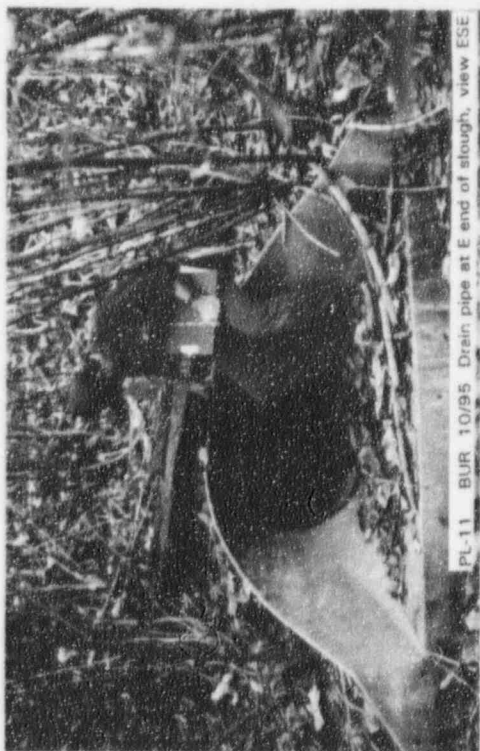
A drain pipe 24 inches in diameter (PL-11), first noticed during the 1994 inspection (DOE 1994), is at the east end of the slough in thick understory southeast of the disposal cell. No water was flowing from the pipe at the time of this inspection, and the area drained by the pipe is not known. No drains were seen on the site east of the pipe.

PL-11 BUR 10/95 Drain pipe at E end of slough, view ESE

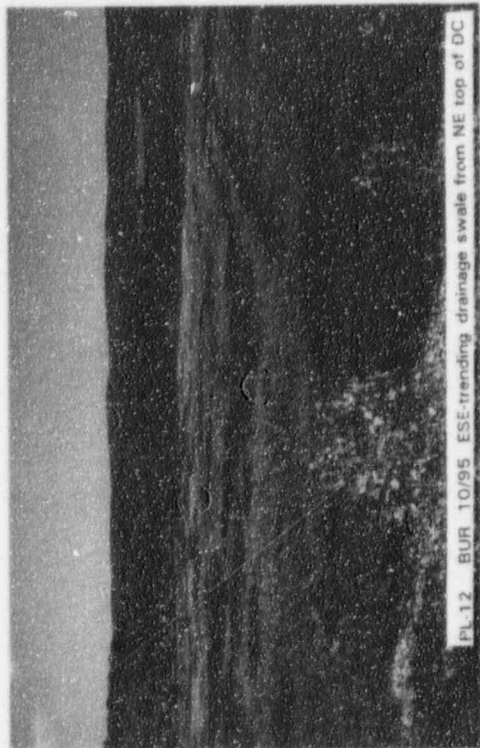
East of the disposal cell and north of the depression, a long, shallow swale about 2 feet deep drains surface water off the site to the east-southeast (PL-12). Just east of the depression, the swale turns southward and crosses the security fence between SM-100 and P17 (Plate 1). Water that ponds in a low-lying area along the toe of the north side slope of the disposal cell cannot reach the swale because of an area of slightly elevated ground about 150 feet wide just north of the northeast toe of the disposal cell (lower left part of PL-12). Collection of water in this area has the potential to infiltrate the disposal cell and may contribute to flow from seeps on the south side slope of the disposal cell. Drainage of water to the east was the intent of construction design, as stated by UMTRA representatives who visited the site in November 1990 during the first precicensing inspection, but final grading failed to achieve the intended drainage.

PL-12 BUR 10/95 ESE-trending drainage swale from NE top of DC

To correct the drainage problem, the 1994 inspection report (DOE 1994) recommended that small-scale recontouring of the high ground be conducted. This translates to constructing a shallow ditch about 2 feet deep and 150 feet long eastward across the area of elevated ground (Plate 1). This would restore surface drainage to its intended design without significantly altering final site contours.

**Recommendation:** Restore surface drainage in this area so it conforms to site design. Construct a shallow ditch about 2 feet deep and 150 feet long across the area of slightly elevated ground that prevents drainage of ponded water eastward into the existing swale.

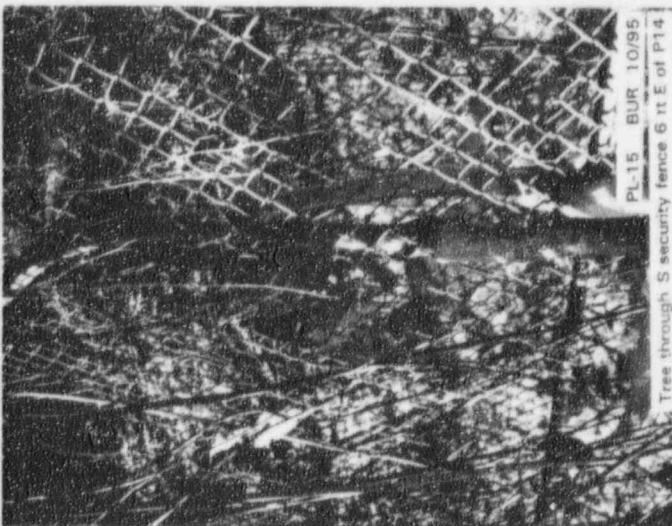
Condition of the security fence around the site is generally good, except in several places in the south part of the site where the fence passes through a wooded and heavily vegetated area. Here, large branches of trees overhanging the fence and trees growing through the fence (PL-15) may soon cause significant damage to the fence. To prevent this damage, it is recommended that trees growing through the security fence be cut down and tree limbs overhanging the fence be cut. This cutting should extend from the area of SM-100 westward along the security fence to the pedestrian gate.

6. The security fence in the south part of the site passes through wooded and heavily vegetated areas where, in places, trees are growing through the fence and large branches of trees hang over the fence. This growth may soon cause significant structural damage to the fence. (See page 10.)

PL-15 BUR 10/95  
Tree through S security fence 6 ft E of P14

**Recommendation:** Cut down the trees growing through the security fence and cut the tree limbs hanging over the fence from the area of SM-100 westward to the pedestrian gate.

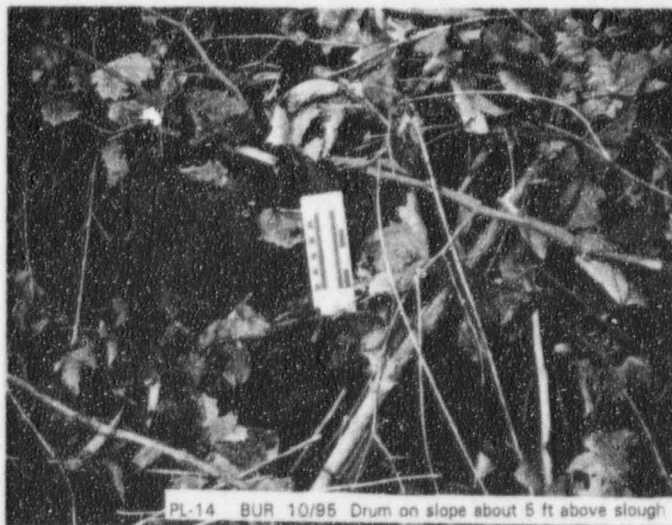
Two rusted, mostly disintegrated, 55-gallon drums were found during the 1994 site inspection (DOE 1994) about 100 feet east of the pedestrian gate. A search for these two drums and others that may occur in the general area was conducted during this inspection. M. Planinsek and T. Buchan participated in the search during the early part of the inspection. What is believed to be the same two drums found in the 1994 inspection were found during this inspection, and their locations are shown in Plate 1. One drum (PL-13) is about 3 feet above the level of the slough just to the north and the other drum (PL-14) is about 5 feet above the slough level. Both drums are obscured by thick vegetation and are near the base of a steep, north-facing slope of fill material containing railroad ties, bricks, and glass. The drums are unlabeled and appear to have contained a solidified, black substance like coal tar. After reviewing the situation of the drums and their contents, which appear relatively immobile, the Commonwealth of Pennsylvania has informed the GJPO that no further sampling or analyses of either the material in the drums or the ground and surface water at the site is necessary.

PL-14 BUR 10/95 Drum on slope about 5 ft above slough

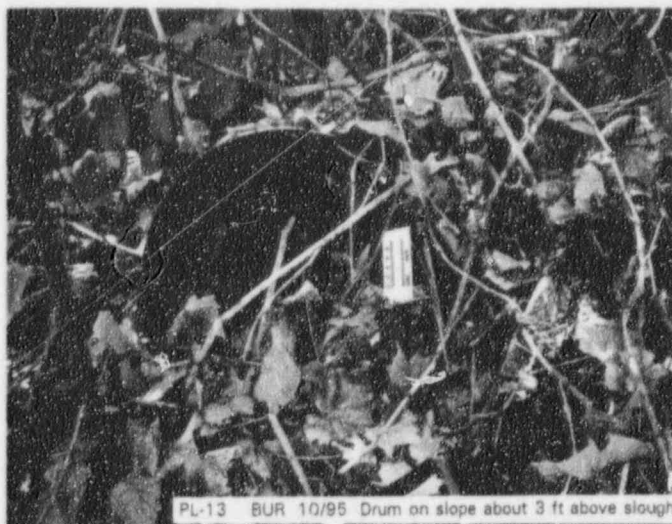
PL-13 BUR 10/95 Drum on slope about 3 ft above slough

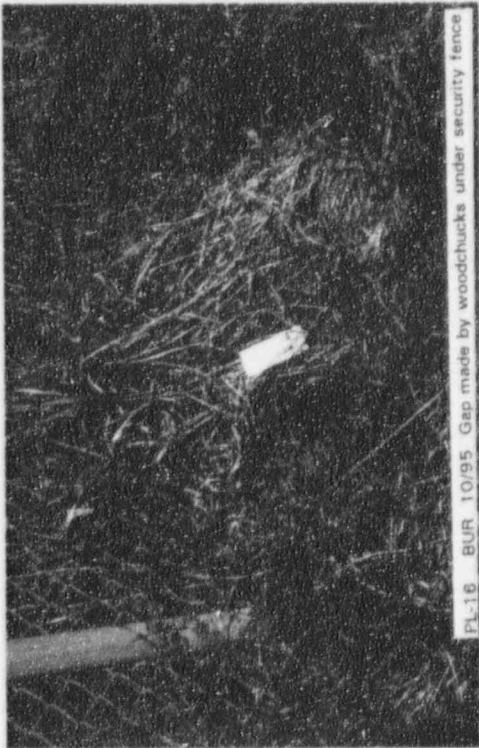
gap under the security fence (PL-16), but it does not pose a threat to the fence. The level of burrowing activity appears to have remained constant for the past 5 years—additional burrows have been noted, but the number of active burrows is about the same. Burrowing will be monitored during future inspections.

PL-16 BUR 10/95 Gap made by woodchucks under security fence

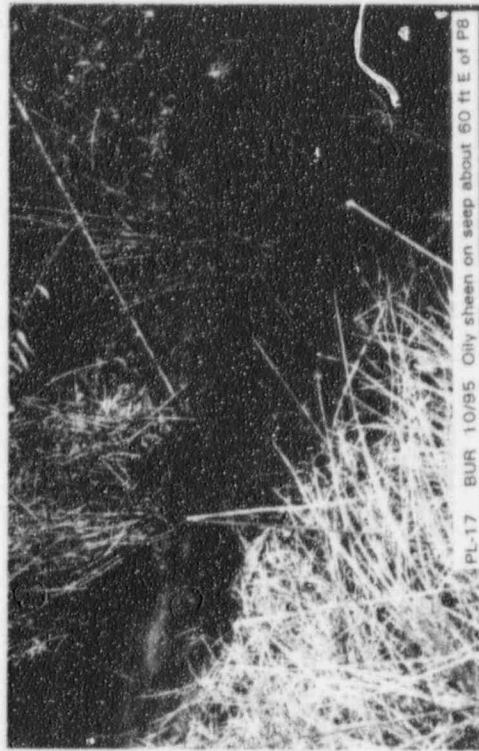
The seep along the security fence about 60 feet east of P8 (just west of the disposal cell) noted in previous inspections was flowing slightly and had a noticeable oily sheen (PL-17). Flow from the seep was estimated at less than 1 gallon per minute at the source, just north of the fence. Water from the seep flows south and joins the slough; just north of the slough, flow was estimated at about 1 gallon per minute. The seep does not threaten the integrity of the security fence or disposal cell, but its flow should be visually monitored during future inspections.

PL-17 BUR 10/95 Oily sheen on seep about 50 ft E of P8

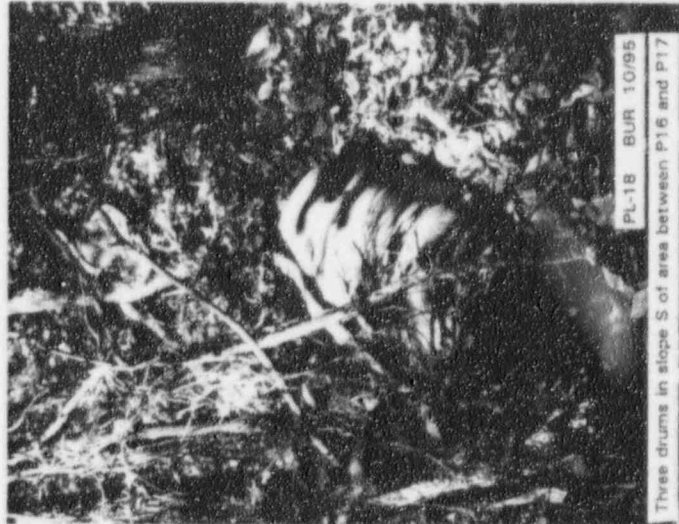
During this inspection, a traverse from west to east was walked by the inspectors across this south margin of the site. M. Planinsek and T. Buchan participated in the inspection of this area, which was suspected to contain drums like those found just south of the slough. A total of 13 partly to mostly disintegrated drums (PL-18) was found in the area during the traverse; the approximate locations of the drums are shown in Plate 1. Some of the drums are empty and some are partially filled with a solid black substance like coal tar (similar to that found in the drums just south of the slough). The steep, wooded fill area also contains an abundance of old railroad ties, bricks, concrete chunks, old tires, metal scrap, and coal slag. Void space between these materials and abundance of vegetation make walking conditions in this area difficult and dangerous. As stated on page 10, the Commonwealth of Pennsylvania has informed the GJPO that no further sampling or analyses of either the material in the drums or the ground and surface water at the site is necessary.

PL-18 BUR 10/95  
Three drums in slope S of area between P16 and P17
