Crystal River Unit 3

Subject: Licensee Event Report (LER) 95-027-00

TITLE (4)
Leak in Underground Emergency Feedwater Piping Suspected to be Caused by Nearby Excavation Using Power Tools

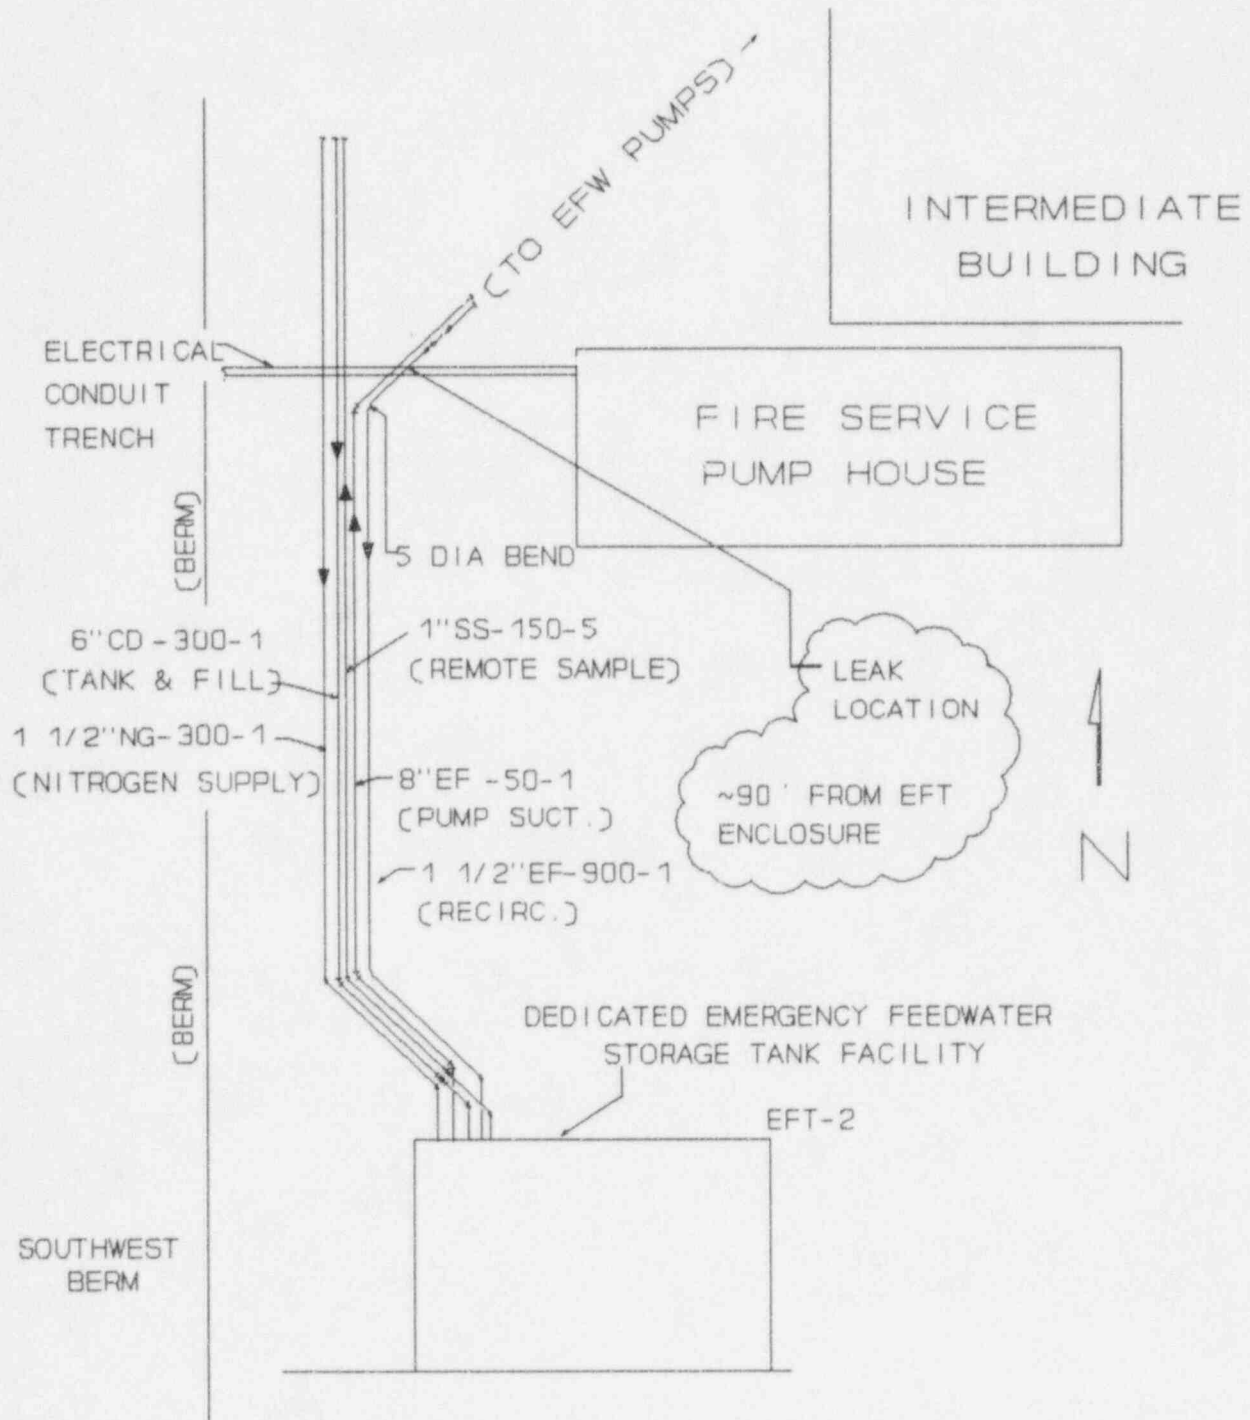
FIGURE 1

On December 8, 1995, excavation confirmed the presence of what appeared to be a galvanically induced throughwall leak in the EFW Pump recirculation line which is a 1-1/2 inch ASME Code Class 3, Seismic Class 1 line. This is a common line for both trains of the EFW system which is required for system testing and EFW Pump minimum flow protection. The location of the leak was such that performance of an ASME code repair could not be accomplished without affecting minimum recirculation capability for both trains. A Code repair would have required a plant shutdown which would have created unwarranted challenges to the normal feedwater system [SJ], hence increasing the potential reliance on the EFW System. Immediate action taken was to install a commercial grade (non-safety related) pipe clamp to terminate the leak. The clamp was rated for a working pressure of 450 pounds per square inch gauge (psig) and was considered to be appropriate for

The primary suspected cause for this event was personnel error which contributed to improper work control practices during a previous excavation activity in the vicinity of EFW pump recirculation piping. The excavation was conducted approximately one year ago (December, 1994) and utilized power tools to dig an electrical cable trench which runs from the fire service pump house to the edge of the berm (see Figure 1). Improper work practices apparently allowed for accidentally removing the coating from a small area of the 1-1/2 inch underground piping. This piping is carbon steel, 1-1/2 inches in diameter and has an enamel coating. It is believed a breach in this protective coating could have set up a galvanic cell between the carbon steel pipe and the alkaline (limestone) fill around the pipe. A formal root cause analysis will be conducted by February 10, 1996 to determine if this preliminary evaluation can be confirmed.

1. The area of the expected leak was excavated on December 8, 1995 and the exact location was identified (see Figure 1).
2. A non-safety, commercial pipe clamp was installed on December 8, 1995 to stop the LEAKAGE.
3. A calculation was performed on December 9, 1995 to determine the internal pressure and leak rate at a hole in the EFW pump recirculation line. The calculation yielded a total recirculation flow of approximately 260 gpm with a corresponding pressure of 310 psig with a leak rate of approximately 1.0 gpm.
4. A structural calculation was performed on December 9, 1995 to provide technical justification for attaching a mechanical clamping device to the

5. A safety related pipe clamp was installed on December 9, 1995 in accordance with ASME Section XI, Code Case N-523.
6. An initial service leak test was performed on December 9, 1995 with EFP-1 running and no LEAKAGE was detected.
7. A plan was developed on December 9, 1995 to monitor defect growth in the area immediately adjacent to the clamping device. In accordance with this plan, a volumetric inspection was performed on December 10, 1995 to obtain baseline ultrasonic data.
8. The exposed piping and clamp have been environmentally protected by use of a tarpaulin cover.

- A work package will be developed to be installed during Refuel 10R (scheduled to begin February 29, 1996) to replace the temporary clamping device with the appropriate 1-1/2 inch enamel coated carbon steel pipe.

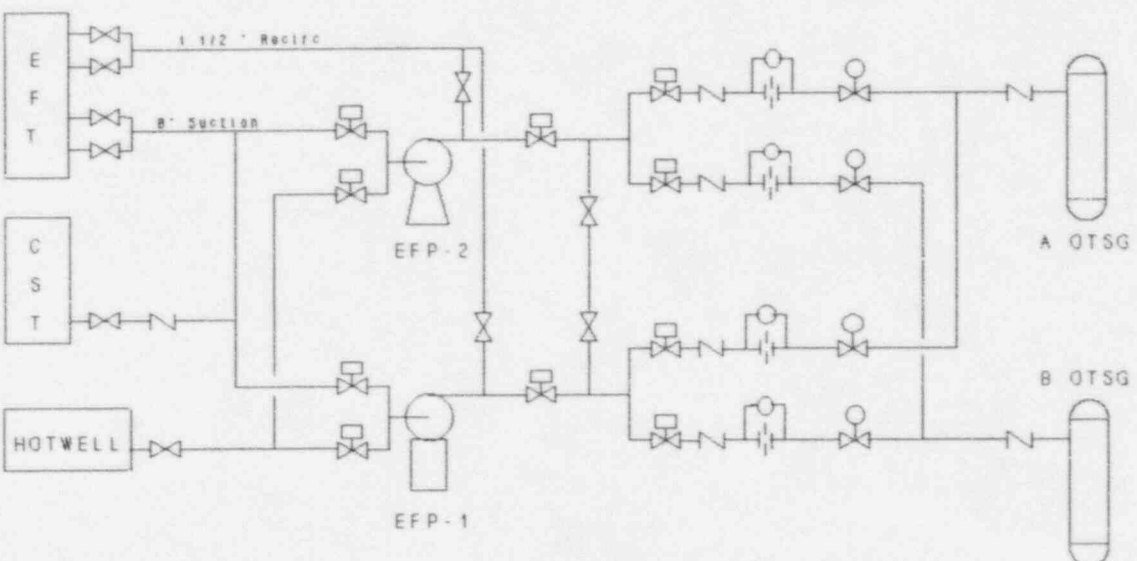
Figure 2

The principle function of the EFW system is to remove decay heat from the Reactor Coolant System [AB] upon unavailability of the normal feedwater [SJ] supply. To achieve this, the EFW system provides secondary coolant to the Once Through Steam Generators [AB,SG] (OTSG). EFW is also used to promote and enhance natural circulation in the Reactor Coolant System. The EFW system consists of two full-capacity independent systems which include two pumps and associated valves and piping. The EFW system piping is designed to ANSI B31.1 ES (Essential Services), Seismic Class I. Each train is capable of supplying sufficient emergency feedwater to either or both OTSG's, from any one of three water sources, the Emergency Feedwater Tank (EFT-2), the Condensate Storage Tank [SD,TK], and the Condenser Hotwell [SD,COND]. The EFW pumps are normally aligned to take water from the Emergency Feedwater Tank (EFT-2) through suction penetrations located on the tank. In the event EFT-2 becomes inoperable, the pump suction may be aligned to the Condensate Storage Tank or the Condenser Hotwell. See Figure 2.

Each of the EFW pumps has a 1-inch minimum recirculation line that directs flow back to the Emergency Feedwater Tank through a common 1-1/2 inch header. The recirculation line is required for system testing and to ensure minimum required recirculation flow of 250 gpm during accident conditions. The common recirculation line is then split into 2 lines where it enters the EFT.
