# NORTHEAST UTILITIES

Reference: Facility Operating License No. NPF-49  
Docket No. 50-423  
Licensee Event Report 92-011-00

LICENSEE EVENT REPORT (LER)

TITLE (4) Reactor Trip During Thermal Backwashing Due to Design Deficiency

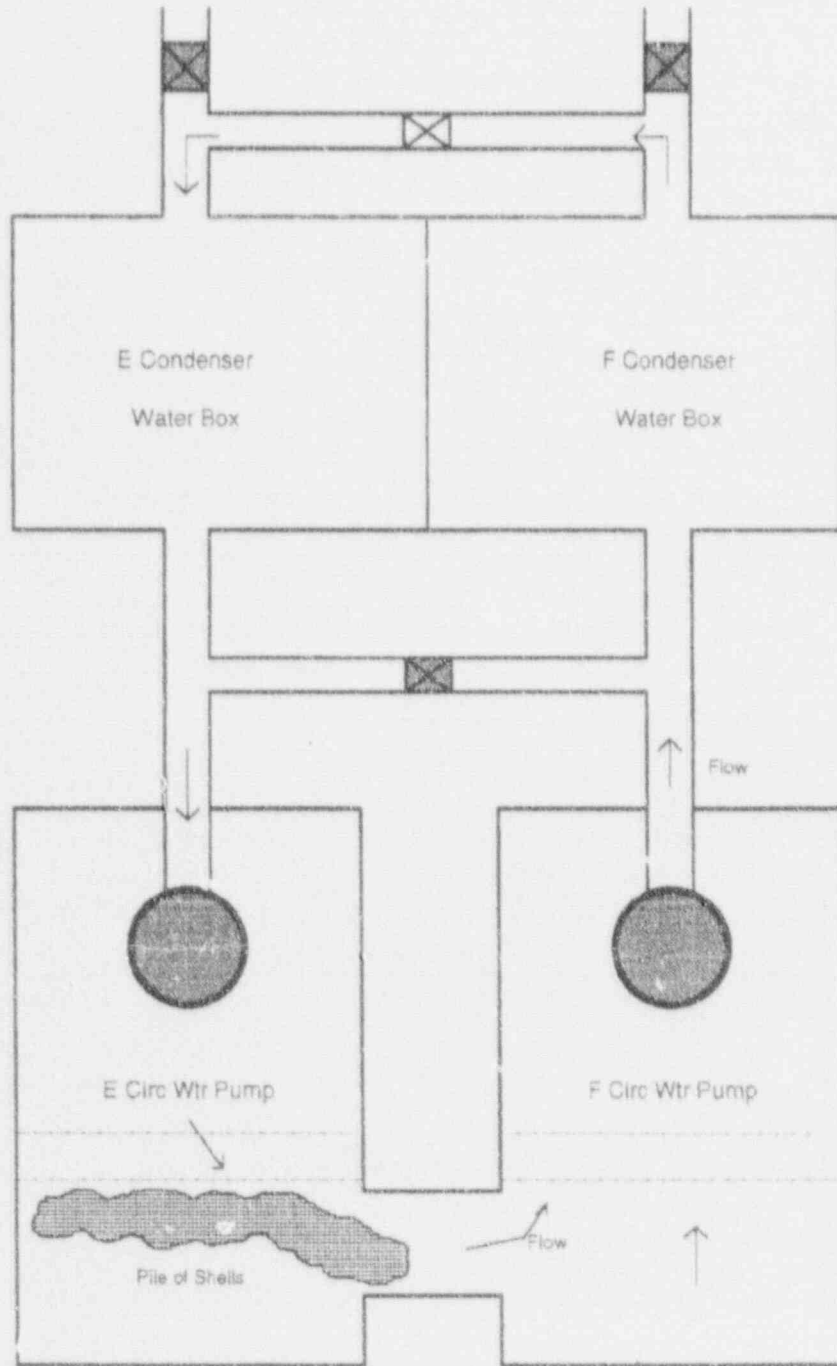
FIGURE 1

The root cause for this incident is design deficiency. The E Traveling Water Screen was not capable of running in the reverse direction while performing a thermal backwash due to structural degradation. Additionally, the E screen did not have sufficient capacity when operated in the forward direction to handle the influx of debris.

A drawing is attached which shows the backwash lineup. When the E CW Bay was thermally backwashed, the F CW Pump drew water from the F Bay, pumped it through through F Condenser Water Box, around to the E Condenser Water Box, and then out through the stopped E CW Pump. The backwash flushes debris and old mussels from the pump side of the traveling screen units to the screen units. With the E Traveling Water Screen Unit in forward, the debris is swept from the pump side to the front of the traveling water screen units. After the backwash of the E CW Pump Intake was complete, preparations were made to backwash the F CW Pump Intake. When E CW Pump was started, the debris apparently began depositing on the E Traveling Water Screen Unit. The debris from the backwash in addition to that coming from the sea exceeded the debris removal capacity of the screen. A high differential level developed and the E CW Pump tripped.

Divers removed the debris from in front of the E and F Traveling Water Screens. The procedure for backwashing the CW pump bays was modified to require CW Pumps that had been started following a backwash evolution to be run in parallel with the other CW pumps for 30 minutes prior to stopping the CW Pump on the next bay selected for backwash. Whenever possible, the traveling water screen which is being backwashed will be run in reverse in order to carry debris over the top and into an area where the screen wash is most effective in removing debris.
