CORPORATION  
Crystal River Unit 3  
Docket No. 50-302

Subject: Licensee Event Report (LER) 95-028-00

TITLE (4)  
Operation Outside Design Basis Caused by Personnel Errors and Inadequate Documentation of Borated Water Storage Tank Vacuum Breaker Capacity

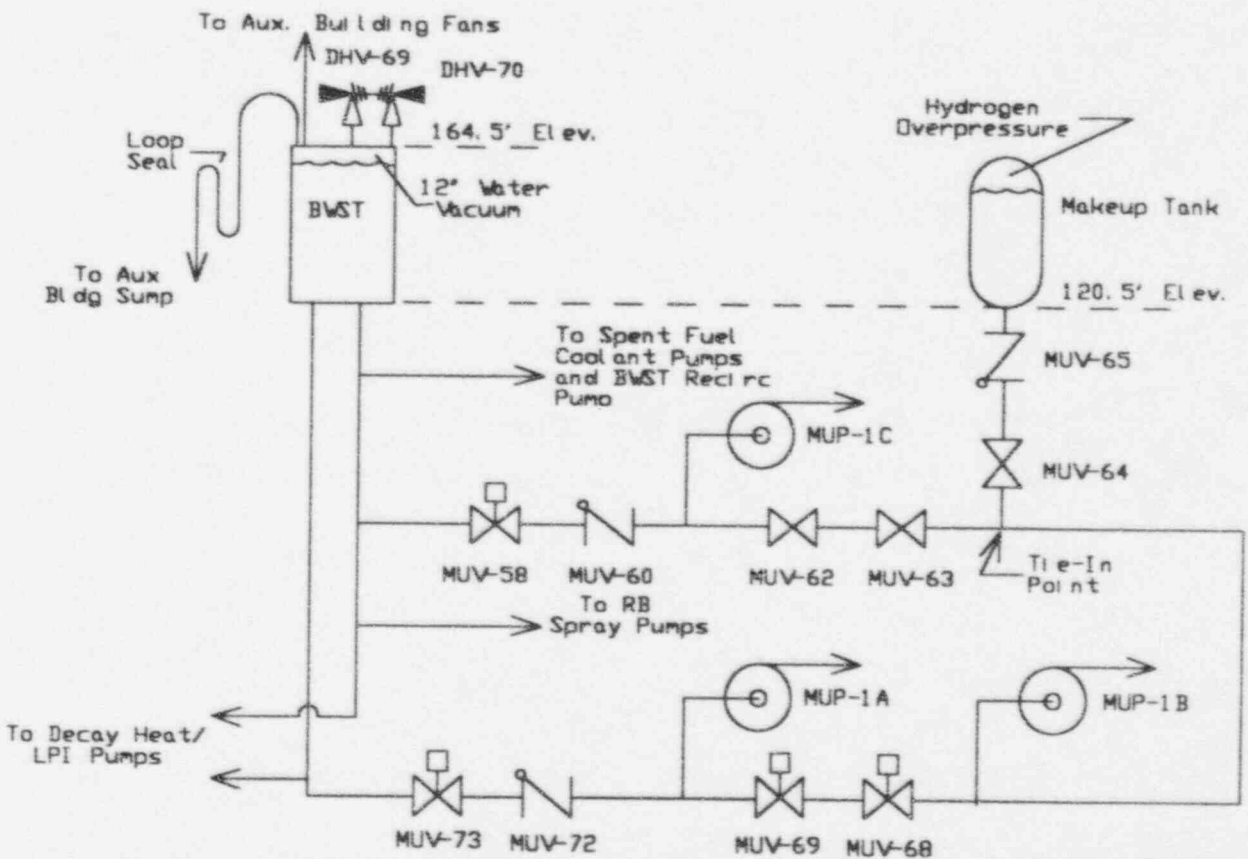
Figure 1

The BWST and RB sump [BE,TK] provide borated water for the Decay Heat (DH) Removal pumps which function as the Low Pressure Injection [BP,P] pumps (LPI) during LOCA's, the Reactor Building Spray [BE,P] (BS) pumps, the Makeup Pumps [CB,P] which function as High Pressure Injection (HPI) pumps [BQ,P] during LOCA's, the Spent Fuel Cooling [DA,P] (SF) pumps, and the BWST recirculation pump. The BWST has four 8-inch penetrations at the top of the tank including the two vacuum breakers, a line to the Auxiliary Building Air Handling Exhaust Fans [UC,FAN] which continuously draw air from the top of the BWST, and an overflow line which has a large loop seal that affords tank overpressure protection. See Figure 1.

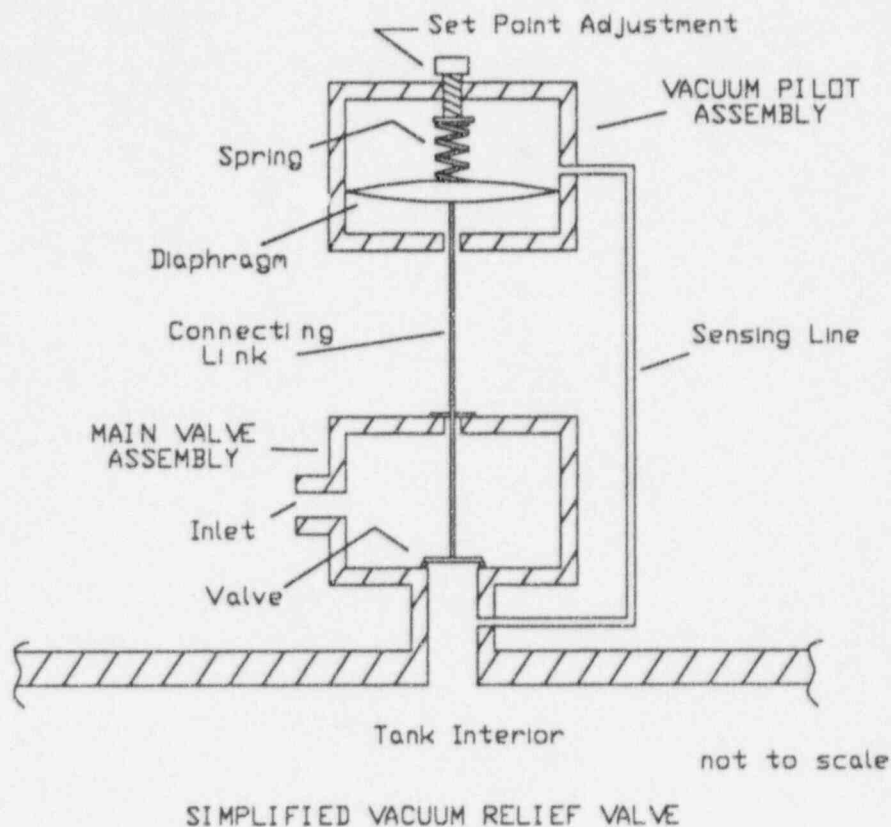
Figure 2

The basic function of DHV-69 and 70 is to equalize the pressure inside the BWST to provide protection against a collapse of the tank when vacuum is created during drawdown (see Figure 2). The valve setpoint is critical in maintaining adequate net positive suction head (NPSH) to the Makeup Pumps which are aligned to take suction from the BWST in their High Pressure Injection (HPI) mode during a large break loss-of-coolant-accident (LOCA). Analyses for Makeup/HPI Pump NPSH and Allowable Makeup Tank [CB,TK] (MUT) Overpressure assume a vacuum breaker setpoint for the BWST of 12 inches water vacuum for the most limiting case where the BWST is at its lowest level, the operating Makeup/HPI pump is Engineered Safeguards (ES) selected and Decay Heat/Low Pressure Injection and Reactor Building Spray pumps are being throttled for switchover to the RB sump. A vacuum in the BWST of greater than 12 inches water would reduce pressure on the BWST side of the tie-in point, thereby reducing NPSH available. As noted in the above Event Description, maintaining an open vent path in place of the removed vacuum breaker assures adequate vacuum relief capacity. With this arrangement, there is currently no impact on the health and safety of the public.

The suspected inoperability of DHV-70 was due to blockage in the sensing line caused by accumulation of corrosion products. A more formal analysis will be developed by February 23, 1996 to determine the exact root cause.

The BWST was determined to be fully OPERABLE with the screened rain-hood installed in place of DHV-70, thereby providing adequate relief capacity.

4. An adjustment will be made to the setpoint on the replacement vacuum breaker and the new valve will be installed prior to draining the Fuel Transfer Canal as noted in the Event Evaluation Section, above. The purpose of the adjustment is to establish added assurance that the valve will open and provide sufficient flow prior to reaching 12 inches of water column vacuum in the BWST. Prior to replacement of DHV-70, the screened rain-hood be installed in place of DHV-69.
