PUBLIC SERVICE COMPANY OF COLORADO

August 21, 1984
Fort St. Vrain
Unit #1
P-84290

SUBJECT: Fort St. Vrain Control
Rod Drive Refurbishment

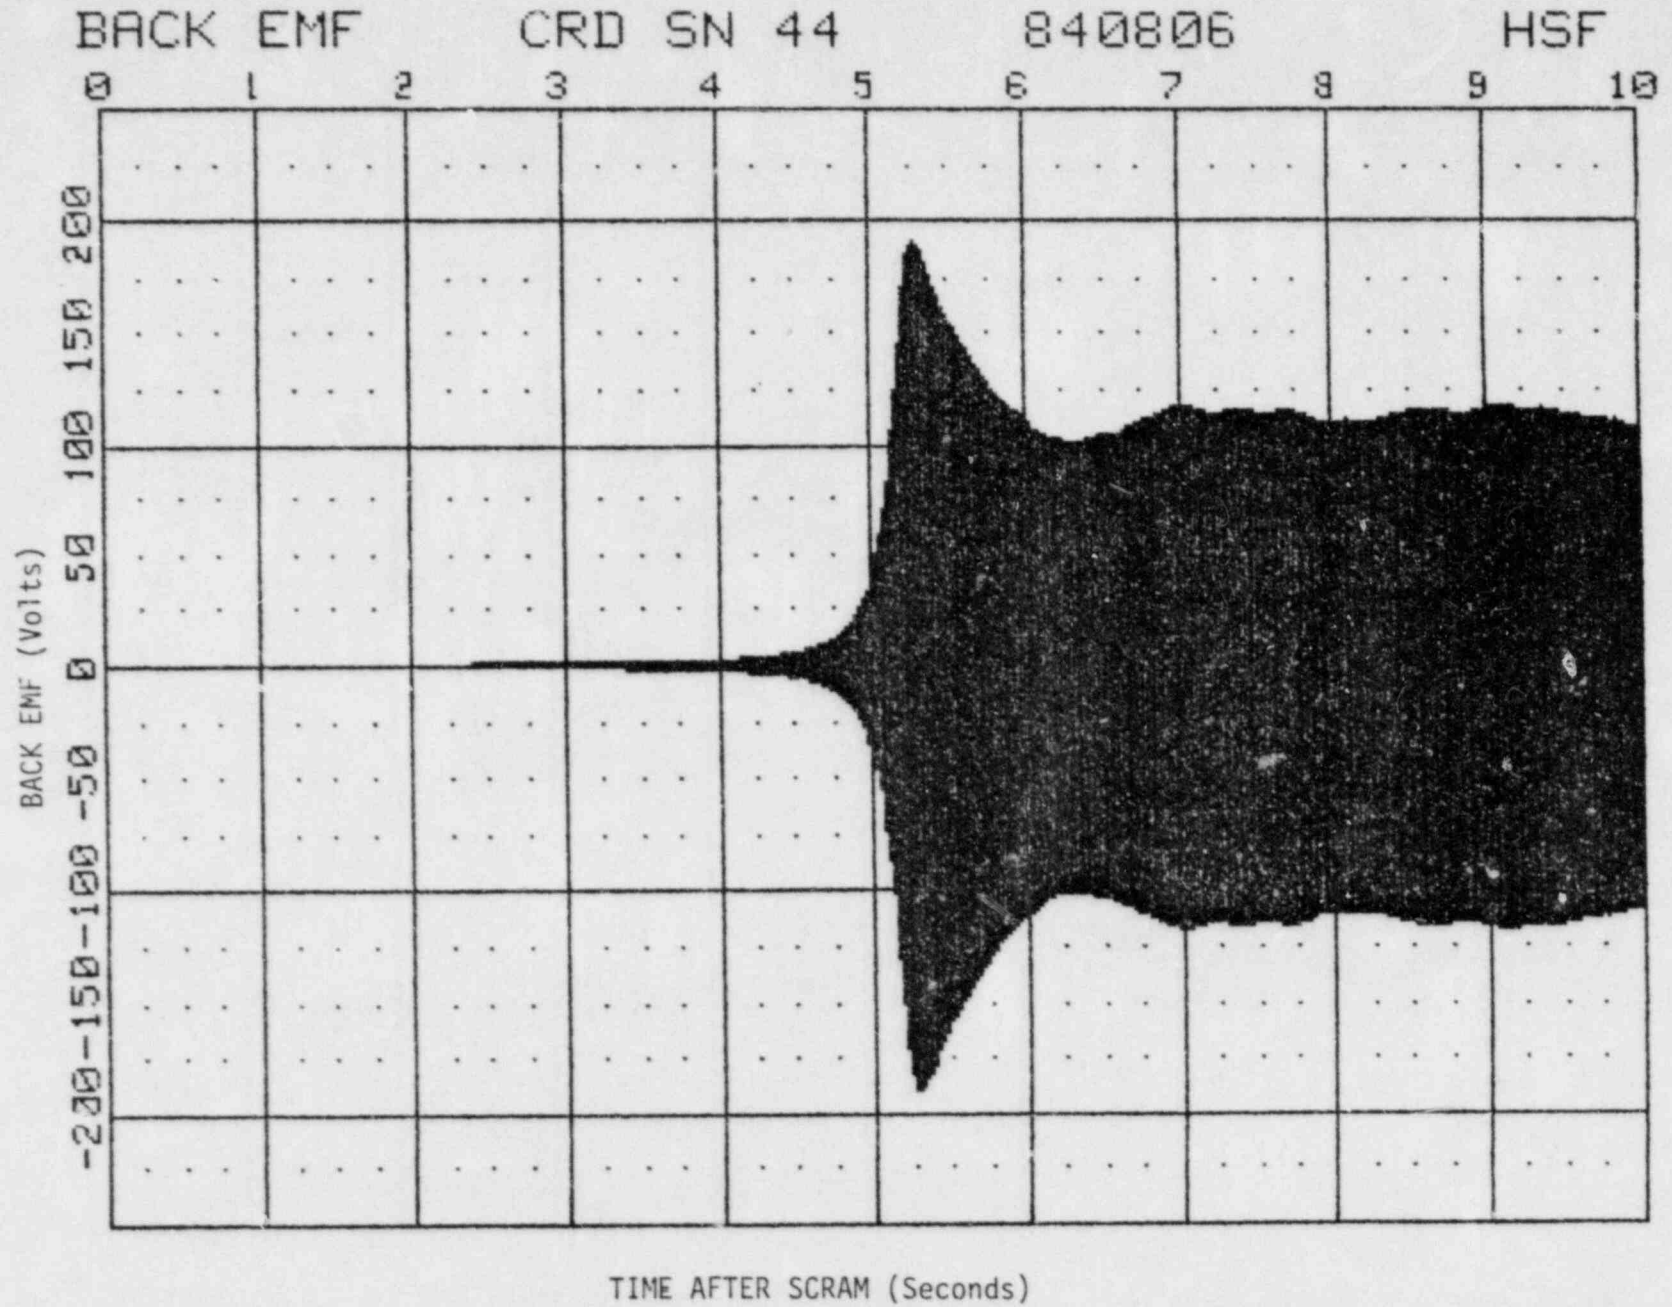
FIGURE 1

Samples of back-EMF data taken from CRD No. 44 (installed in Region 28 on June 23, 1984) are provided in Attachment 3. Figure 1 of Attachment 3 shows the back-EMF signature at the beginning of scram prior to any refurbishment work having been performed. Note the amount of time that it took the control rod to reach maximum scram velocity. Scram was initiated at $T = 0$ seconds, and the point at which the maximum scram velocity was reached (i.e., the first voltage maximum or regenerative peak) was at $T = 5.25$ seconds. Also note the magnitude and the erratic variations in the voltage wave amplitude subsequent to the first peak voltage. Figure 2 shows the signature after refurbishing only the CRD shim motor and brake assembly. A marked improvement was observed. (The data was digitized for computer analysis and plotting. The slight variations on the edges of the trace are normal.) This signature is very similar to that of an ideal trace on a new CRD. The data shown in Figure 3 was taken following refurbishment of the 200 Assembly. Based on this signature, it was concluded that a gear train assembly problem had been created during rework, and the 200 Assembly was disassembled again. It was found that a shim had been placed incorrectly during the first reassembly. The shim placement was corrected, and the 200 Assembly was reassembled a second time. Figure 4 shows the signature after all work was completed. By comparing Figure 2 and Figure 4, it can be concluded that refurbishment of the 200 Assembly did not significantly improve the CRD operation.

All of the CRDs that failed to scram on June 23, 1984, for which pre-refurbishment back-EMF signatures have been obtained (from Regions 6, 10, 25, and 28), had pre-refurbishment back-EMF signatures exhibiting similarities to Figure 1 of Attachment 3. The magnitude of the average peak-to-peak voltages was generally low, and erratic wave amplitude variations were characteristic. Back EMF signatures taken on a majority of the CRDs that scrambled properly on June 23, 1984, have exhibited larger average peak-to-peak voltage values and more constant wave amplitudes similar to Figure 4 of Attachment 3.

Back-EMF Trace for
CRD No. 44 (Installed in Region 28 on 6/23/84)
Taken Prior to Refurbishment

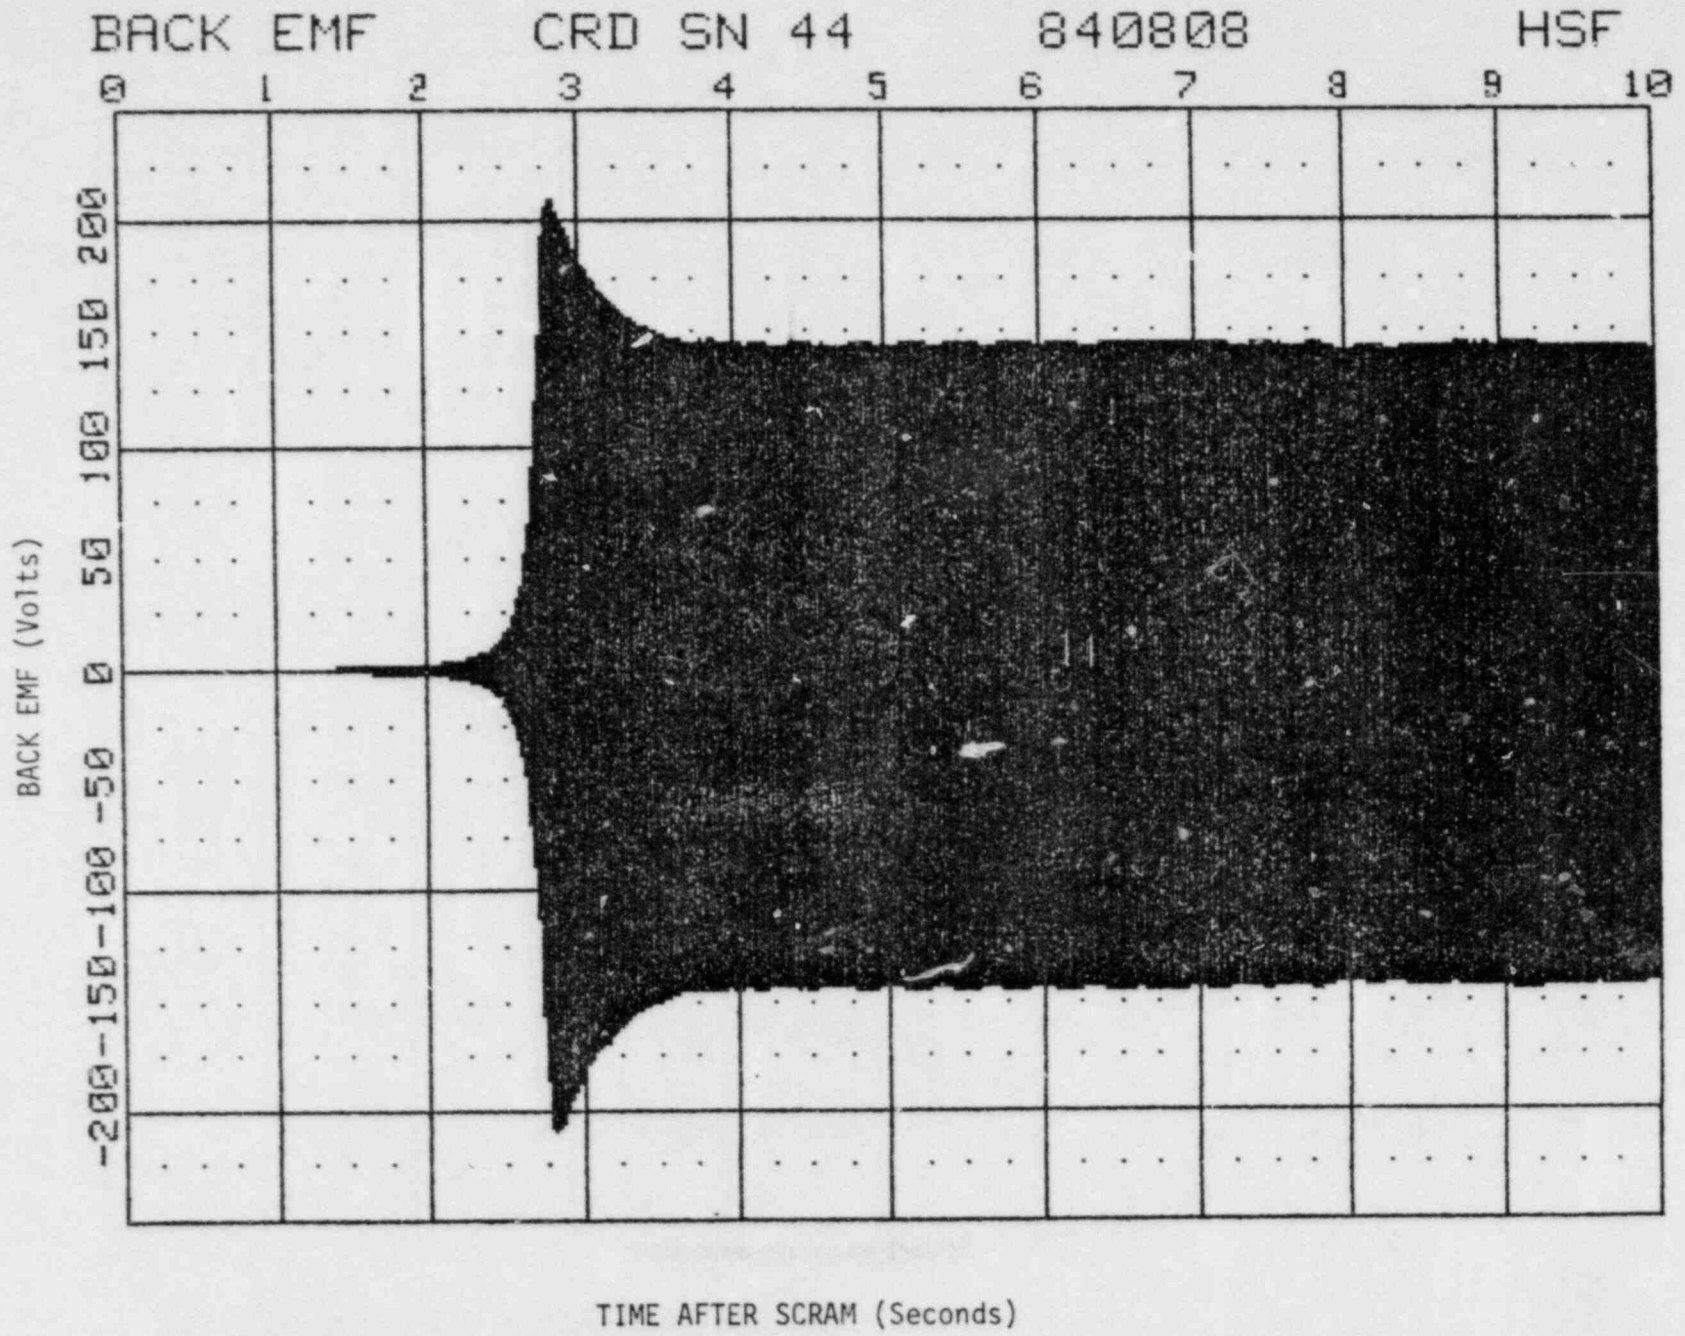
FIGURE 2

Back-EMF Trace for
CRD No. 44 (Installed in Region 28 on 6/23/84)
Taken After Refurbishment of Shim Motor/Brake Assembly Only

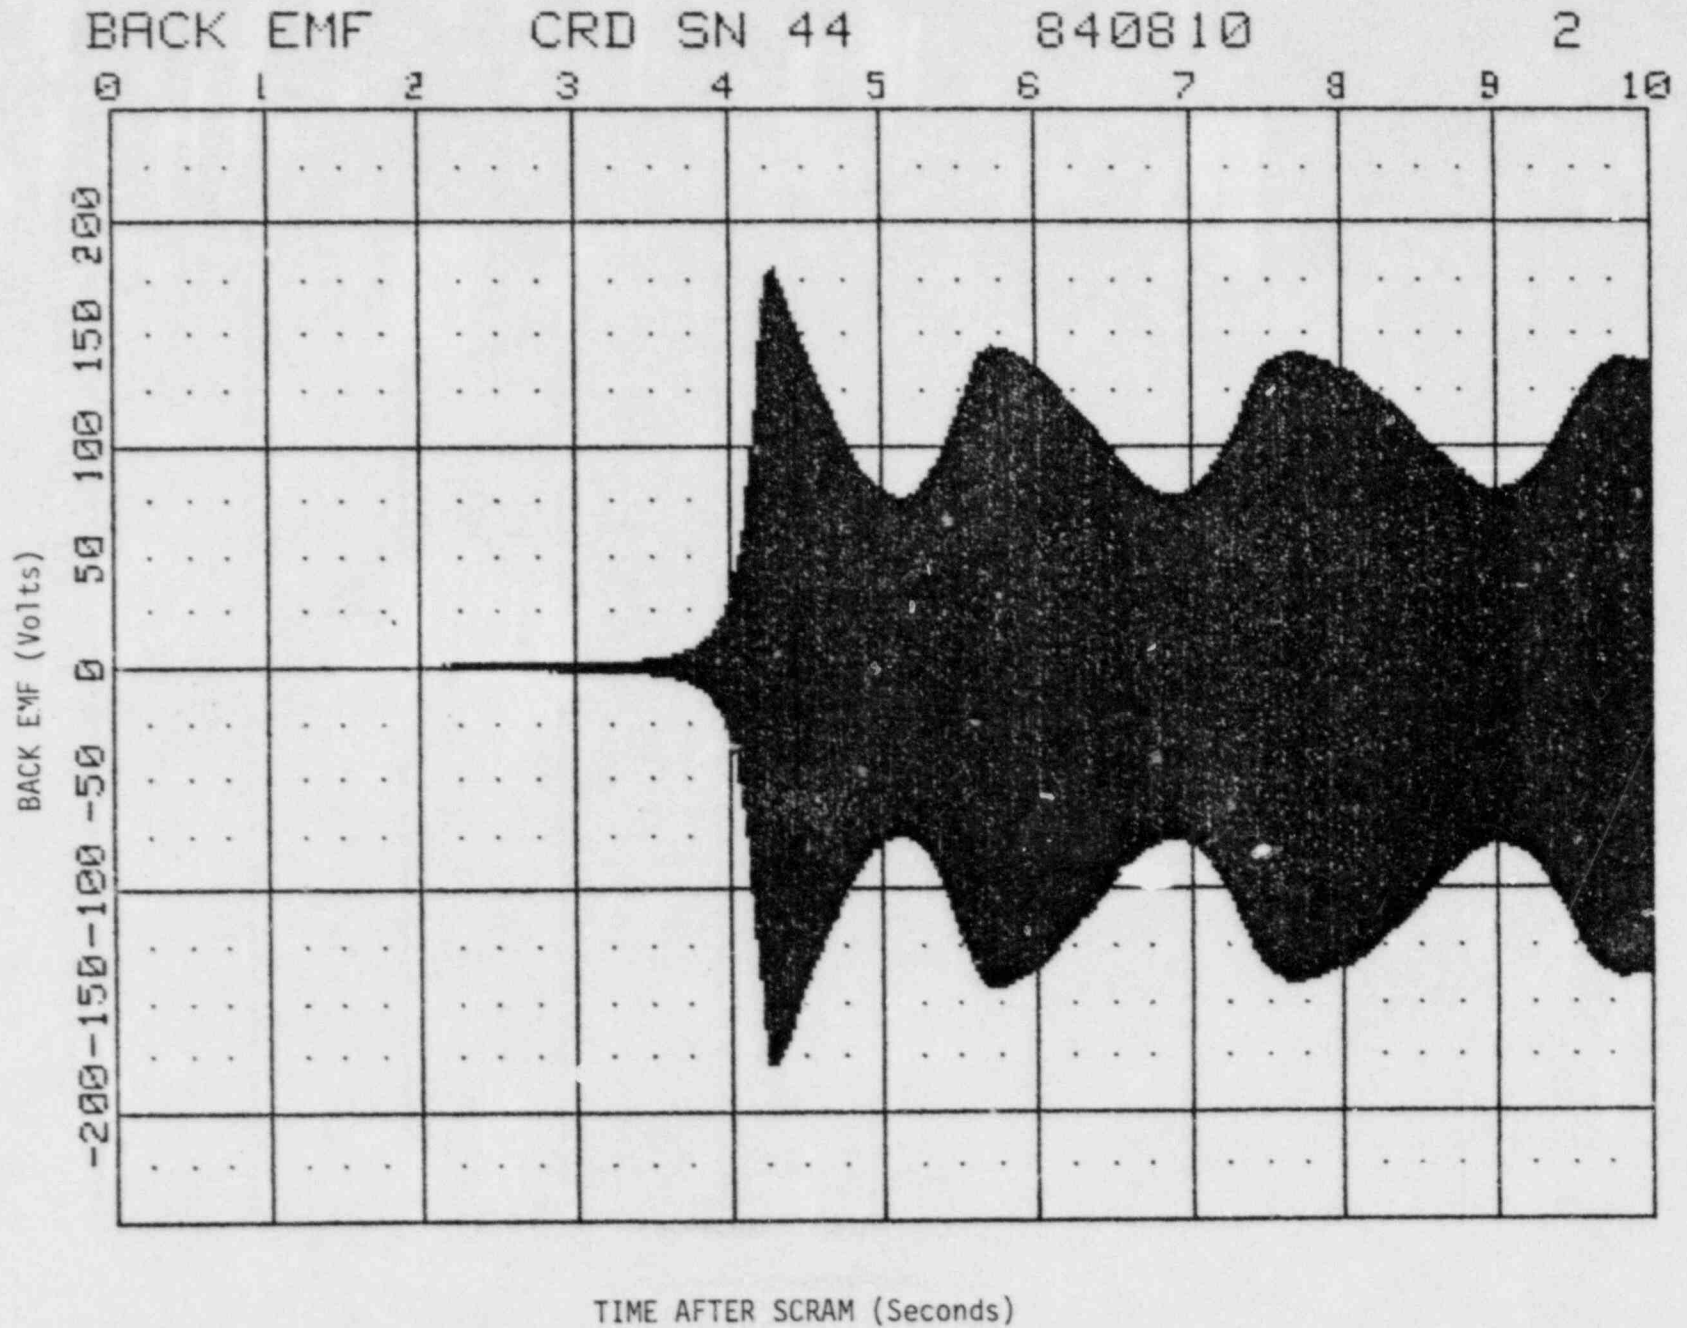
FIGURE 3

Back-EMF Trace for
CRD No. 44 (Installed in Region 28 on 6/23/84)
Taken After Refurbishment (With Misplaced 200 Assembly Shim)

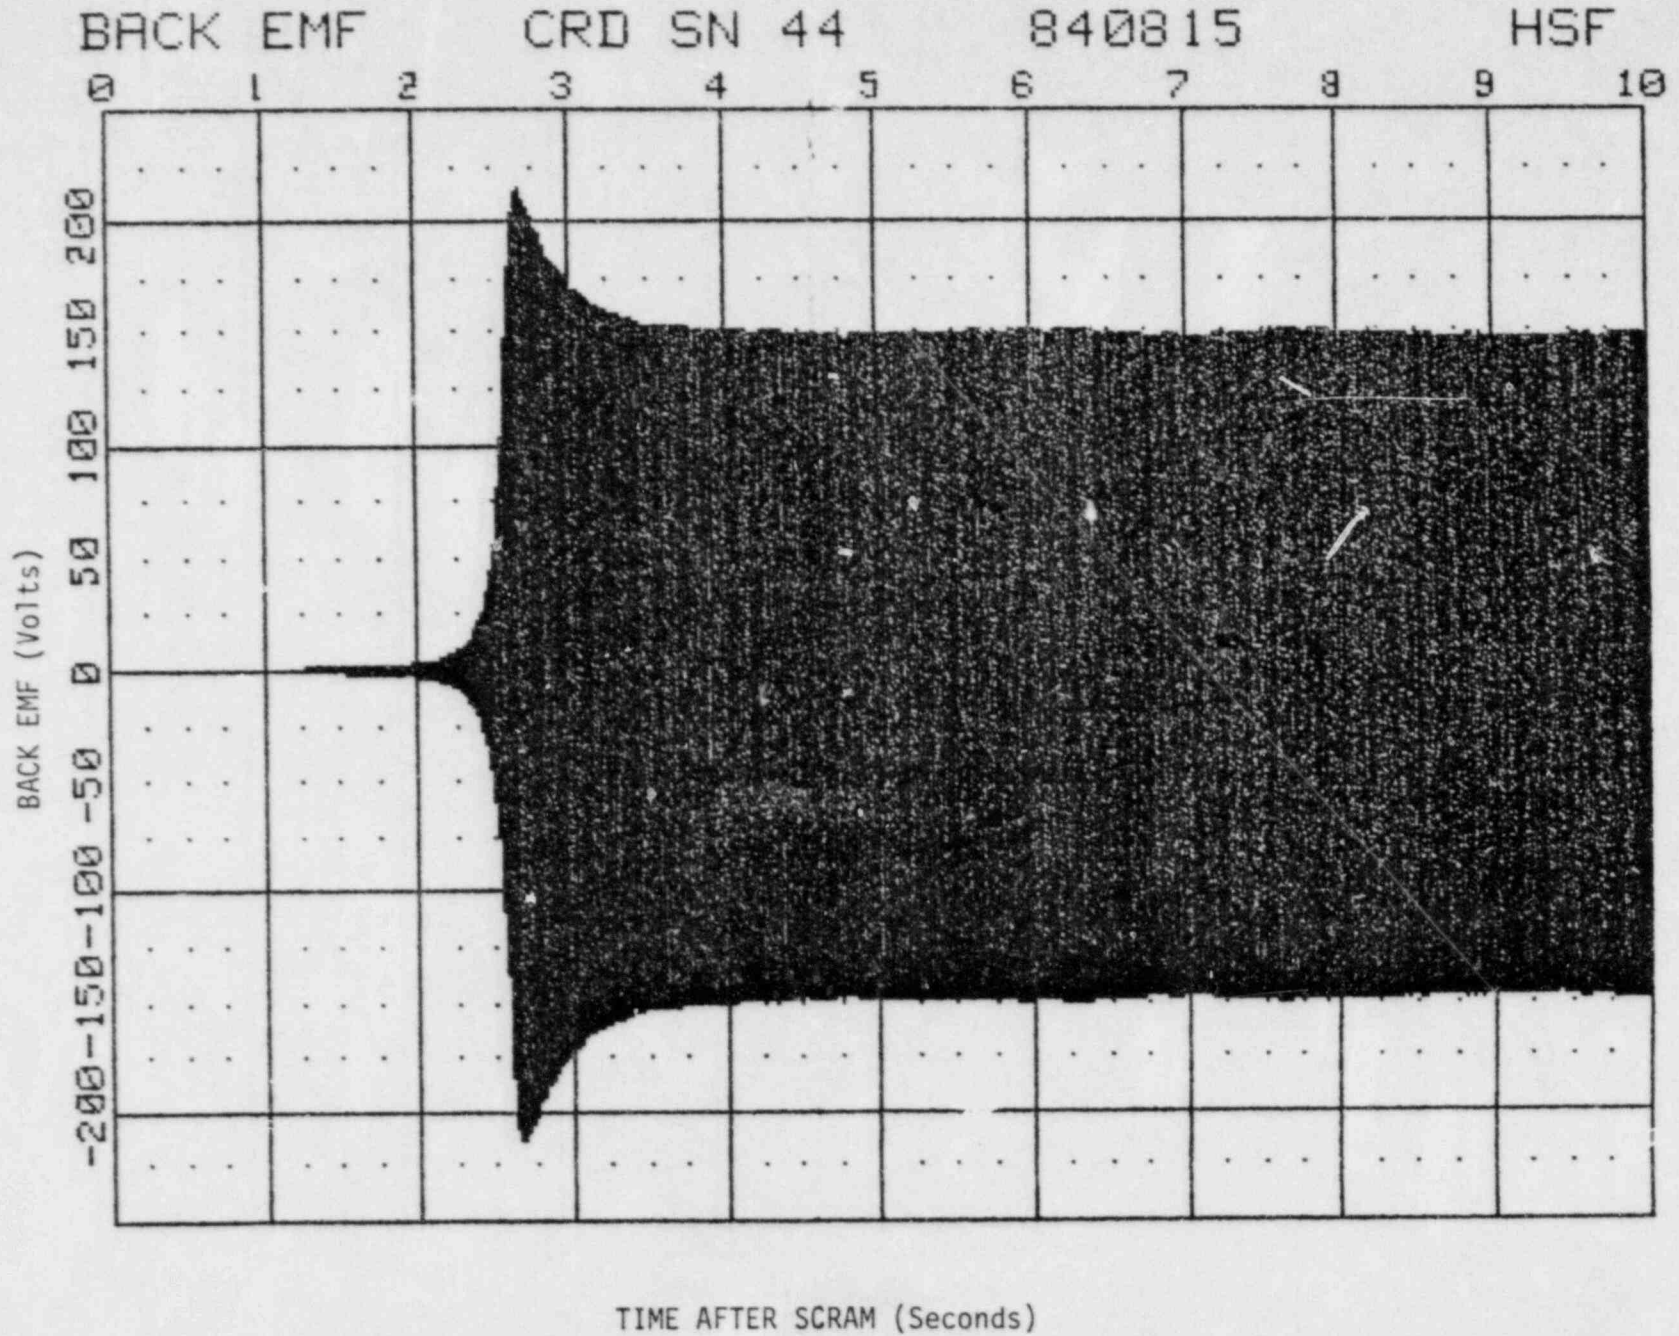
FIGURE 4

Back-EMF Trace for
CRD No. 44 (Installed in Region 28 on 6/23/84)
Taken After Refurbishment (Correct 200 Assembly Shim Placement)
