PRAIRIE ISLAND NUCLEAR GENERATING PLANT
Docket Nos. 50-282 License Nos. DPR-42
50-306 DPR-60

Request for Temporary Relief from the Requirements for
Code Repair of a Degraded Cooling Water System Pipe

REQUEST for RELIEF

Cooling Water System Indications Below Code Minimum Wall

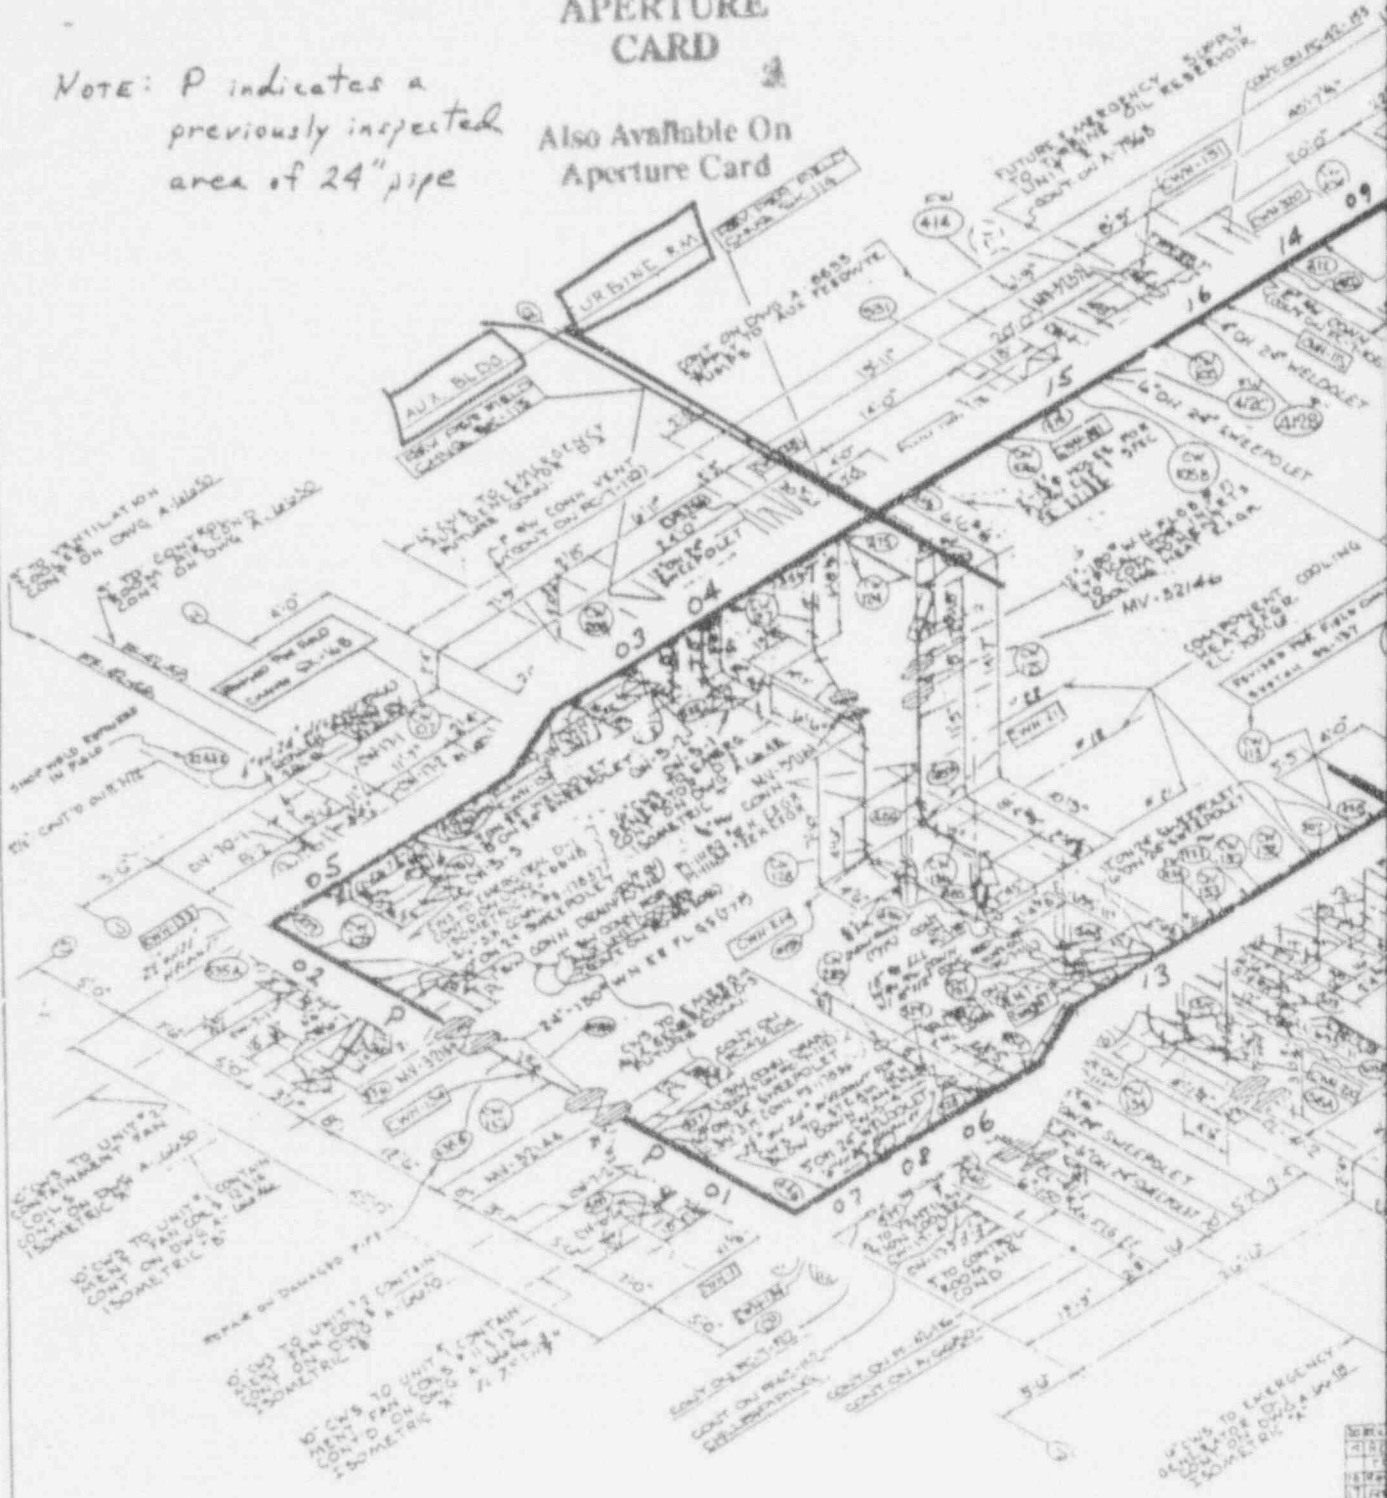
The locations of the inspected areas are shown on Figure 1. This piping was designed and constructed to ANSI B31.1 and later classified ASME Code Class 3 for Section XI inspection purposes. Design temperature is 100 °F and design pressure is 150 psig. Therefore, this piping is considered moderate energy piping per Generic Letter 90-05.

AREAS INSPECTED

NOTE: P indicates a previously inspected area of 24" pipe
