U.S. NUCLEAR REGULATORY COMMISSION
REGION IV

Inspection Report No. 50-482/92-01

Facility: Wolf Creek Generating Station (WCGS)

Areas Inspected: Special announced team inspection of the WCGS electrical distribution systems (EDS). The team evaluated the functional design and capabilities of the EDS and those mechanical systems necessary to support the EDS.

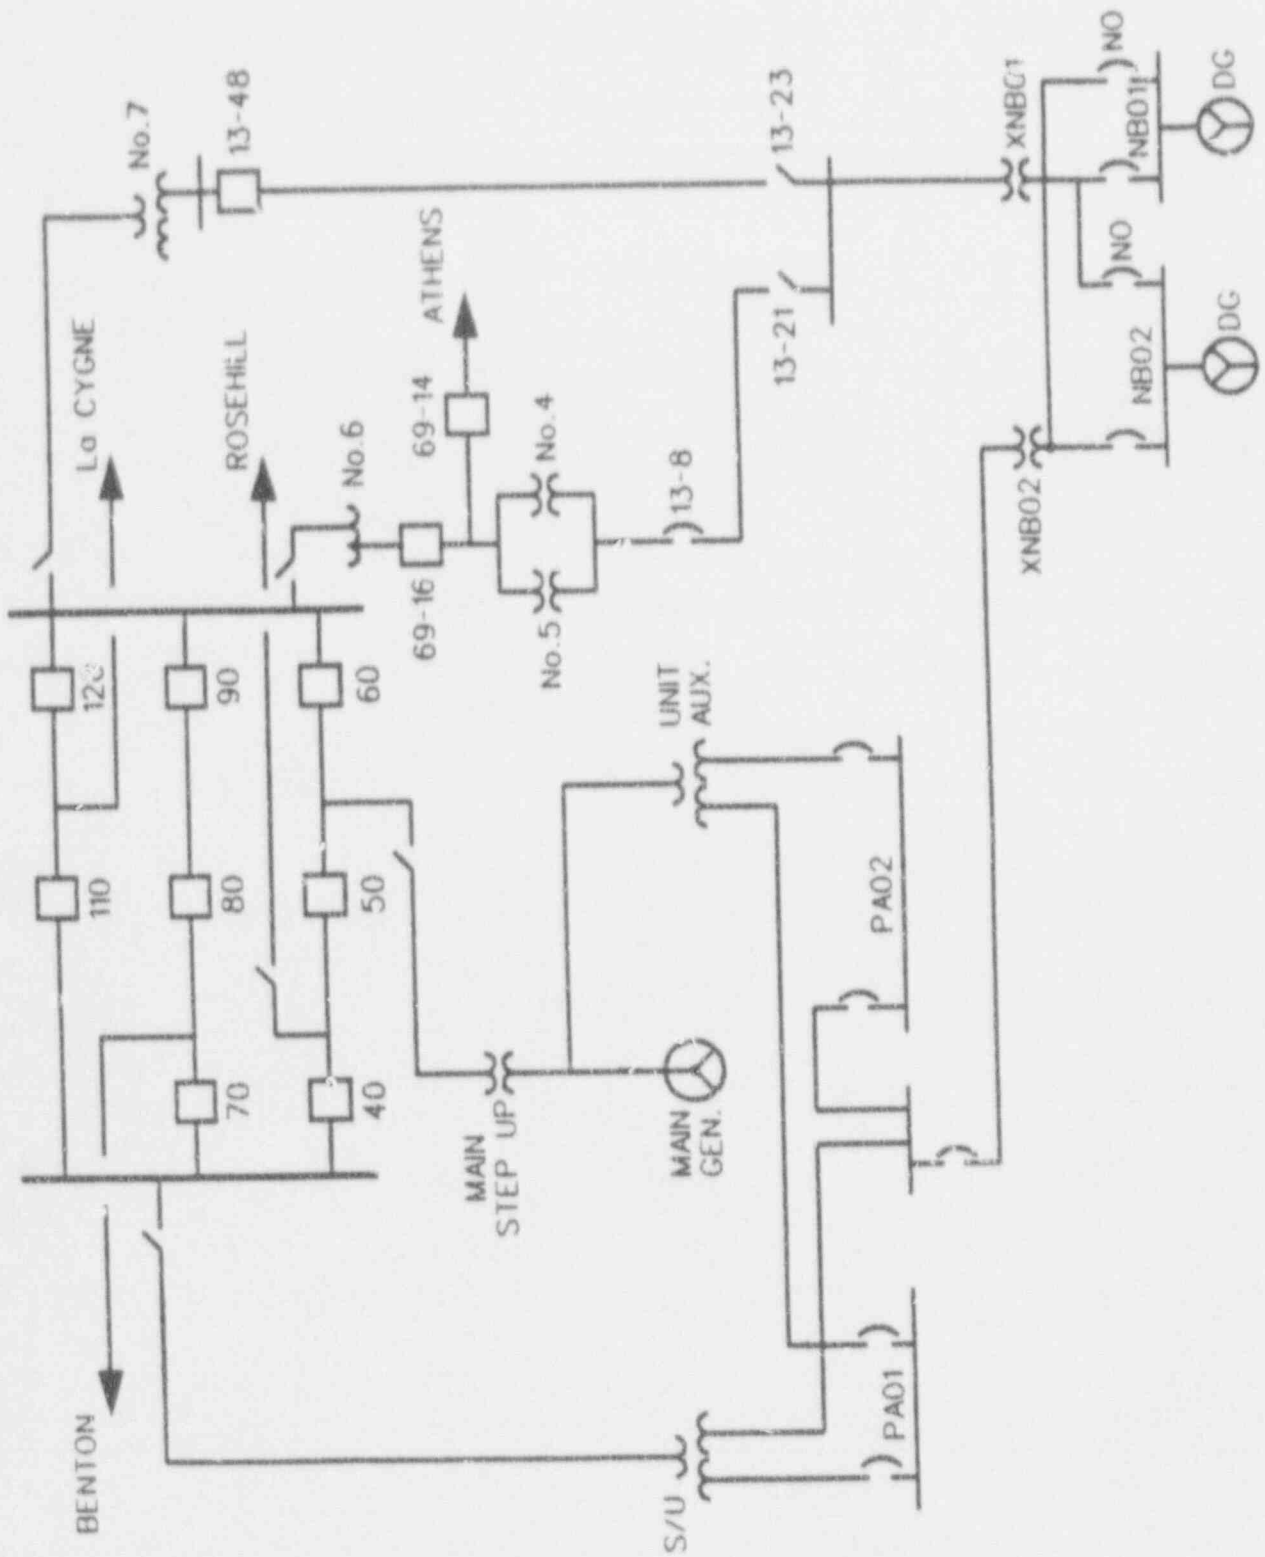
ATTACHMENT 2

The WCGS was serviced by three, full capacity, 345kV transmission lines connected to the switchyard in a breaker-and-a-half configuration. The switchyard was also serviced by two 69kV transmission lines, one of which could be utilized as an alternate source of offsite power. The offsite power was routed to the facility through two load paths. The startup transformer was connected to the east bus of the switchyard by overhead transmission lines and provided power to two 13.8kV buses during unit shutdown conditions. The startup transformer also provided the normal source of power to one of the two engineered safety features (ESF) buses through ESF Transformer XNB02. The other ESF bus was normally energized by the west bus of the switchyard through underground feeders from Switchyard Transformer No. 7 to ESF Transformer NB01. Both of the ESF transformers could be energized through alternate load paths. A simplified diagram of the EDS is provided in Attachment 2.
