UNITED STATES OF AMERICA  
NUCLEAR REGULATORY COMMISSION

BEFORE THE ATOMIC SAFETY AND LICENSING BOARD

In the Matter of	)	
	)	
LONG ISLAND LIGHTING COMPANY	)	Docket No. 50-322-0L
	)	
(Shoreham Nuclear Power Station,	)	
Unit 1)	)

JOINT TESTIMONY  
of  
CARL H. BERLINGER, SPENCER H. BUSH,  
ADAM J. HENRIKSEN, WALTER W. LAITY, AND PROFESSOR ARTHUR SARSTEN  
on  
CONTENTIONS CONCERNING TDI EMERGENCY DIESEL GENERATORS  
at the  
SHOREHAM NUCLEAR POWER STATION

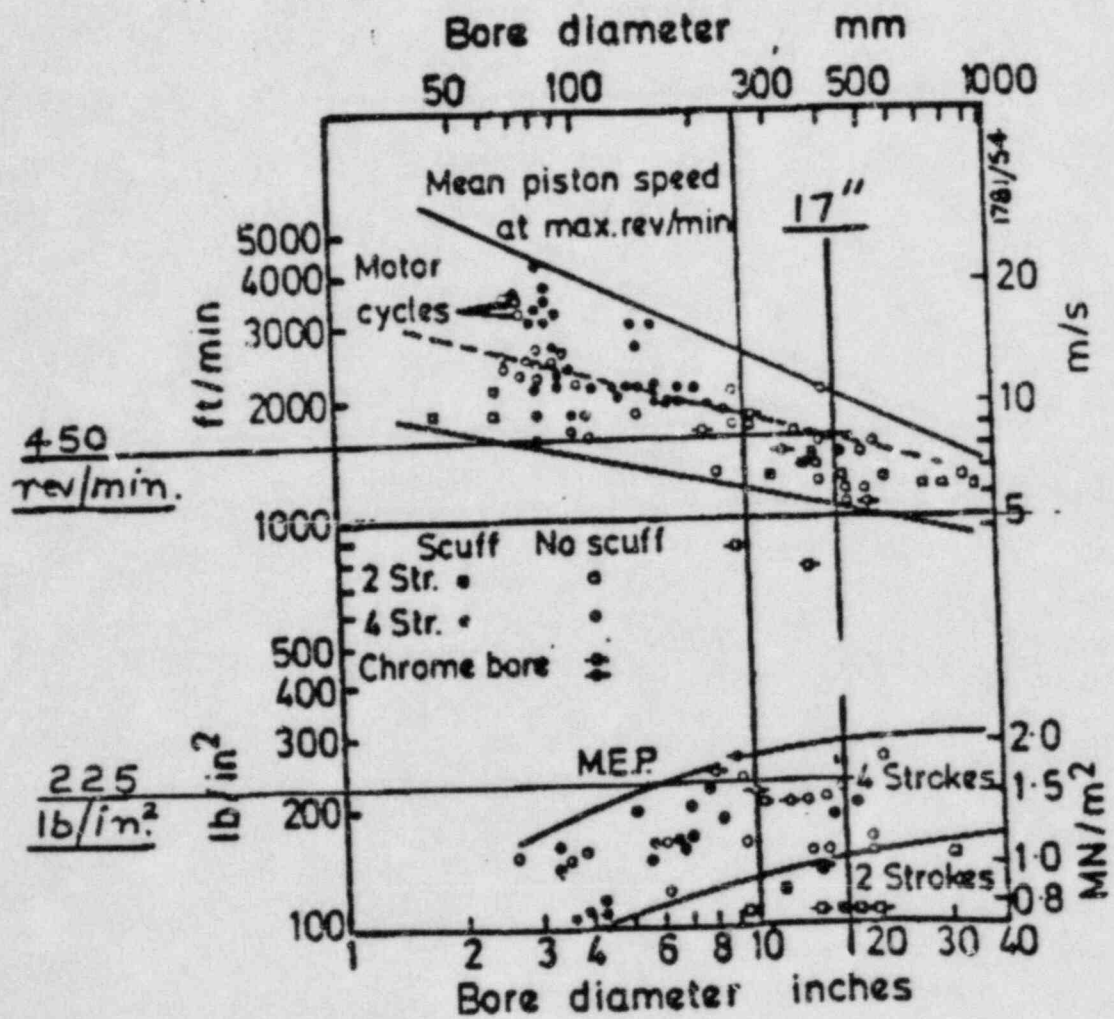
**Fig 4 Incidence of Scuffing**

A GRAPH IS ENCLOSED, PAGE WHICH SHOWS PISTON SCUFFING SHOULD NOT OCCUR ON THIS ENGINE AT THIS RATING AND SPEED UNDER NORMAL CONDITIONS

THE PREFERRED ALTERNATIVE IS GRAPHITE COATINGS.
