Subject: Licensee Event Report 92-015 for the Fort Calhoun Station

LICENSEE EVENT REPORT (LER)

FACILITY NAME (1) Fort Calhoun Station Unit No. 1

TITLE (4) Loss of Shutdown Cooling Flow Control and Flow Indication

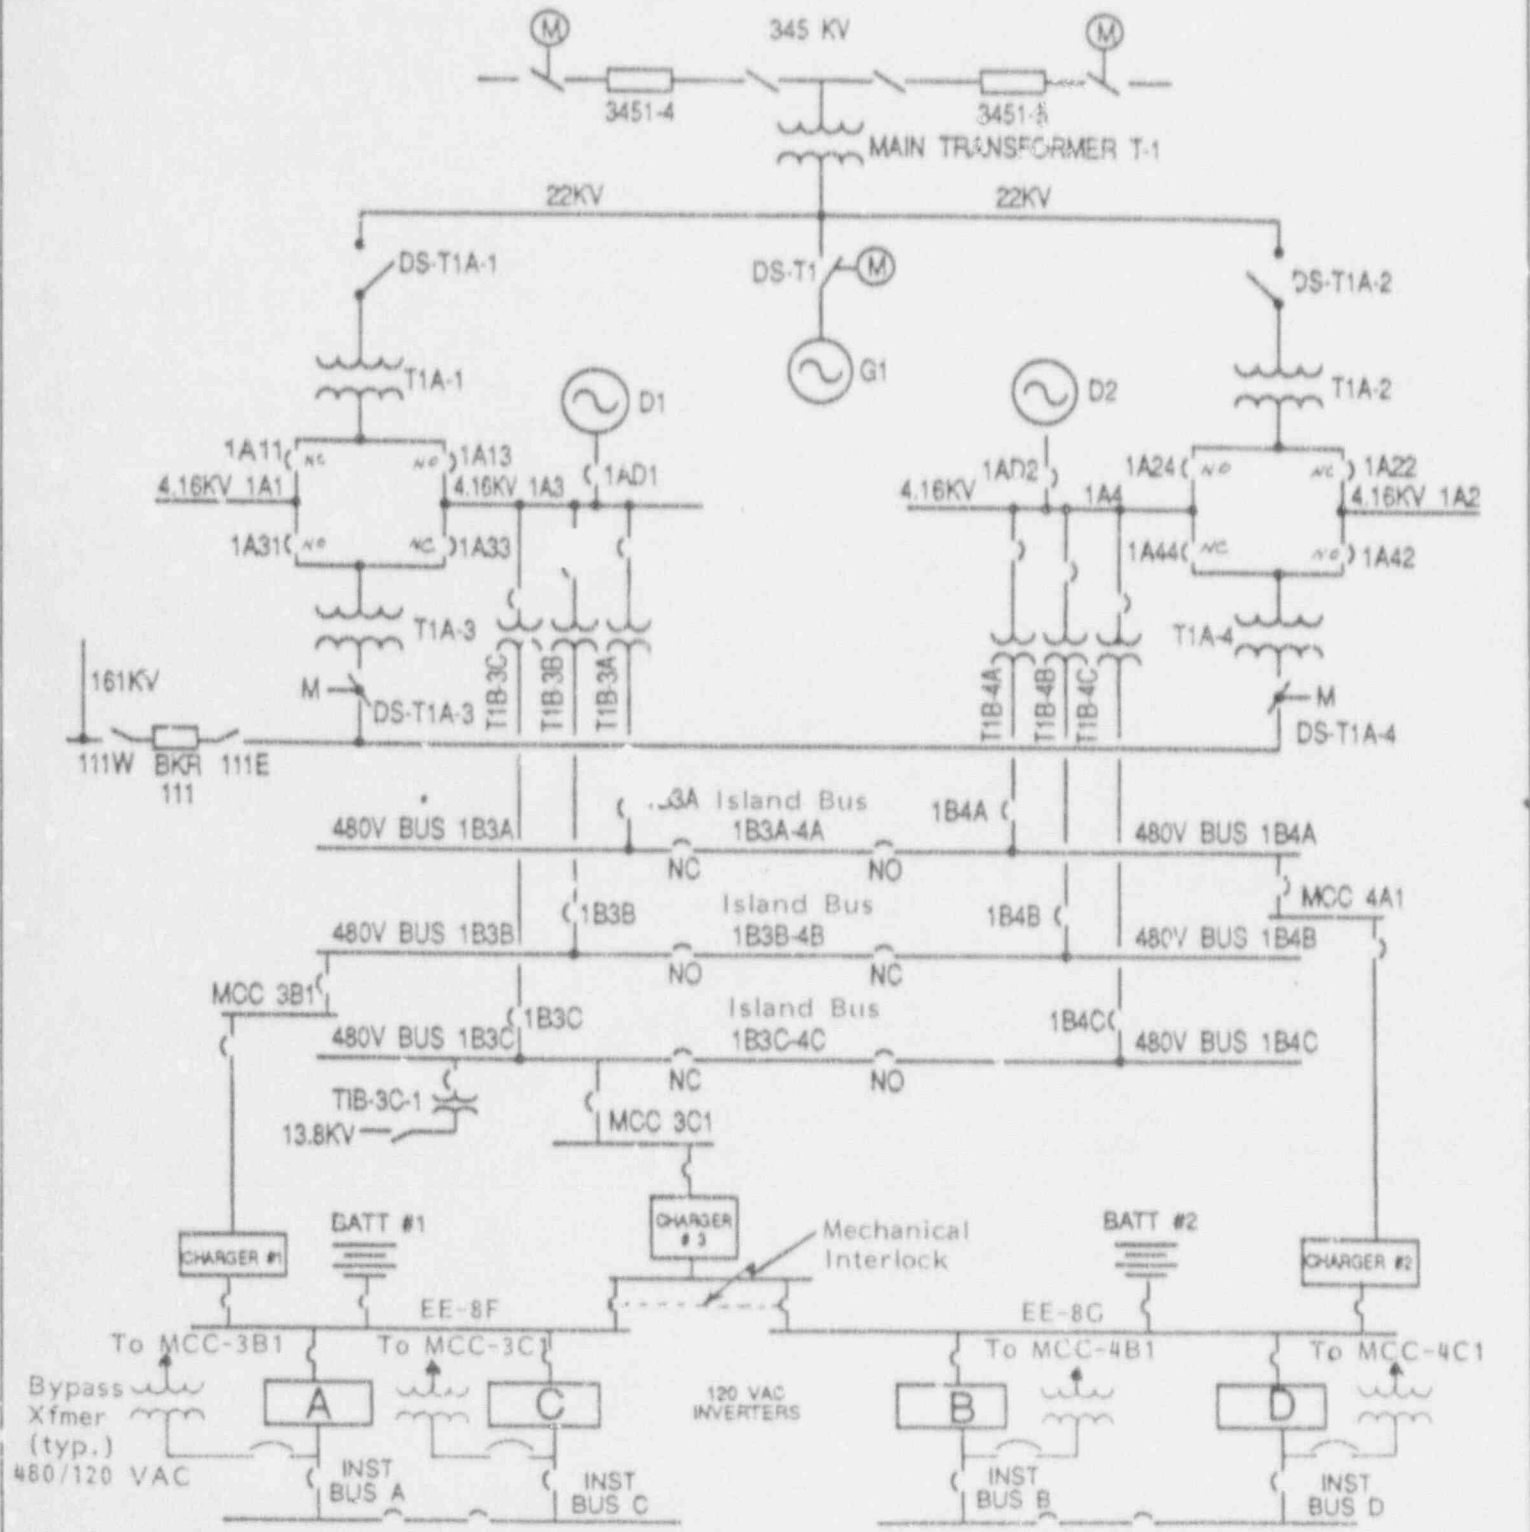
FIGURE 1

The Electrical Distribution System at Fort Calhoun Station (Figure 1) includes two safety related 4.16kV buses (1A3 and 1A4) which feed a total of nine 480V buses. Of the nine 480V buses, three (buses 1B3A-4A, 1B3B-4B and 1B3C-4C) can be tied to either of two adjacent 480V buses, allowing them to be fed from either 1A3 or 1A4. The normal electrical line-up has 4.16kV Bus 1A3 feeding five 480V buses (1B3A, 1B3B, 1B3C, 1B3A-4A and 1B3C-4C) and 4.16kV Bus 1A4 feeding four 480V buses (1B4A, 1B4B, 1B4C and 1B3B-4B).

The power for plant control and instrumentation is provided by the 125V DC System. This system is designed to operate without interruption during design basis accident and adverse environmental conditions. The system includes two separate DC buses. Each 125V DC bus feeds three inverters. Two inverters on each 125V DC bus (Inverters A, B, C, and D) feed the Reactor Protection System and Engineered Safety Feature loads, and one additional inverter on each 125V DC bus (Inverters 1 and 2, not shown on Figure 1) feeds the auxiliary instrument bus loads.

On April 12, 1992, while Fort Calhoun Station was in a refueling outage (in Mode 5, refueling shutdown), the plant Electrical Distribution System was in an off-normal line-up. 480V Bus 1B4A, when recently returned to service, but the normal supply breaker for this bus was not available. Therefore, bus-tie breakers were closed (connecting 480V Buses 1B3A-4A and 1B4A) in order to power Bus 1B4A from the opposite safety related 480V bus (1A3).

The overcurrent trip device on the 1B3A feeder breaker initiates a breaker trip once the overcurrent setpoint is surpassed. Once initiated, the trip device proceeds to trip the breaker even if input/load current is subsequently reduced. The additional loading from the off-normal electrical alignment and the conduct of the HPSI System check valve test caused an overcurrent condition to be sensed by the breaker. Approximately 50 seconds after the pumps were secured the feeder breaker to 1B3A tripped free on the long-time delay overcurrent trip. Once the overcurrent condition was sensed, the trip devices proceeded to trip the breaker even though the load was reduced approximately 50 seconds before the breaker tripped. Major loads being supplied through the breaker included: Air Compressor CA-1C, Battery Charger #2, Instrument Bus #2, Component Cooling Water Pump AC-3B, Spent Fuel Pool Cooling Pump AC-5A, the Security Battery Charger, Radiation Monitor M-060 and several ventilation fans. The operating crew immediately checked the status of shutdown cooling, started an air compressor, and verified that the standby component cooling water pump started.
