Subject: Waterford 3 SES
Docket No. 50-382
License No. NPF-38
Reporting of Licensee Event Report

LICENSEE EVENT REPORT (LER)

FACILITY NAME (1)
WATERFORD STEAM ELECTRIC STATION UNIT 3

TITLE (4)
ESSENTIAL CHILLED WATER SYSTEM FLOW DEGRADATION

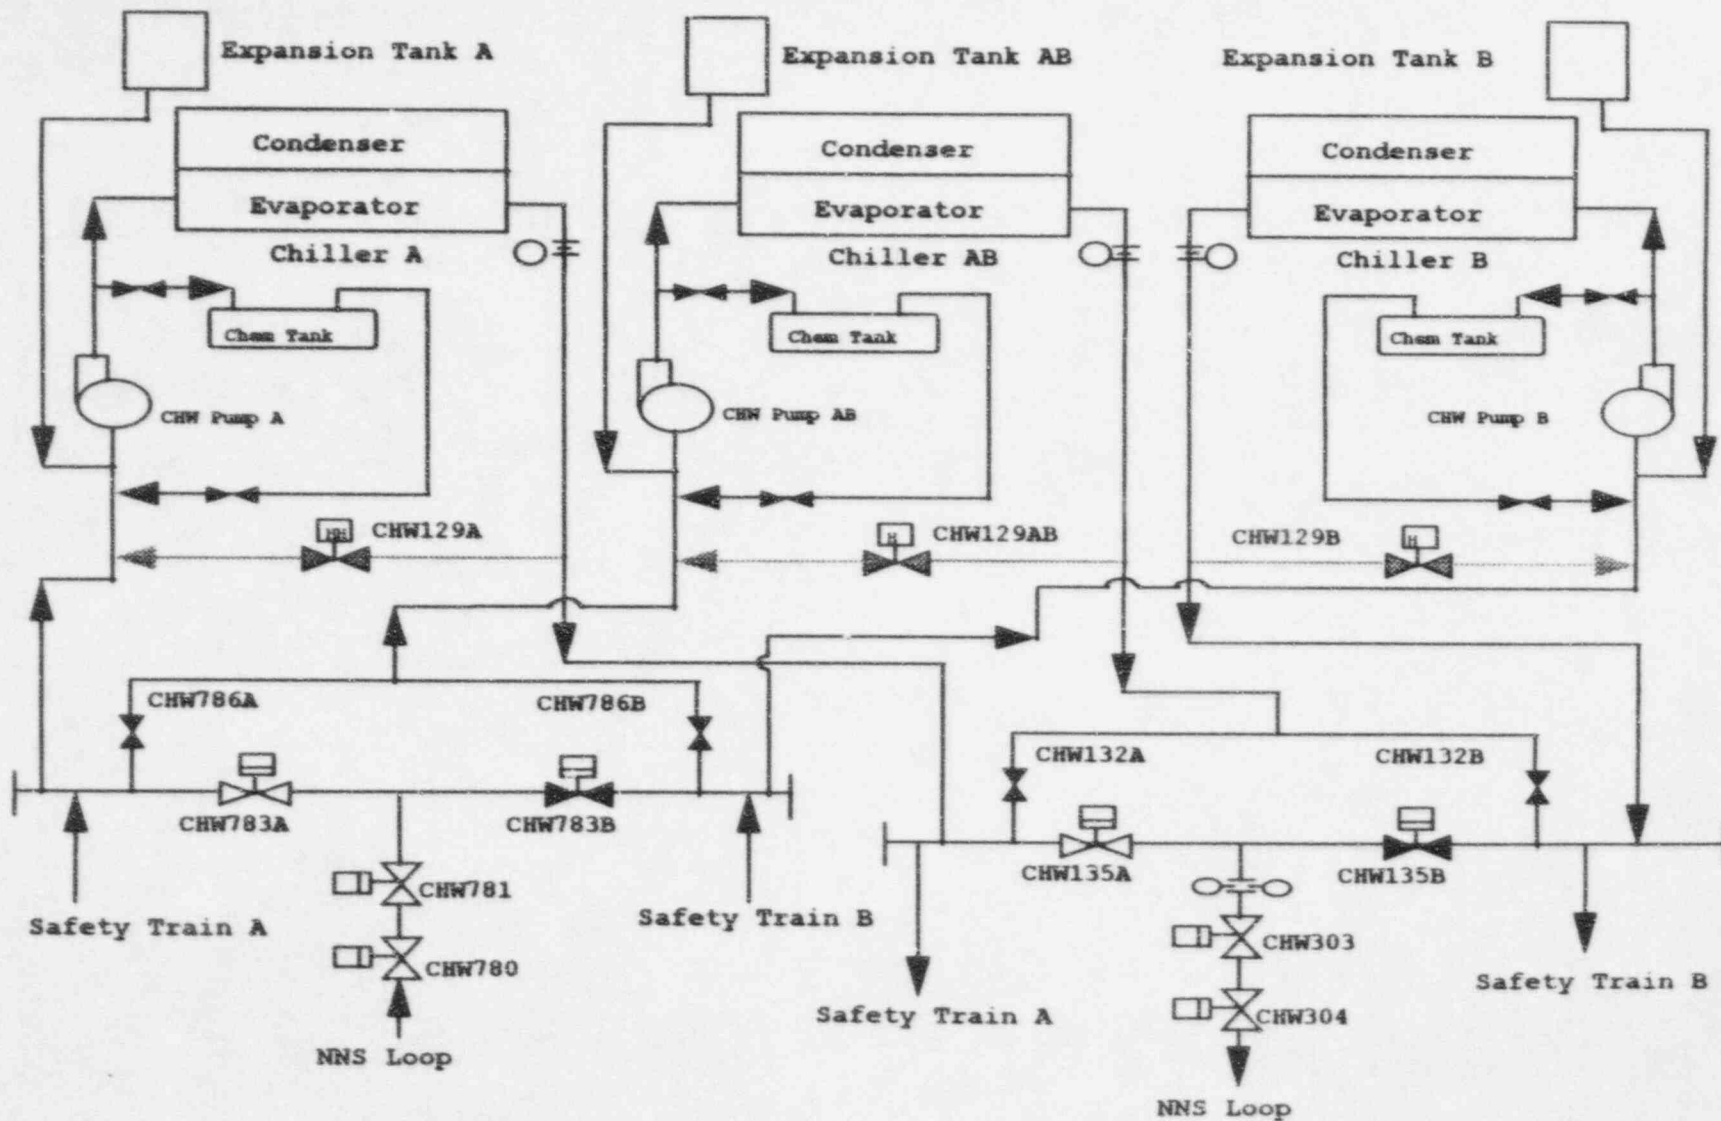
ATTACHMENT A (1 of 4)

(Refer to Attachment A) The Essential Chilled Water system consists of three 100 percent capacity subsystems. Each consisting of: one water chiller compressor unit (EIIS, KM-CMP), one chilled water pump (EIIS, KM-P), and associated piping, valves, instrumentation and controls.

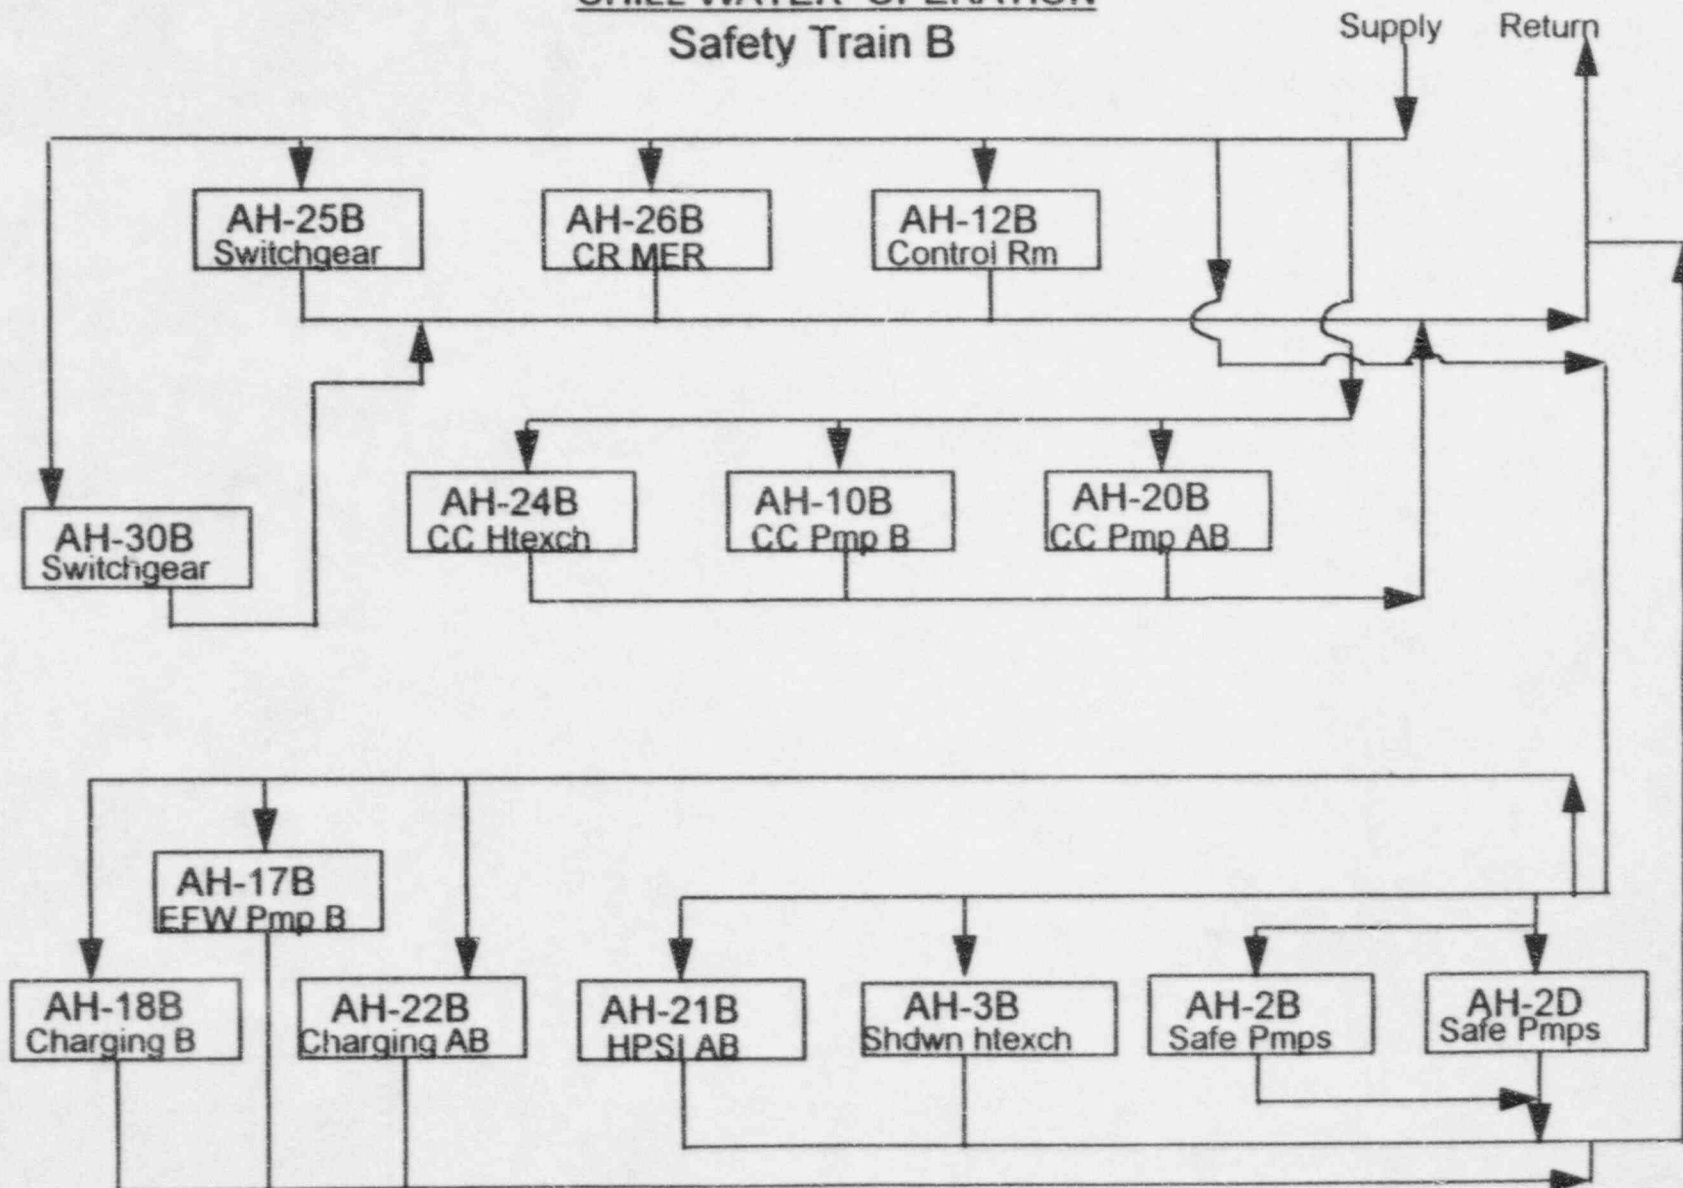
Safety Train B

During the performance of the test, it was discovered that the Essential Chilled water sub-loop which supplies chilled water to the room coolers for the 'B' Safeguards pump room and the Shutdown Heat Exchanger Room 'B' (AH-2(B), AH-2(D) and AH-3) was lower than required. The required sub-loop flow was approximately 94 gpm. The flow measured in the sub-loop was approximately 54 gpm. Sub-loop flows to the other three sub-loops remained adequate throughout this test. The total flow for the Essential Chilled Water train 'B' during this test (STP 01135688) was measured to be approximately 480 gpm. This was greater than the accident minimum required flow rate of approximately 424 gpm, but was less than the design flow rate of 510 gpm.

On June 1, 1995, the chilled water loop 'B' was again subjected to a flow balance test via Special Test Procedure 01136204. This test, however, had the 'B' chilled water pump and chiller aligned to the 'A/B' train. During the performance of this test the "as found" flow rates for Chilled Water loop 'B' with the Chilled Water pump 'B' aligned was 320 gpm, which was less than the accident flow. This was with CHW-115B in a ONE NOTCH OPEN position. During investigation of the event, it was found that with CHW-115 B fully open, the flow rates for the 'B' loop were acceptable (580 gpm).

The root cause for the conditions of room coolers with little or no flow is attributed to iron deposits that have settled, over time, on the seats of

the individual room cooler chilled water manual throttle valves. These valves remain in a low flow condition for the majority of the time due to their small throttled position (i.e., only a few turns from closed) and the normally throttled closed position of their associated flow control valves. This allowed iron deposits to settle on the valve seats and block flow through the small opening between the disc and seat. When the valves were cycled, the sediment and rust was flushed and adequate flow was restored. Additionally, chemistry results indicated a large increase in the iron concentration of the Chilled Water System subsequent to these flushing manipulations. It should be noted that although a large increase was seen, the total iron concentration remained below the administrative limits set by Waterford.

Immediate corrective action was taken to restore the chilled water flow to established design conditions. Four valves were adjusted by the special test procedure: Chilled Water Pump Discharge Valve, CHW-115 A/B, Safeguards Room 'B' Room Cooler Outlet Isolation Valves, CHW-840A and B and Charging Pump & Emergency Feedwater Systems Chilled Water Return Header 'B' Isolation, CHW-823. Adjusting these valves established chilled water flow to 565 gpm total loop flow and 95 gpm for the safeguards room 'B' sub-loop flow. Additionally, Design Engineering evaluated the "as found" flow conditions of the 'B' chilled water train and concluded that the flows were satisfactory for the 'B' Chilled Water train to perform its intended support safety function.

A special test (Work Authorization 01140352) was developed and performed during refuel 7 outage to drain and flush the B and A/B (from the B header) Chilled Water headers. Subsequent flow verification testing indicated improved flow performance. The room coolers associated with the A Chilled Water header will be drained and flushed during subsequent component outages this operating cycle (Cycle 8).
