Public Service Electric and Gas Company P.O. Box 236 Hancocks Bridge, New Jersey 08038
Hope Creek Generating Station

HOPE CREEK GENERATING STATION
DOCKET NO. 50-354
UNIT NO. 1
LICENSEE EVENT REPORT 92-005-00

TITLE (4): Engineered Safety System Actuation: Control Room Ventilation isolation and Emergency Filter start due to Personnel Error.

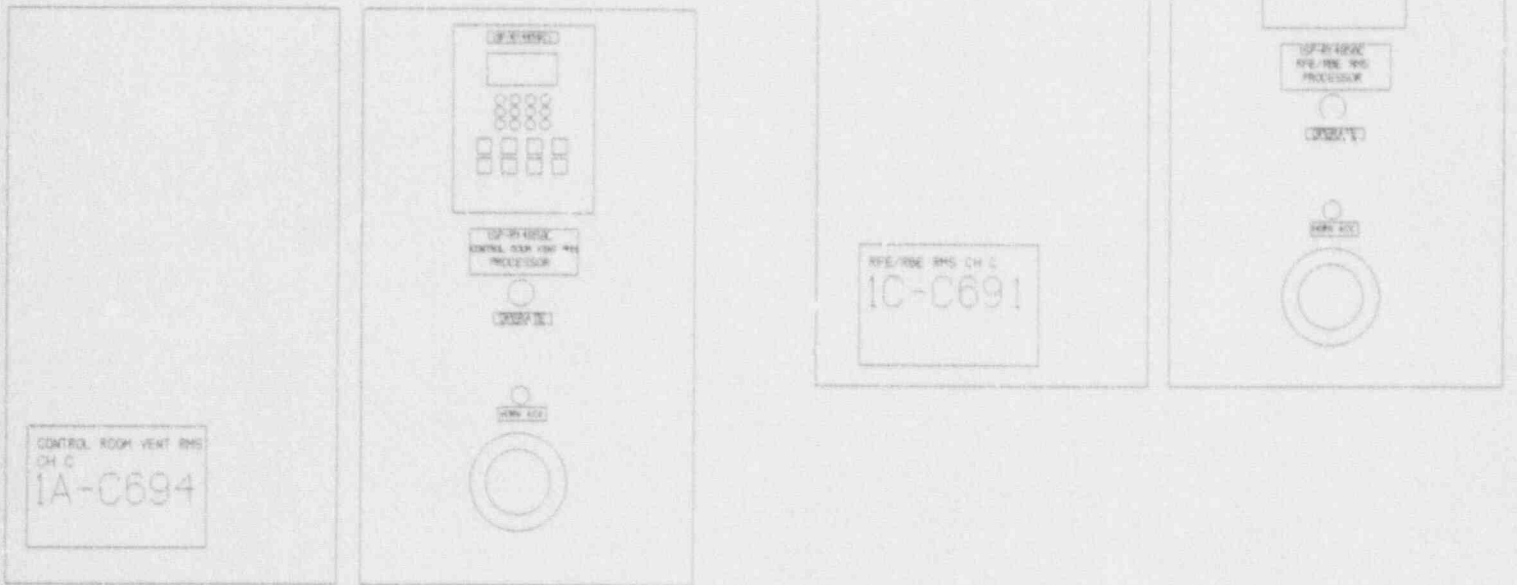
ARRANGEMENT OF RM-80

The RM-80 for the Reactor Building/Refuel Floor exhaust channel being tested 1SP-RY-4856C, is located in the lower relay room approximately five feet from the RM-80 for the Control Room Ventilation system supply 1SP-RY-4858C. The cabinets are identical in appearance and are only distinguishable by the identification labels.

The technicians perform the test from two separate locations, one in the main control room, the other at the RM-80 in the lower relay room. The technician working in the relay room initially identified the correct RM-80 channel which was to be removed from service. He then walked to another area of the relay room to contact the technician in the control room via the page system. The control room technician instructed the relay room technician to down power the RM-80. Upon returning to the area where the RM-80 was located the technician proceeded to the adjacent panel and turned off the power to the Control Room Intake RM-80 resulting in the isolation of the control room ventilation and CREF start.

The root cause of this event is inadequate self checking on the part of the technician in the lower relay room. The procedure contained the instrument number for the channel being worked but the technician did not properly identify the correct channel when performing the step after receiving the instructions via the page system. The similarity in the numbering of the rad monitor channels also contributed to this event.

1. The technician involved has been counseled on the need for proper self checking methods during the performance of testing activities.
2. This event will be included in I&C continuing training program, stressing the need for proper self checking methods.
3. A review and evaluation of I&C RMS surveillance procedures will be conducted to determine the need for double verification and the use of unique identifiers during testing.
