January 19, 1996  
NG-96-0129

Subject: Duane Arnold Energy Center  
Docket No: 50-331  
Op. License No: DPR-49  
Licensee Event Report #95-013  
File: A-118a

TITLE (4) HPCI Inoperability Due To Water in HPCI Turbine Steam Exhaust Line

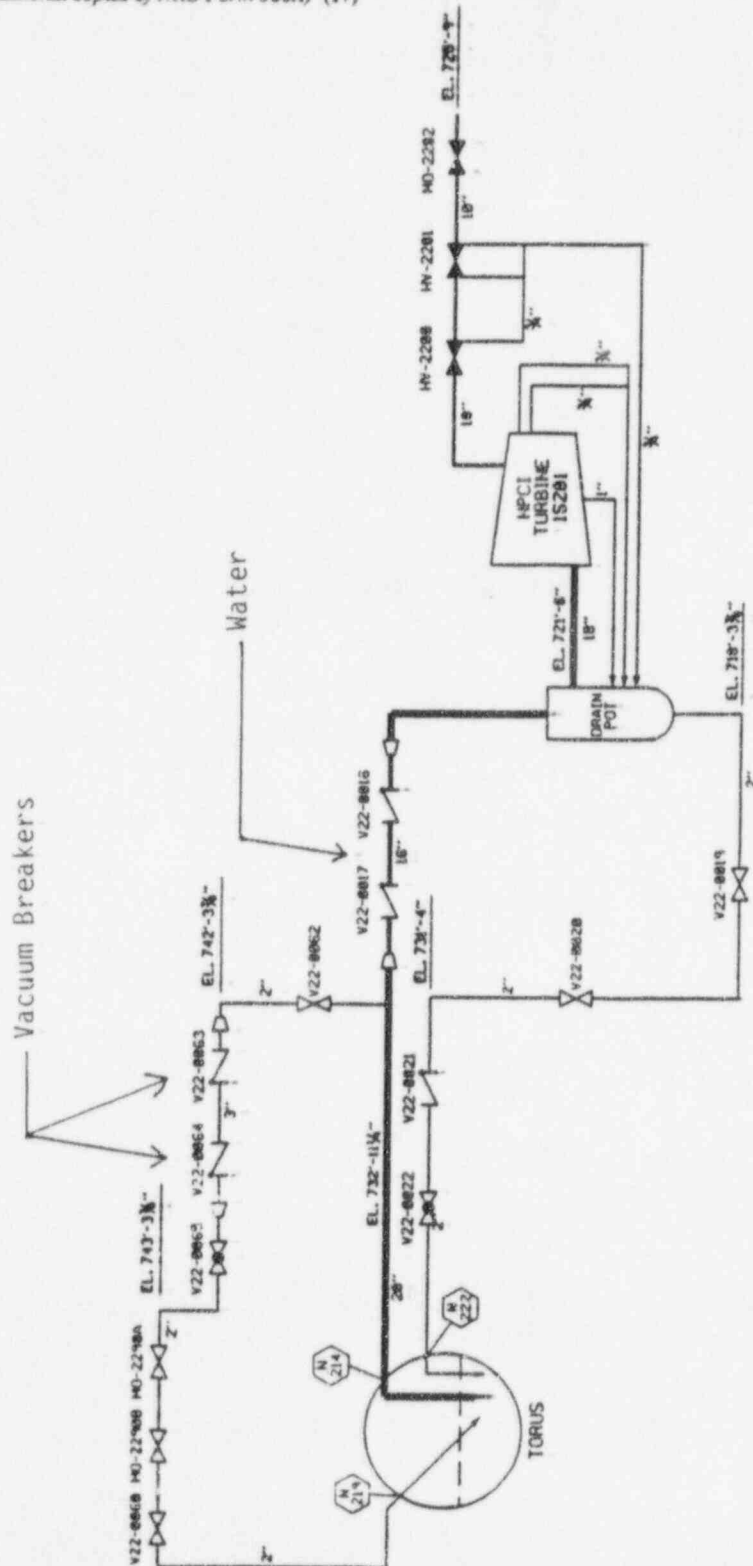
Figure 1  
 HPCI System Exhaust Line

On December 21, 1995, during the CMAR investigation, approximately 170 gallons of water were drained from the exhaust line between isolation valve V22-0017 and check valve V22-0016. See Figure 1. The source of this water was not immediately known and the effect of this water on HPCI operability was also unknown. Therefore, at 1003 hours, the HPCI auxiliary oil pump was placed in "pull-to-lock" to prevent HPCI operation. HPCI was declared inoperable and a 14 day Limiting Condition for Operation (LCO) was entered. HPCI was then test run without incident from 2151 to 2222 hours on December 21, 1995, but not declared operable. Following this run, approximately one cup of water was drained from the exhaust line.

Following HPCI turbine operation, steam condensation cycles cause vacuum conditions within the exhaust line as the steam cools. This vacuum is sufficient to draw water from the torus into the exhaust line. Vacuum breakers V22-0063 and V22-0064 (See Figure 1) open upon sufficient vacuum in the exhaust line to allow water in the vertical exhaust line leg to drain to the torus. However, they may not prevent water from entering the exhaust line initially. If valve V22-0017 does not promptly close following turbine operation, the 58 foot length of 16 inch pipe between valves V22-0017 and V22-0016 provides additional vacuum to draw water into the exhaust line from the torus and water may be drawn into the section of pipe between the two valves. The geometry of valve V22-0017 is such that a dam exists that will not allow water in the bottom half of the horizontal pipe between the two valves to drain out to the torus, even when V22-0017 is open. It is believed that valve V22-0017 was open long enough following HPCI operation on December 15 and 27 and on January 11 to draw water into the exhaust line in this manner. Chemical analysis of the water drained from the exhaust line supported the conclusion that the water came from the torus.

Once water is in this section of the exhaust line, it is trapped except for possible minor leakage through valve V22-0016 to the drain pot. (The possibility of water becoming trapped in the exhaust line following HPCI operation was documented in 1973 General Electric correspondence.) The vacuum breakers were verified to be operable and leakage past check valve V22-0016 was measured and found to be acceptable but increased from the previous refuel outage test. This increased leakage past check valve V22-0016 resulted in the additional and prolonged drain pot alarms that ultimately caused HPCI to be declared inoperable as discussed above. Valve V22-0016 was subsequently inspected and repaired on January 11, 1996.

- Water was found in the exhaust line only between valves V22-0017 and V22-0016, and not in the HPCI turbine.
- The HPCI exhaust line is horizontal with no vertical loop seals.
- The horizontal pipe where the water was found should be no more than half full.
- The pipe diameter increases from 16 inches to 20 inches downstream of V22-0017, decreasing potential water slug velocity in the downstream piping during HPCI operation.
- General Electric Service Information Letter 480 has been implemented at DAEC, providing a softer HPCI startup transient.
- Vacuum breakers V22-0063 and V22-0064 were verified to be operable.
- Non-intrusive monitoring of V22-0017 operation indicated normal disc to seat contact upon flow reduction, indicating that its isolation function is operable and leak rate testing found seat leakage within the acceptable range.

A subsequent test of the HPCI system on January 11, 1996 showed that the exhaust line could potentially be more than half full of water. The potential to be more than half full is supported by a more detailed engineering review of the V22-0017 valve geometry (i.e., the valve seat is physically above the pipe centerline). Also by this date, it was determined that water in the line could potentially form a solid water slug upon HPCI initiation. Preliminary analysis supported by General Electric determined that in spite of these two changes from the December 22 operability determination, the HPCI system would still be able to fulfill its safety function. Work on a final detailed analysis is underway.

- With support from General Electric, a detailed analysis of HPCI operability with water in the turbine exhaust line will be performed. This analysis will be completed by March 19, 1996.
- The HPCI exhaust line will continue to be drained following each HPCI run until the detailed analysis has been reviewed by the Operations Committee. This is implemented via Operations Department Shift Orders.
- Valve V22-0017 will be opened and inspected during the next cold shutdown. CMAR A28281 has been written for this inspection. This will be completed no later than December 31, 1996.
- Valve V22-0016 was repaired under CMAR A28570 on January 11, 1996.
