UPDATED REPORT - PREVIOUS REPORT DATE MARCH 6, 1984  
**LICENSEE EVENT REPORT (LER)**

FACILITY NAME (1) Browns Ferry - Unit 1	DOCKET NUMBER (2) 0 5 0 0 0 2 5 9	PAGE (3) 1 OF 0 3
--	--------------------------------------	----------------------

TITLE (4)  
 Shutdown Cooling System Not Available Due to Valve Failure to Open

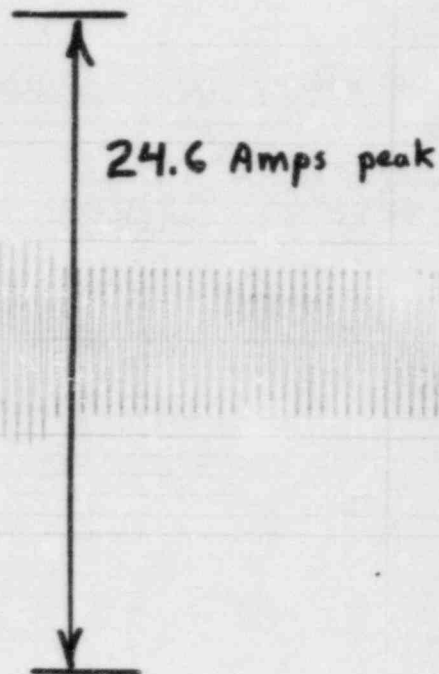
### GRAPH #3

1. After the reactor has been in operation, there is substantially greater torque required to initially "break loose" the valve when opening and going into shutdown cooling mode as compared to subsequent cycling of the valve. (Compare graph 1 to graph 2.)
2. After the "close" torque switch was readjusted to within the range specified by Limitorque, there was a substantial reduction in the torque required to initially "break loose" the valve upon opening and going into shutdown cooling mode. (Compare graph 1 to graph 3.)

Unit 1 FCV 74-48 8/21/84  
First Opening Stroke going into Shutdown Cooling  
Close Torque Switch set @ 1.9

Electrical Maintenance Instruction 18 is being revised to improve recording and review of acceptance criteria and data recording of torque switch settings. A modification is under evaluation to install torque limiter plates on the torque switch to prevent a setting higher than the maximum recommended value. (Limitorque has installed these limiting plates on all torque switches made since 1974.) The failed motor has been returned to the Reliance Electric Motor factory for an additional failure analysis. The results should be available by February 15, 1985.
