Subject: Radwaste Overboard Discharge Piping Maintenance

Subject: Oyster Creek Nuclear Generating Station  
Docket No. 50-219  
Radwaste Overboard Discharge Piping Maintenance

Subject Chemistry Sampling: Overboard  
Discharge Pipe Break

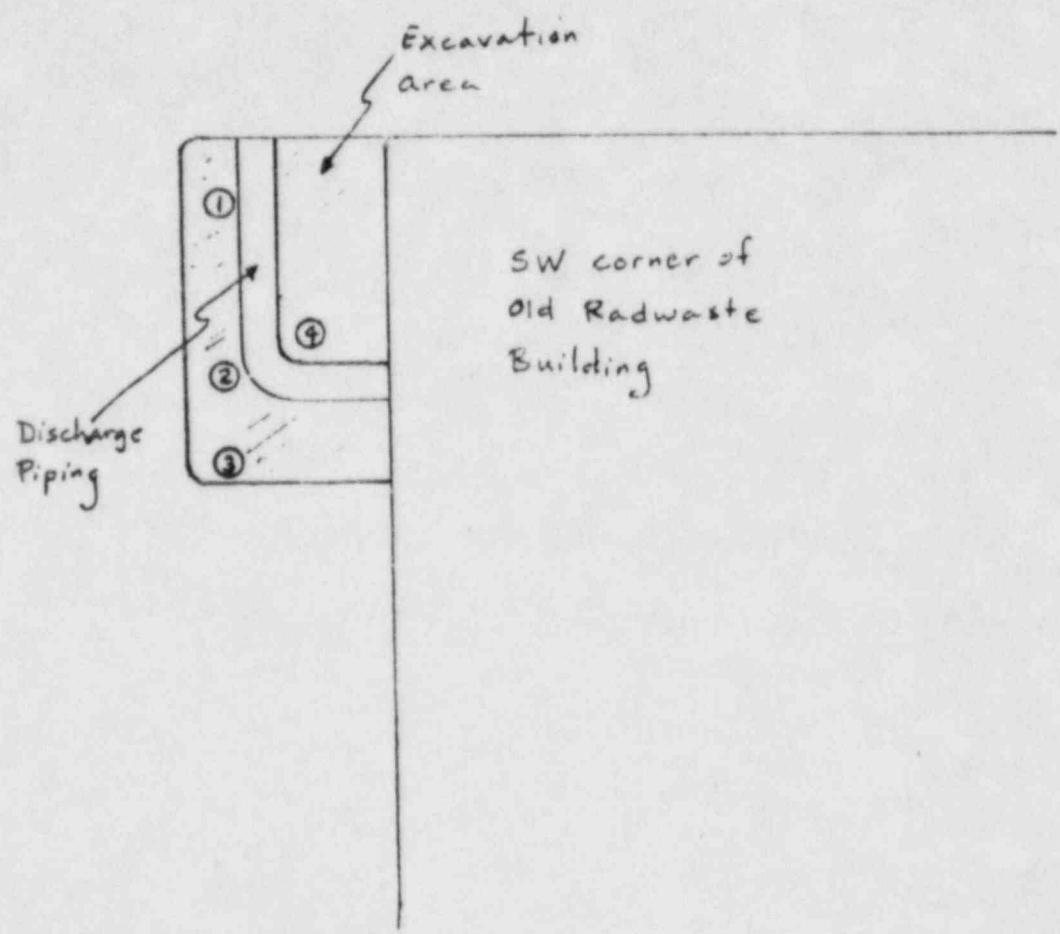
Attachment 1

Chemistry collected seven (7) soil samples during excavation of the area around the discharge piping. Four (4) samples were approximately at the same elevation as the discharge piping. The sample locations are mapped on Attachment 1.

Table 2 contains the results of the radiological analyses. Sample Number 4 shows greater activity levels for both  $Co^{60}$  and  $Cs^{137}$ . The activity levels for these four (4) samples do not exceed 10 CFR 30 limits nor the administrative limit for  $Cs^{137}$  of 10 times 10 CFR 20 limits.

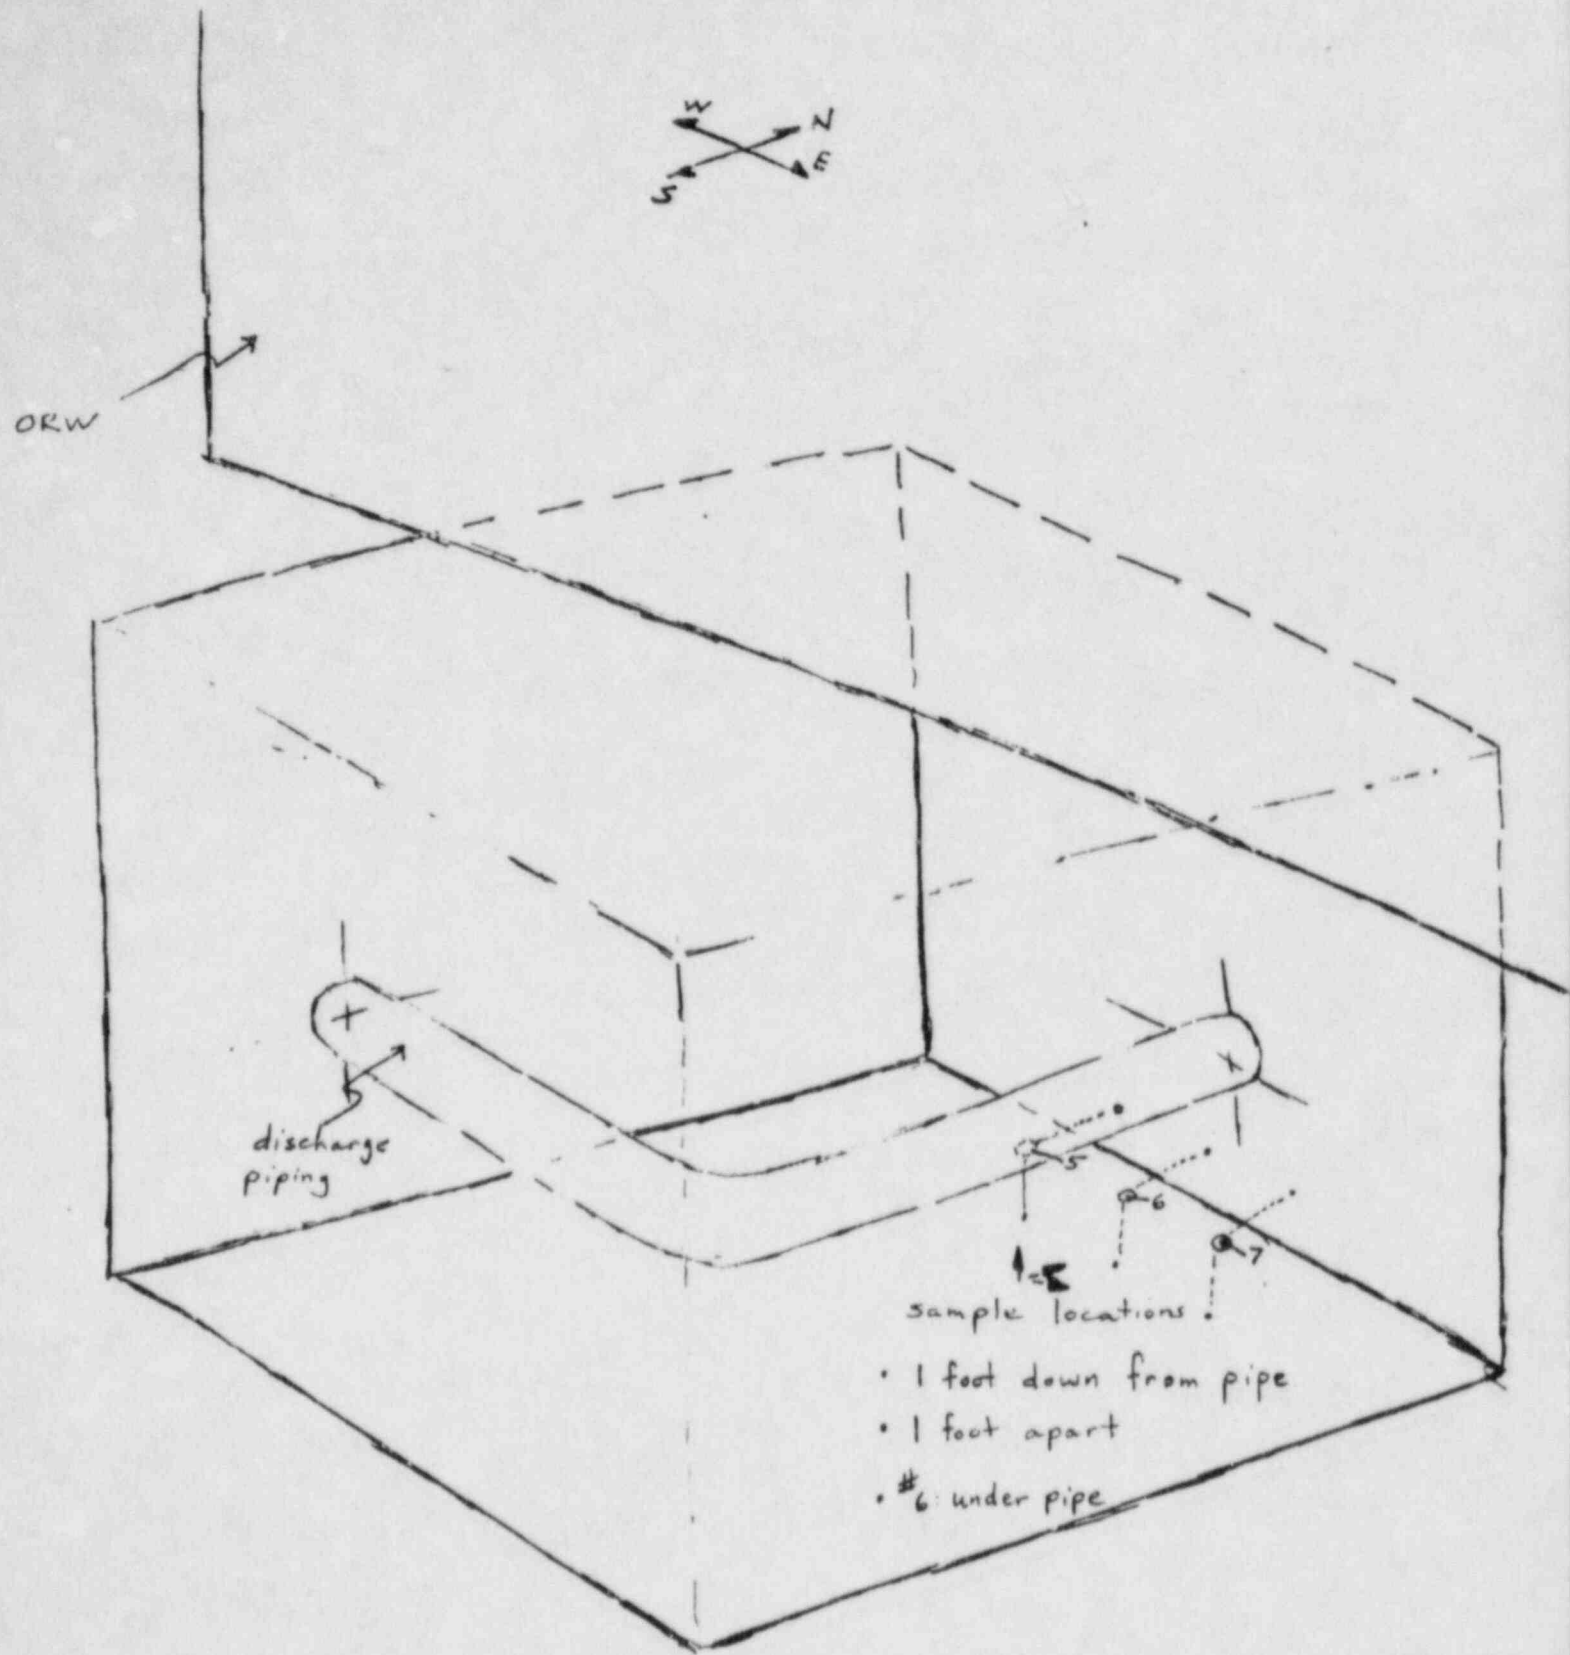
Attachment 2

Chemistry collected three (3) additional samples approximately one (1) foot below the discharge piping. These samples (5-7) are mapped on Attachment 2.

Table 3 contains the results of the radiological analyses. The activity levels for these three (3) samples do not exceed 10 CFR 30 limits nor the administrative limit for Cs<sup>137</sup> of 10 times 10 CFR 20 limits.
