Iowa Electric Light and Power Company

Subject: Duane Arnold Energy Center  
Docket No: 50-331  
Op. License DPR-49  
Licensee Event Report #92-006

LICENSEE EVENT REPORT (LER)

FACILITY NAME (1): Duane Arnold Energy Center  
 DOCKET NUMBER (2): 050003311  
 PAGE 3 OF 08  
 TITLE (4): Emergency Safety Feature Actuation During Modification Acceptance Testing Due To Damaged Switchyard Cable

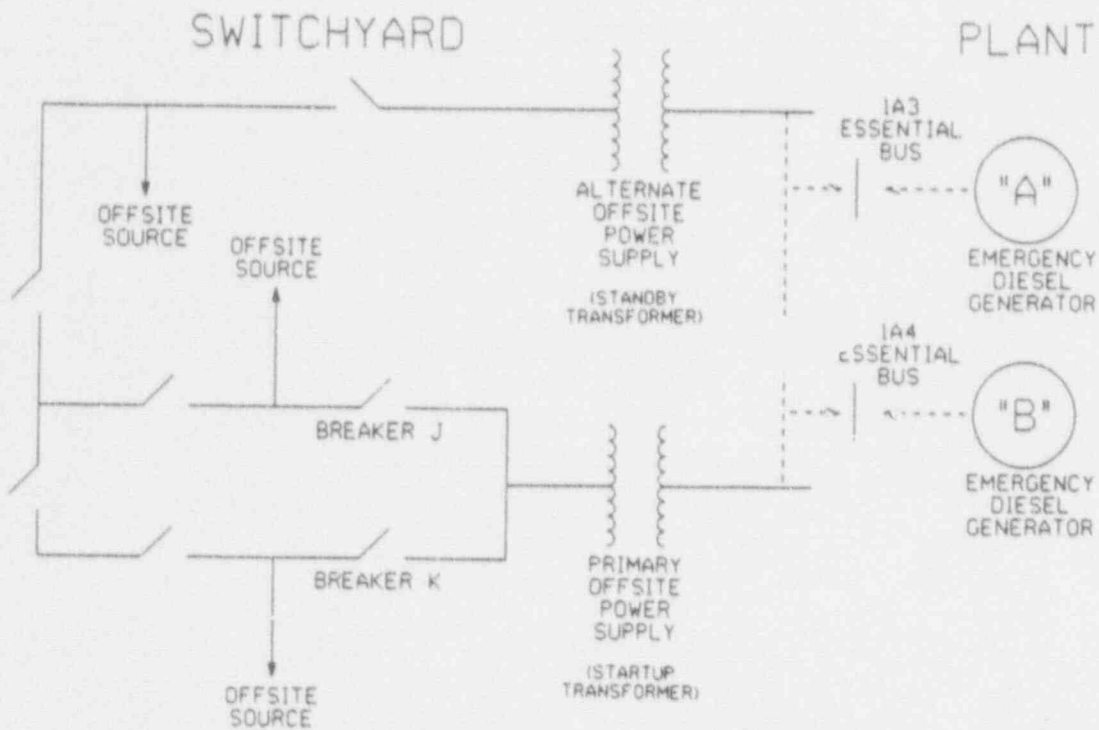
FIGURE 1:

On April 16, 1992, with the plant in cold shutdown, a test of a newly installed 161 KV breaker resulted in several Emergency Safety Feature actuations, including automatic starting of an Emergency Diesel Generator. At the time of the event, the Duane Arnold Energy Center (DAEC) was in the final stages of a refueling outage, with all fuel in the vessel and the "A" side of the Residual Heat Removal System in service to provide shutdown cooling for the vessel inventory. A Modification Acceptance Test was in progress for a new 161 KV circuit breaker, Breaker K, which had been installed in the site switchyard during the outage. The breaker had been installed to eliminate the possibility of a single breaker failure after a line fault resulting in a loss of offsite power to the plant. Breaker K operates in parallel with a previously existing breaker, Breaker J. Each breaker can connect an offsite line to the transformer normally used to supply offsite power to the plant. (See Figure 1).

During the Modification Acceptance Test, both the J and K breakers were to be opened (de-energized) to simulate a failure of the primary source of offsite power to the plant's 4160 V essential buses (a transformer connected to the switchyard). Per design, the essential (Class 1E emergency) buses, 1A3 and 1A4, were each expected to "fast-transfer" within a few cycles to the alternate offsite power supply source (another transformer). A second design feature, an automatic "slow-transfer" which occurs over approximately 4.5 seconds, is also available. (See II. Cause, and III. Analysis, for more discussion of "slow" and "fast" transfers).
