# WOLF CREEK

Subject: Docket No. 50-482: Licensee Event Report 92-009-00

FACILITY NAME (1) **Wolf Creek Generating Station**      DOCKET NUMBER (2) **05000482**      PAGE (3) **1 of 05**

TITLE (4) **Technical Specification Violation - Failure Of Humidity Sensors Results In Inoperability Of Both Trains Of The Control Room Emergency Ventilation System**

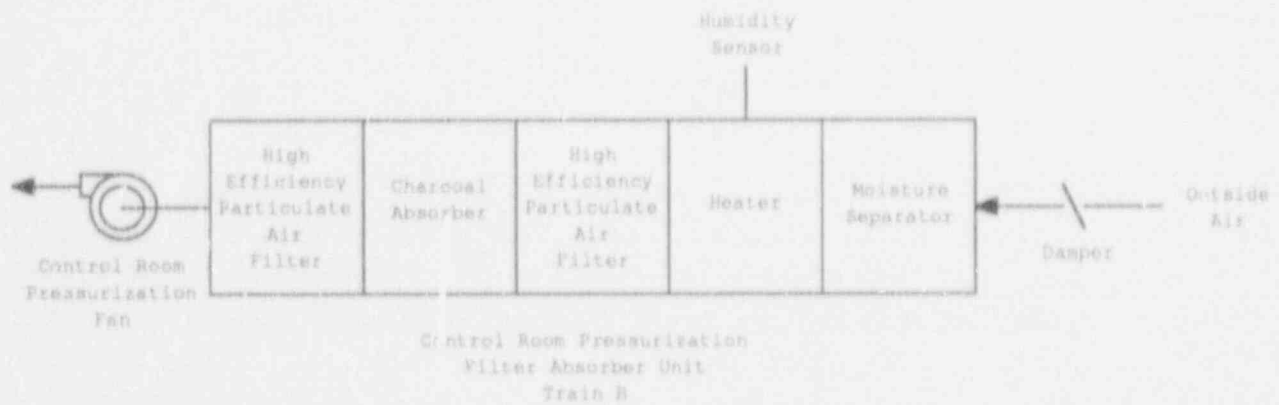
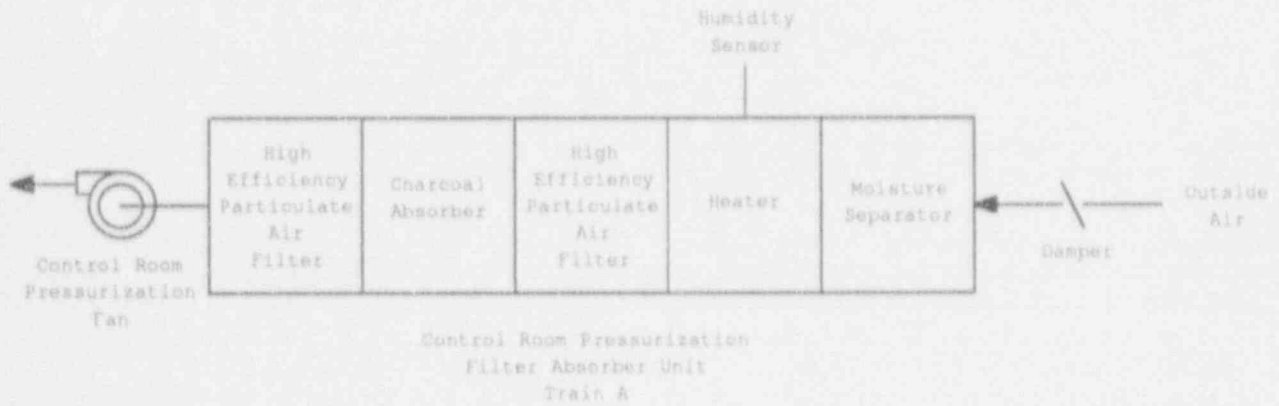
Figure 1

The Control Room pressurization filter absorber units [Figure 1] consist of, in part, moisture absorbers [VI-MSR], heaters [VI-EHTR], high-efficiency particulate air filters [VI-FLT] and charcoal absorber units [VI-ABS]. The heaters are designed to heat the influent air stream to reduce its relative humidity before it reaches the filters and absorber units. This ensures that the filters and absorbers are not damaged or plugged and that they retain their efficiency. The design function of the charcoal absorber units is to remove gaseous iodine from the air stream prior to entering the Control Building. A relative humidity sensor is provided prior to the filters in each train to sense relative humidity and to control the electric duct heaters upstream of the sensor.

This event resulted from a failure of the relative humidity sensors in the Control Room pressurization filter absorber units. The root cause of this failure was attributed to normal wear of the sensor. To preclude future inoperability of both relative humidity sensors, the sensors will be replaced every 36 months. Procedure INC L-1000 is conducted every eighteen months and had been successfully conducted on October 19, 1990 for both sensors. An engineering evaluation request has been initiated to determine if it is feasible to bypass the relative humidity sensors to allow continuous operation of the heaters. If it is determined feasible to bypass the relative humidity sensors, the replacement of the sensors every 36 months will be discontinued.
