# Florida Power

CORPORATION  
Crystal River Unit 3  
Docket No. 50-302

Subject: NRC Inspection Report No. 50-302/95-14  
NRC to FPC letter, 3N0995-02, dated September 1, 1995

FLORIDA POWER CORPORATION  
NRC INSPECTION REPORT NO. 50-302/95-14  
REPLY TO A NOTICE OF VIOLATION

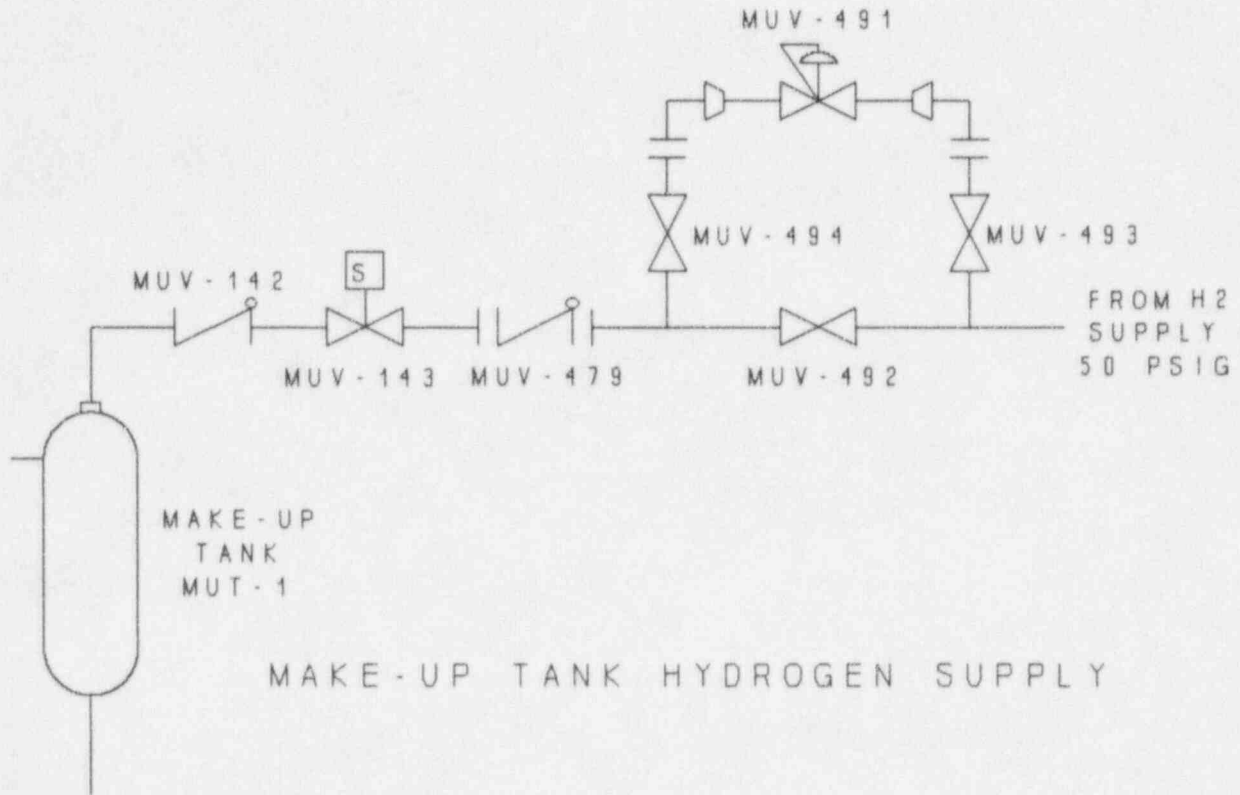
FIGURE 1

2. There are two methods to add H<sub>2</sub> to the MUT, opening MUV-493 to allow H<sub>2</sub> through the regulator (MUV-491) or bypassing the regulator by opening the manual bypass valve (MUV-492). MUV-492 and MUV-493 have been proceduralized to ensure only one will be opened by a "dedicated operator" during hydrogen addition. The valve to be opened will depend on the method used.

- a) Continue to leave the regulator (MUV-491) normally isolated and use the manual isolation valves to add hydrogen to the MUT as described above. It was also agreed that manually charging the MUT with hydrogen would not be considered an Operator Work Around and that long term, this method was preferred because it is fast and puts more focus on the evolution.
- b) Generate a design change to lower the setpoint on MUV-491 to a value that would bring it into compliance with design assumptions, adding a level of defense when using the regulator to add H<sub>2</sub> to the MUT.
