OAK RIDGE NATIONAL LABORATORY

On February 4, 1992, I traveled to the McGuire Nuclear Station Unit 1, near Charlotte, North Carolina. This plant, operated by Duke Power, is a 1180-MW electrical plant and has four Westinghouse Model D-2 Steam Generators. This plant went into operation about 1980, and soon experienced problems with fretting in the preheater section as did other model D2, D3, and to a lesser extent, D4 steam generators.

**Tube leak in 1992** On December 12, 1991, after a refueling outage, McGuire 1 was restarted. On January 16, the plant was brought down due to a tube leak of 235 gallons per day. This leak was determined to be in the free span of tube R47C46 in steam generator D, between the 20th and 19th tube supports in the cold leg. The defect had been detected at the 1991 outage, erroneously

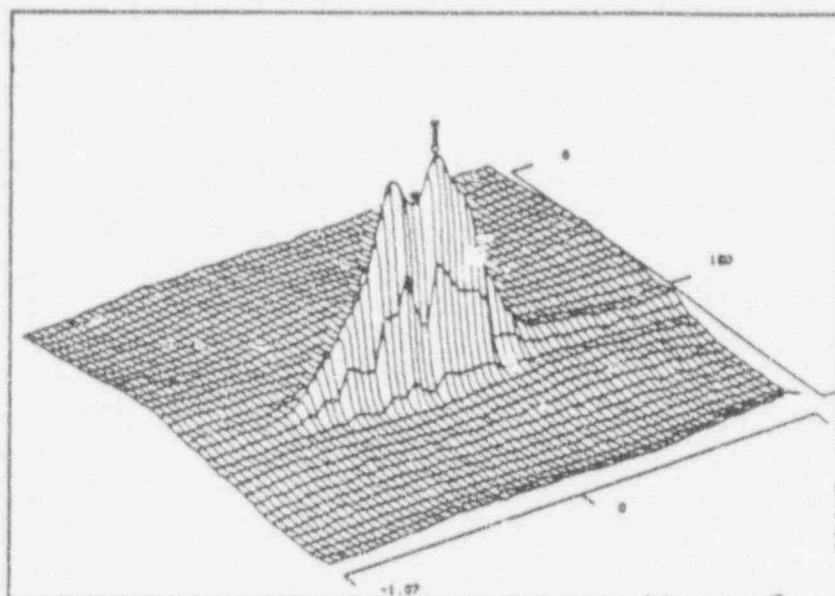
classified as a manufacturer's burnishing mark (MBM), and ignored. The tube had also been inspected using the MRPC, but the results had not been reviewed by the proper personnel before the unit was returned to power. The defect in tube R47C46 in generator D was very similar to the tube R18C25 in generator B, with the exception that the plant was

Figure 1 MRPC scan of the leaking tube, R47C46.

shut down before a tube rupture due to the new, more stringent leak rate rules. A plot of the MRPC scan of tube R47C46 made after the leak is shown in Figure 1.

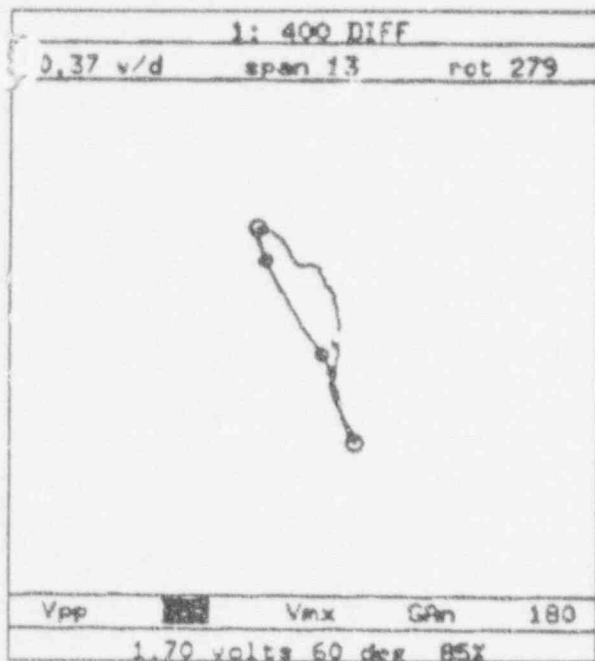
**Growth rate of the defect** McGuire 1 has used 100% bobbin coil inspection of the full length of the tube since the 1989 tube rupture. The 1990 inspection, the last one before the 1991 inspection that detected the defect, showed no trace of the defect at the location of the leak. There was a possible precursor indication of the 35 KHz absolute channel that could have been caused by a ferromagnetic deposit on the tube or a ferromagnetic region of the tube, but the signal could also be due to random noise. Several indications were also found in the leaker tube near the 15th tube support. There was no sign of these indications either on the 1990 scan of the tube, indicating that they were of the same fast growing phenomenon. On the basis of the lack of a signal in 1990, the phenomenon could grow in as fast as several week's time to full wall penetration. The eddy-current depth measurement made using the 400kHz differential signal from the bobbin probe during the 1991 outage was 85%, with a voltage amplitude of 1.7 volts, as shown in Figure 2. The depth measurement after the leaker was 98%, with a voltage of 7.0 volts, as shown in Figure 3. This would indicate that the defect grew at a rate of about 13% per month, although the growth rate would probably be non-linear in this range. There are also considerable uncertainties in the eddy-current measurements, but this is the best data available.

Figure 2 Tube R47C46 before the leak

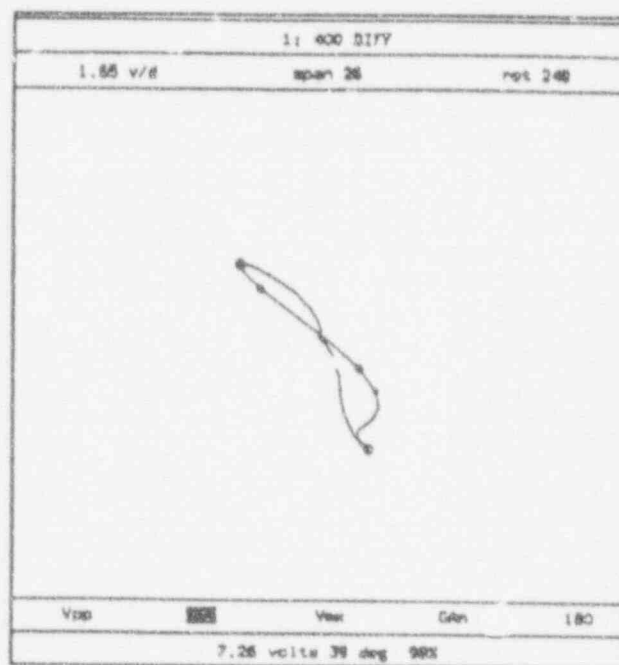
Figure 3. Tube R47C46 after the leak

**Possible growth scenario** One possible scenario is that a small groove that was too small to be easily seen by eddy currents was inscribed into the tube during manufacturing. An axial groove is visible on the scan of tube R47C46 between the 19th and 20th tube support plate that has the same circumferential location as the crack. However, I was told that this type of indication appears on many of the tubes. This groove accumulated deposits during operation and the chemical concentration of the deposits initiated the IGSCC. The time for the material to concentrate in the groove and to initiate the corrosion is on the order of several years, but the time required for the corrosion to propagate through the tube wall once it has started may be on the order of several months. However, at the time, this scenario is only speculation. The tube that ruptured in 1989 appeared to have a long scratch mark, and the tube that leaked in 1992 also had a long mark. The

initial leaking crack extended about 3 1/2 in. according to the ultrasonic scan, and several additional crack-like indications were found between the 15th and 14th tube support. Due to the location of both the 1989 tube rupture and the 1992 leak in the cold leg, the phenomenon is apparently not temperature related. It is also not generator related nor related to the heat of material.
