**LICENSEE EVENT REPORT (LER)**

WOLF CREEK GENERATING STATION

Loss of Emergency Bus NB02 Due to Degraded Gasket on Motor Operator Cabinet

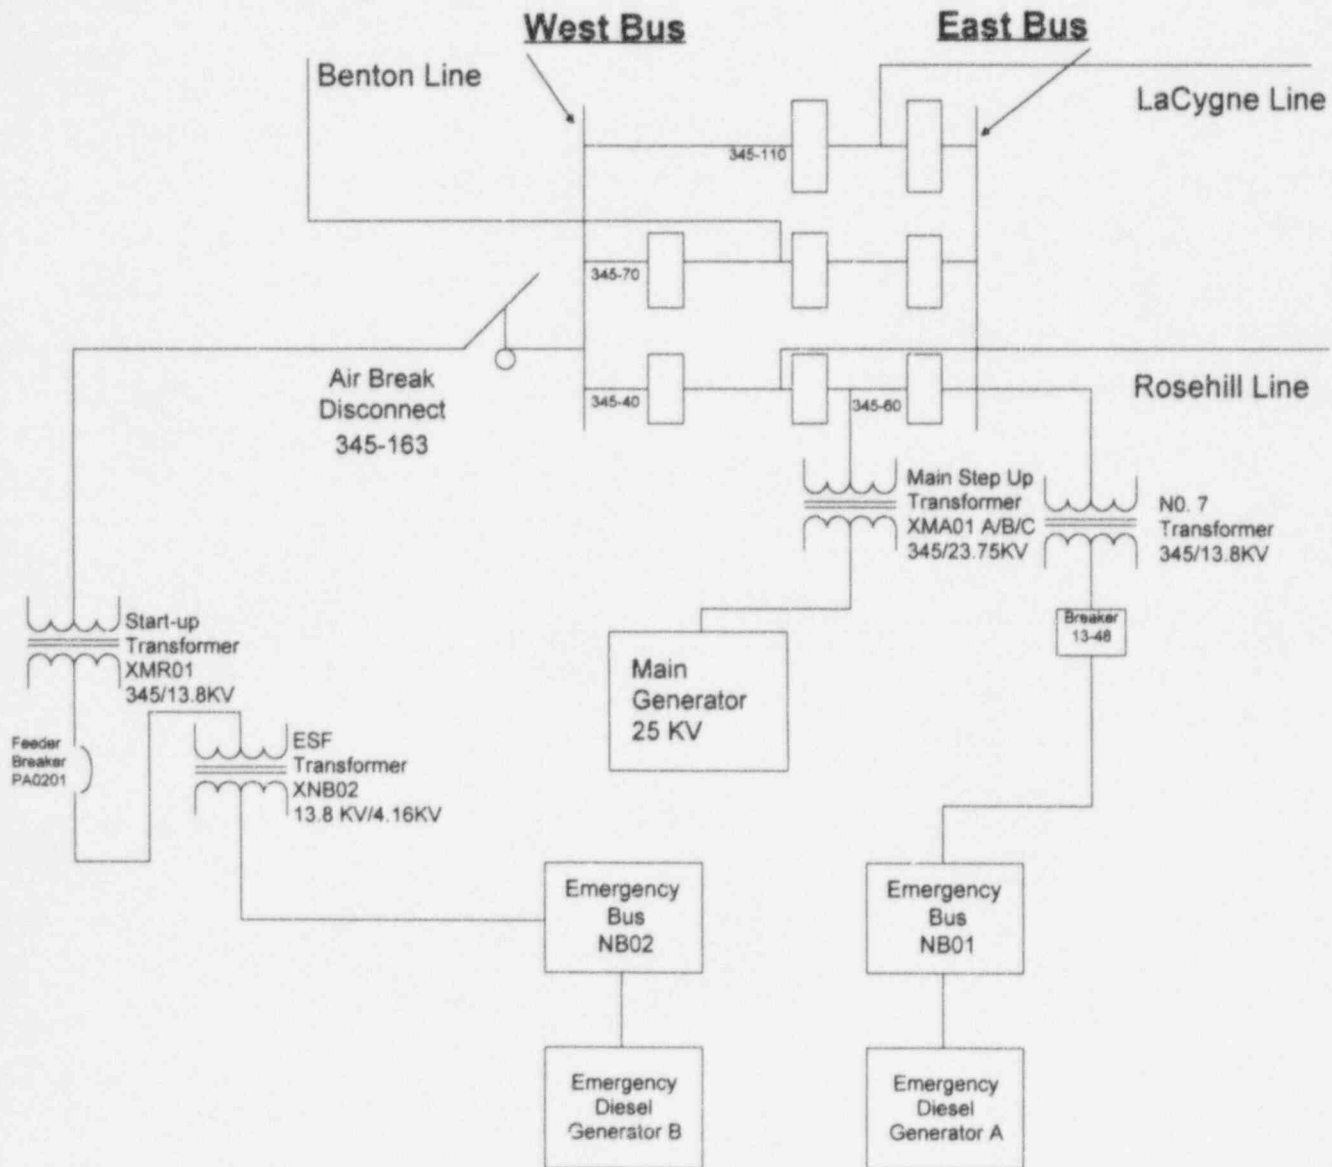
**Figure 1**

At 1942 CST, on November 10, 1995, a degraded gasket allowed moisture (snow, ice, sleet) to intrude into the motor operator cabinet [CAB] for air break disconnect [DISC] 345-163. The cabinet is located in the WCGS switchyard. The moisture caused open contacts to short which energized the motor and opened air break disconnect 345-163. The disconnect opened with the line energized. Air break disconnect 345-163 is an electrically operated switch designed to be operated, either locally or remotely, under no load conditions. When air break disconnect 345-163 opened, power from the switchyard was lost to the Start-up Transformer and ESF Transformer (XNB02), which supplies the Emergency Bus (NB02). Three breakers (345-70, 345-40, and 345-110) [BKR] opened in the switchyard on the differential relay trip completely de-energizing the West Bus (Reference Figure 1).
