U.S. NUCLEAR REGULATORY COMMISSION

Report No. 50-286/84-14

Facility Name: Indian Point Nuclear Generating Station, Unit 3

Inspection on June 16, 1984 to July 31, 1984 (Inspection Report 50-286/84-14)

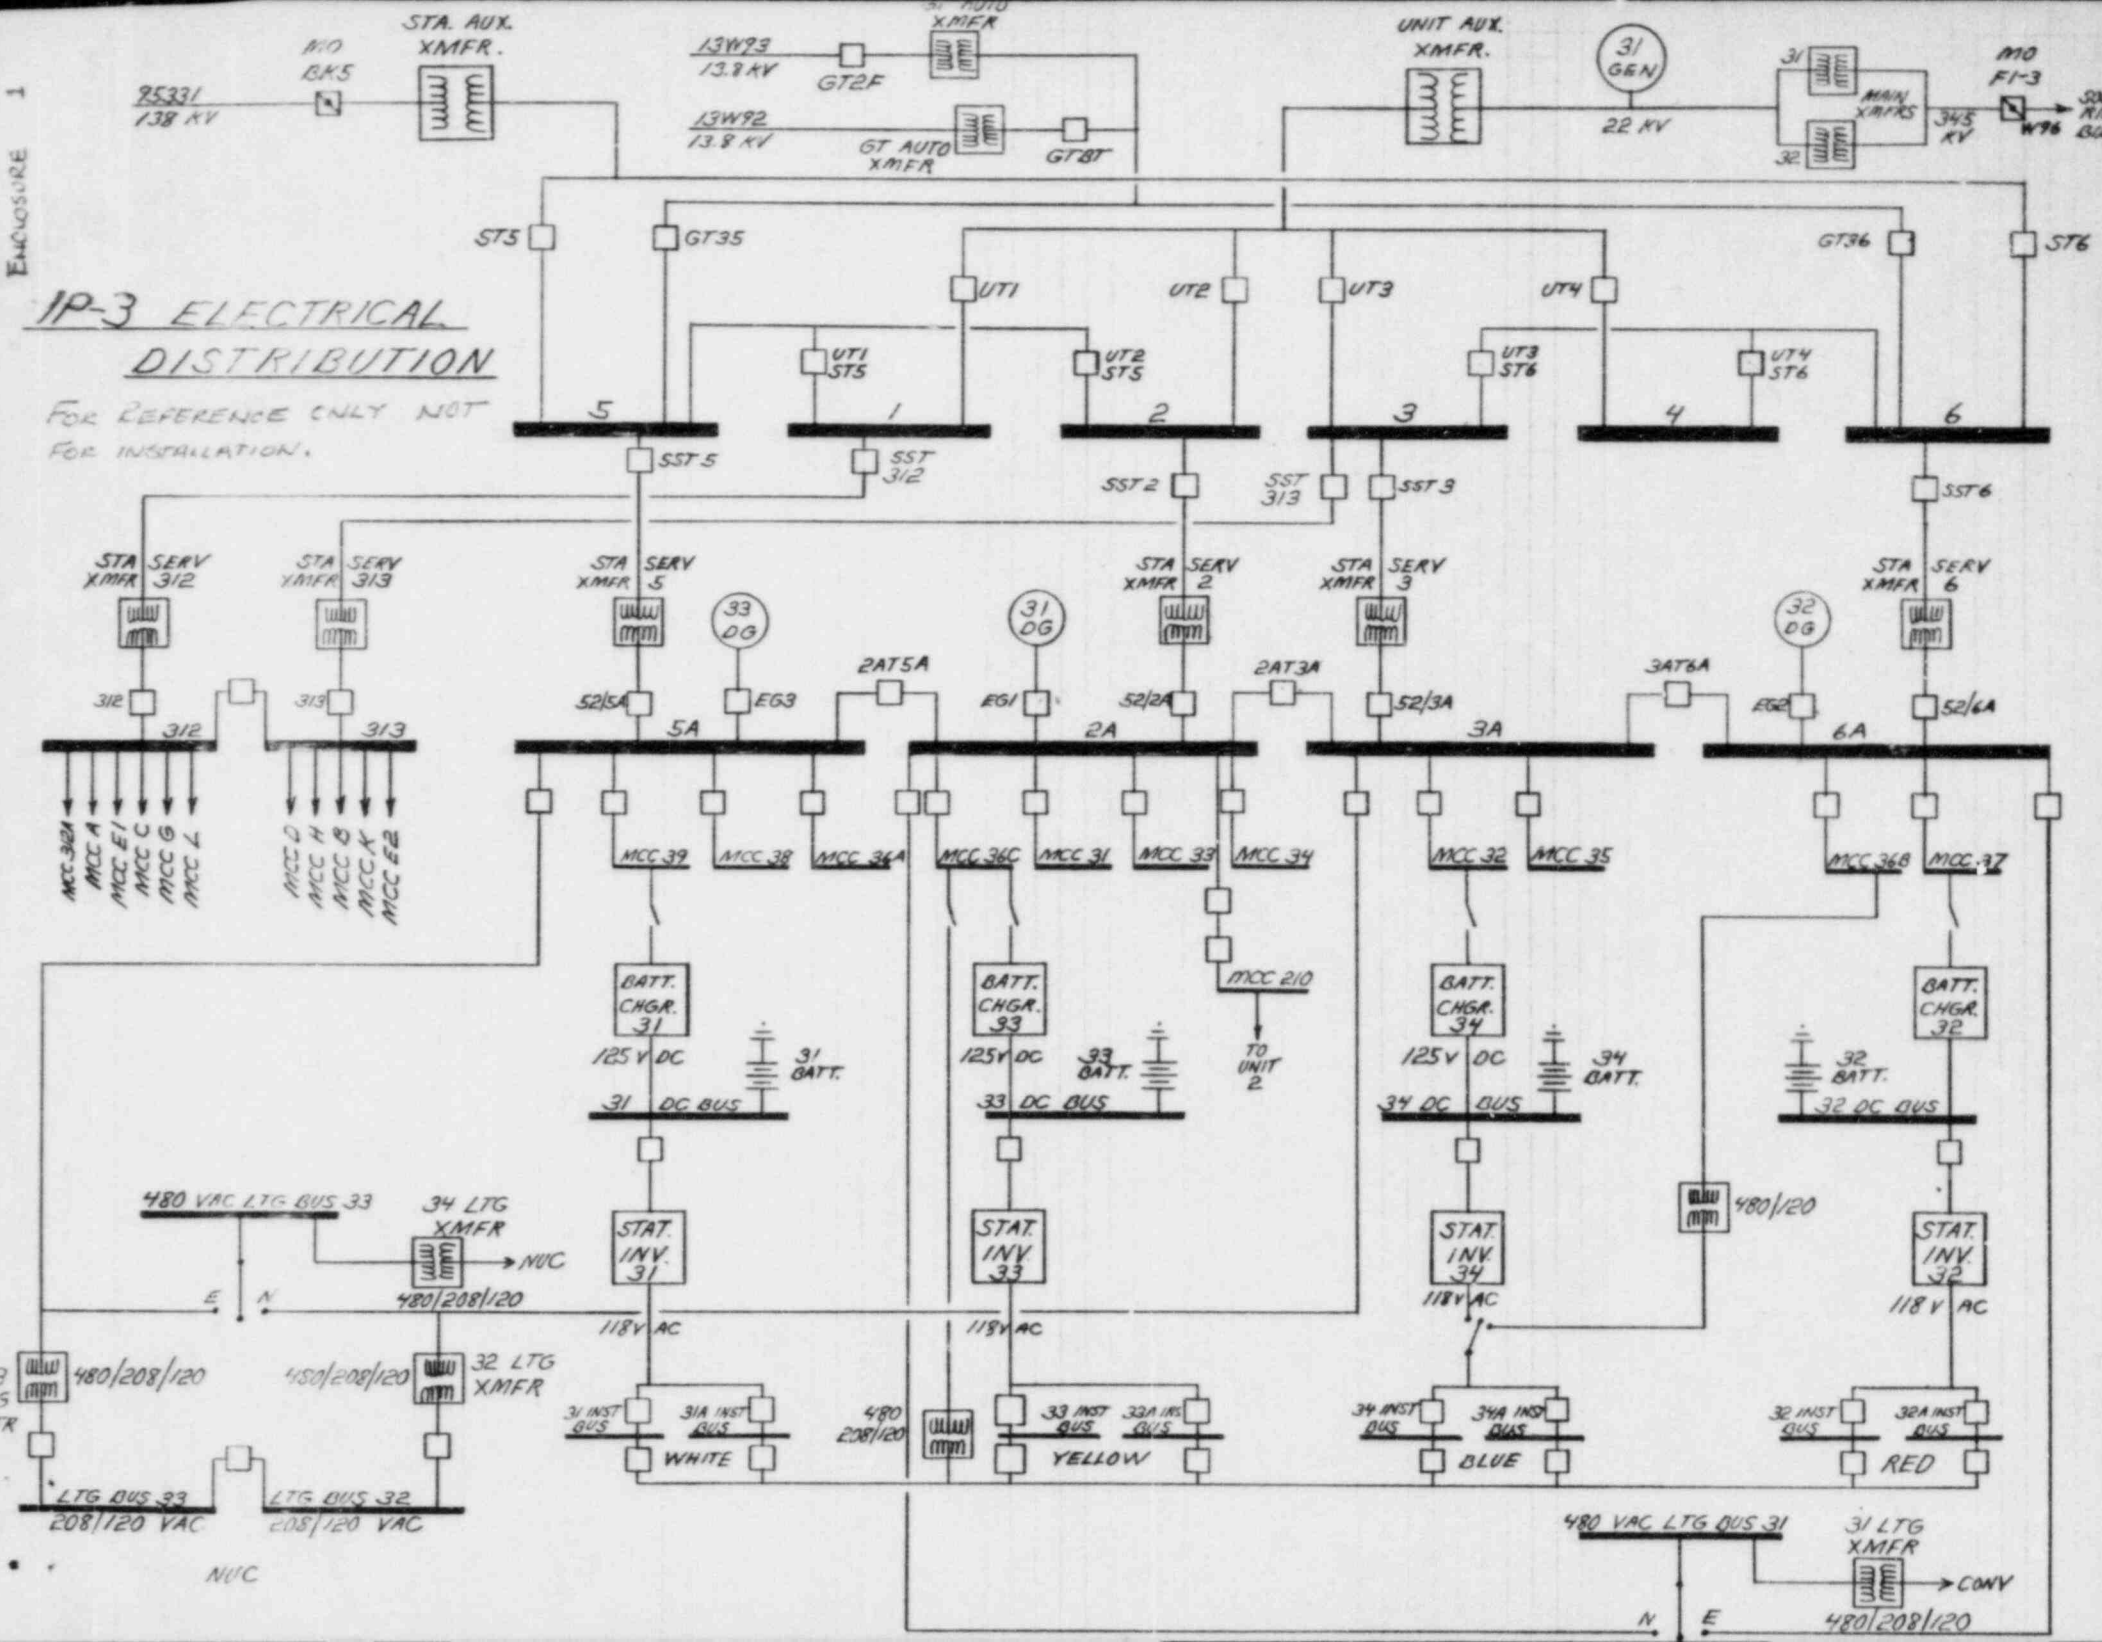
1P-3 ELECTRICAL DISTRIBUTION

On July 11, the licensee informed the NRC that a possible unreviewed safety question existed which was identified during the Systems Interaction Study. A scenario was identified that could lose two safety related 480 volt electrical busses. The licensee had been informed during the previous week, by the NRC Project Manager in conjunction with the NRC vendor, conducting the System Interaction Study, that a postulated event could lose one RHR pump. Through the subsequent week, the licensee and vendor were in communications with relation to the concern. Then on July 11 at 11:20 p.m., the licensee informed the NRC that the possible unreviewed safety question existed.

With the loss of #32 battery concurrent with a safety injection #6A bus would strip all loads not required for Safety Injection (SI). This includes the #32 Battery Charger. Results: #32 DC bus becomes de-energized, and breaker closing power is lost to all breakers on #6A bus including 3A-6A tie breaker 3AT6A. Closing power is also lost to selected breakers on the 6.9KV busses, UT3ST6 and UT4ST6, which are part of the transfer of busses that occurs after a reactor trip (caused by SI). Results: The transfer of busses leaves bus 3 and 6 deenergized and station transformers 3 and 6 cannot supply power to 480V busses 3A and 6A. The diesels start and #32 diesel breaker closes onto the dead 6A bus, but Nos. 31 and 33 diesels will not close in because their respective busses remain energized.

The licensee performed a safety evaluation to determine that the installation of a jumper in Emergency Diesel Generator #31 output breaker did not violate the design requirements of the engineered safeguards system. This jumper would allow tie breaker 2AT3A to close automatically on the transfer of busses and energize 3A bus. Thus, if the scenario above was to occur, then only bus 6A would be lost, which is within the design of the unit.

The licensee had been in communication with the design vendor (Westinghouse) after identifying the potential for loss of two busses. The vendor concurred that the scenario had not been analyzed. The vendor also concurred that the installation of the jumper did not degrade the safeguards system, and that it could be used as a possible fix. The licensee is still investigating the incorporation of a more permanent fix.
