U.S. NUCLEAR REGULATORY COMMISSION
REGION IV

Inspection Report: 50-445/95-25
50-446/95-25

Facility Name: Comanche Peak Steam Electric Station, Units 1 and 2

Inspection Summary

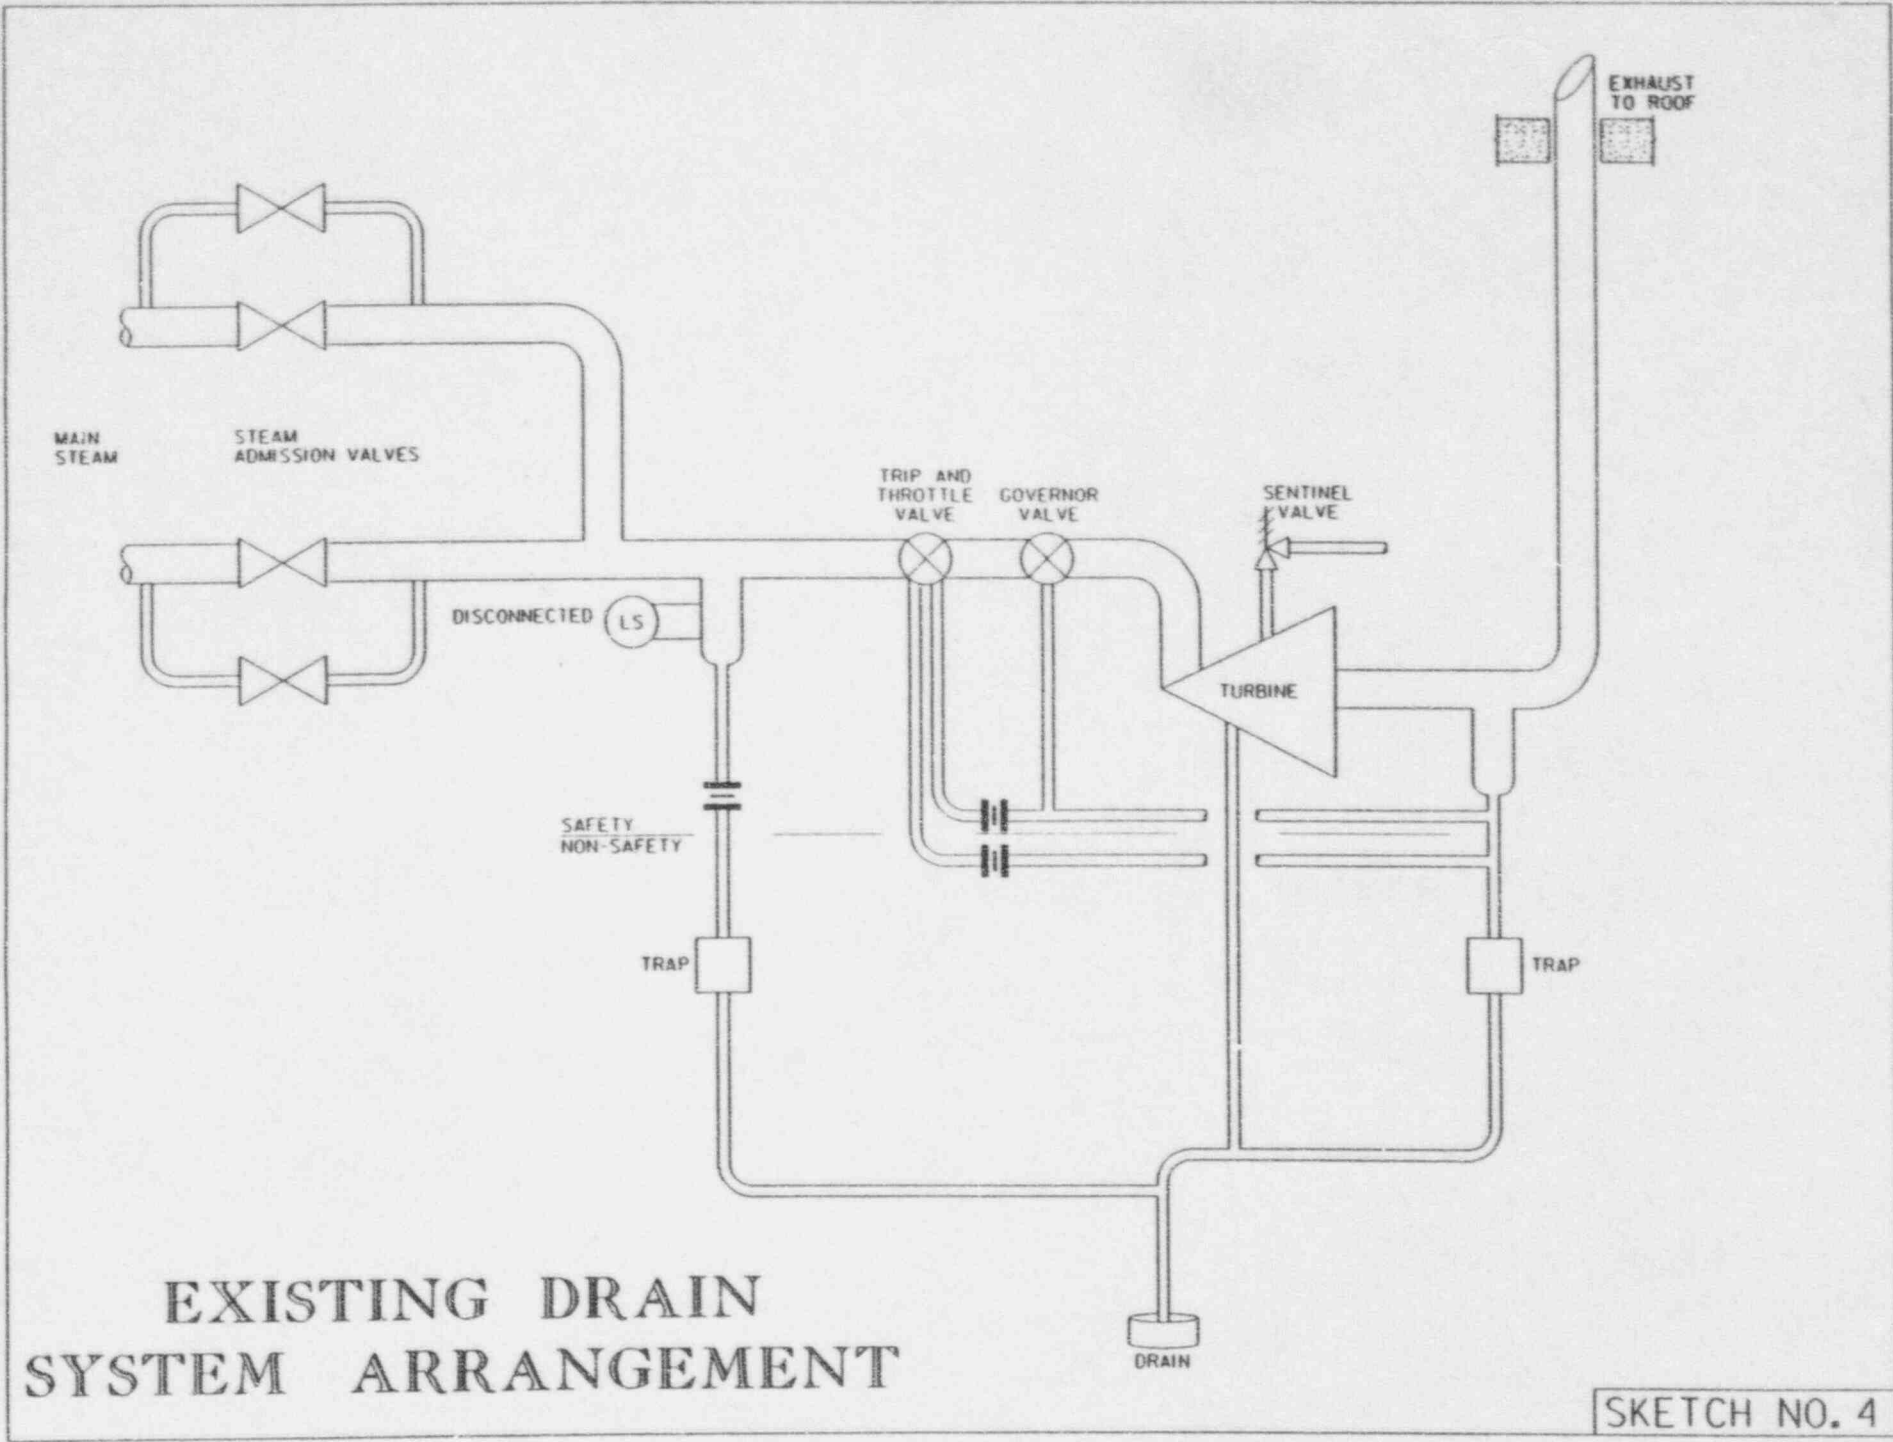
SKETCH NO. 4

EXISTING DRAIN SYSTEM ARRANGEMENT

- Degraded steam trap performance reduced the drain system capability.
- Alarms for water level in the drain system are not part of the current design
- Slight binding was detected in the governor valve cam linkage
- Inboard packing bushing damage may have increased stem drag

- Reworked steam traps
- Adjusted cam plate linkage to eliminate binding
- Performed test in which turbine was run under normal conditions, stopped for 13 minutes and restarted
- Initiated compensatory action to bypass steam traps at a frequency sufficient to insure no back up of condensate in the drain system

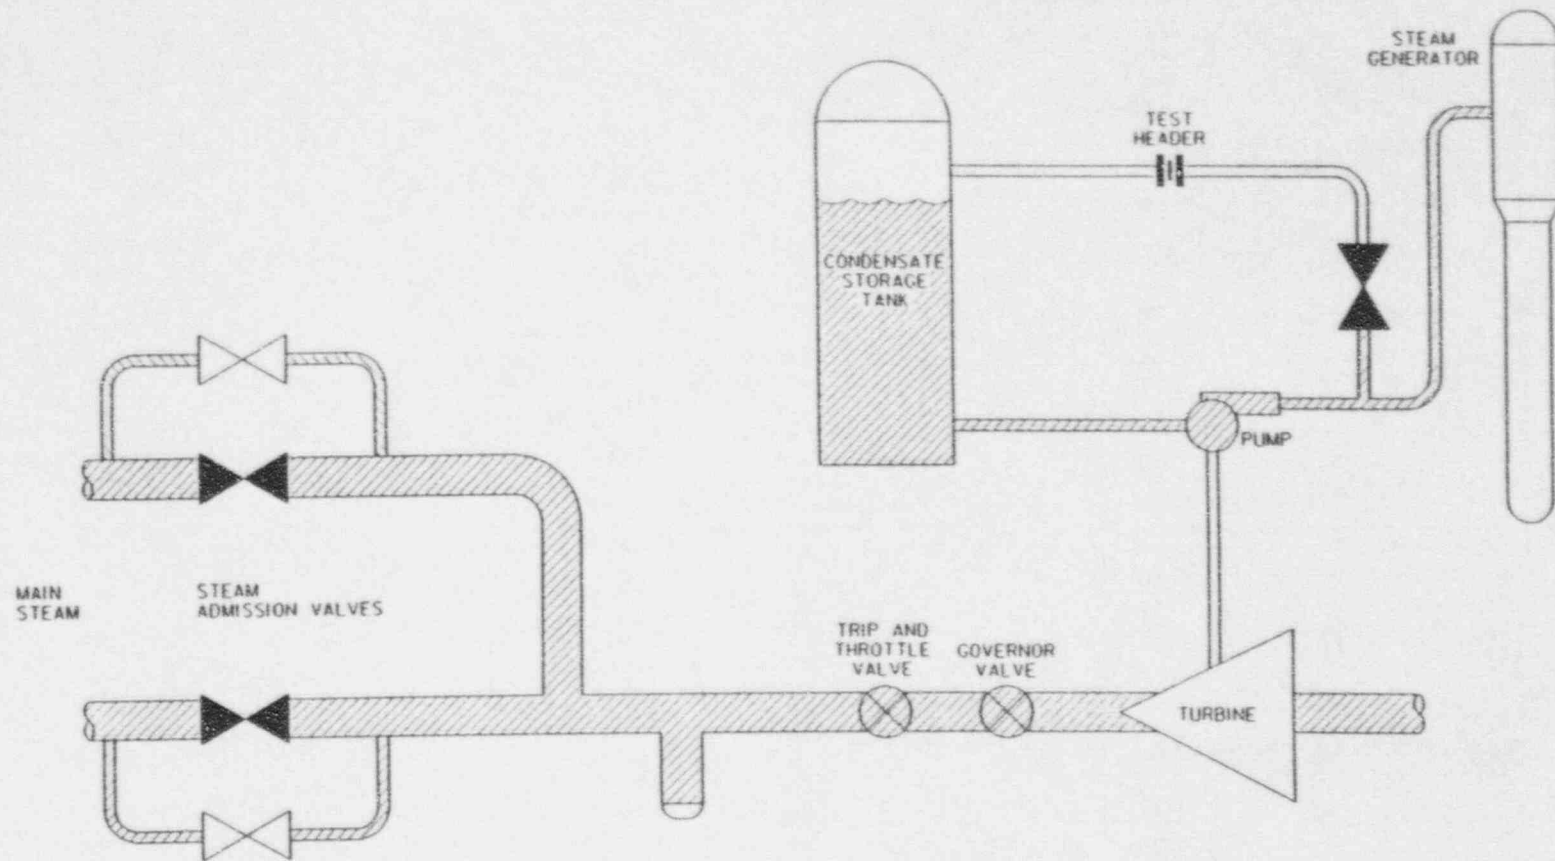
SKETCH NO. 5

- The non-standard warm up run is believed to have caused excess water to accumulate in the system, based on eyewitness accounts. The governor valve was not able to control turbine speed.

- Pump discharge was lined up to Steam Generators (normal warm up run is lined up on test line to condensate storage tank)
- Turbine speed controller set to maximum speed (normal warm up run is set to minimum speed)
- Both Steam Admission bypass valves were opened to admit steam to turbine (normal warm up run is performed with one bypass valve open)

WARM-UP RUN (4 MIN ELAPSED TIME)
SYSTEM ARRANGEMENT

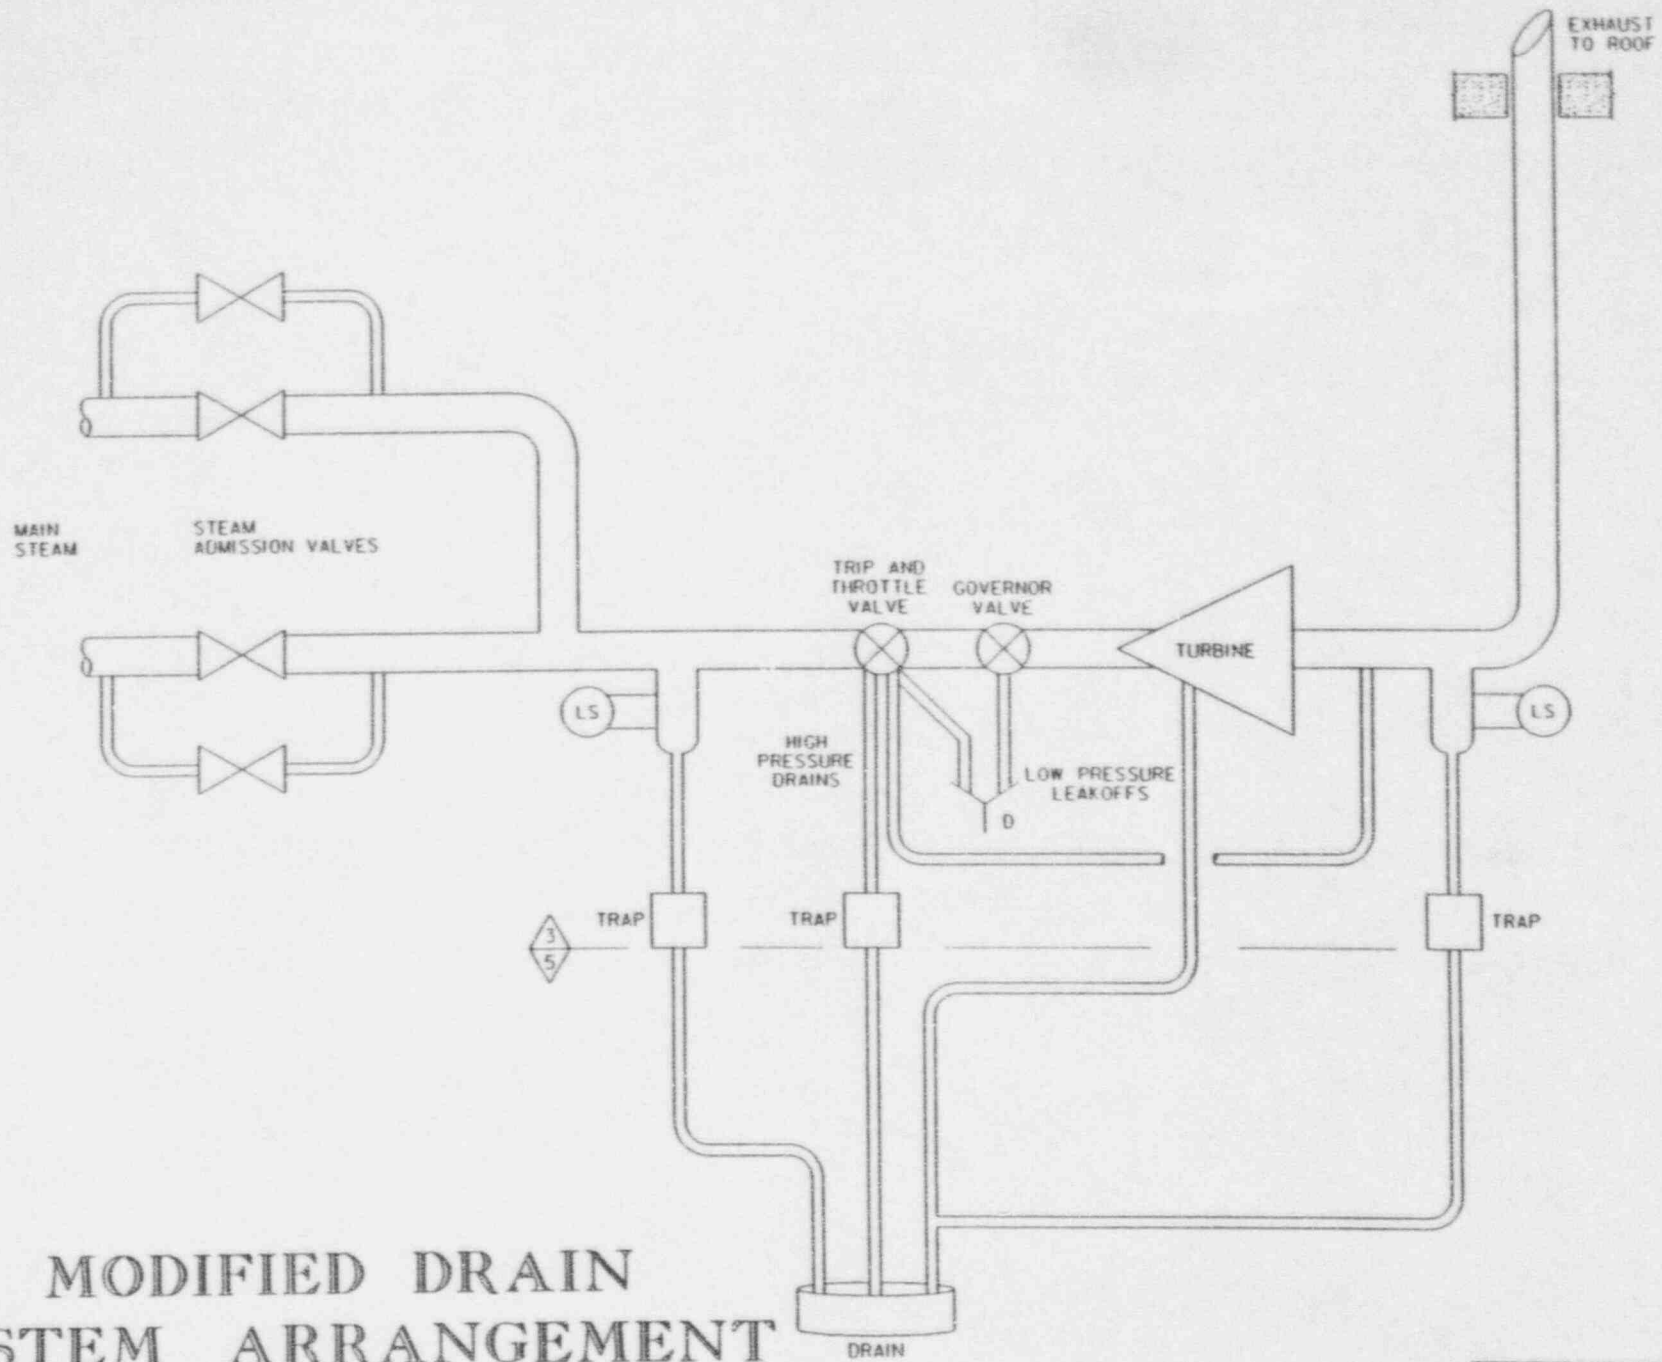
SKETCH NO. 6

MODIFIED DRAIN
SYSTEM ARRANGEMENT

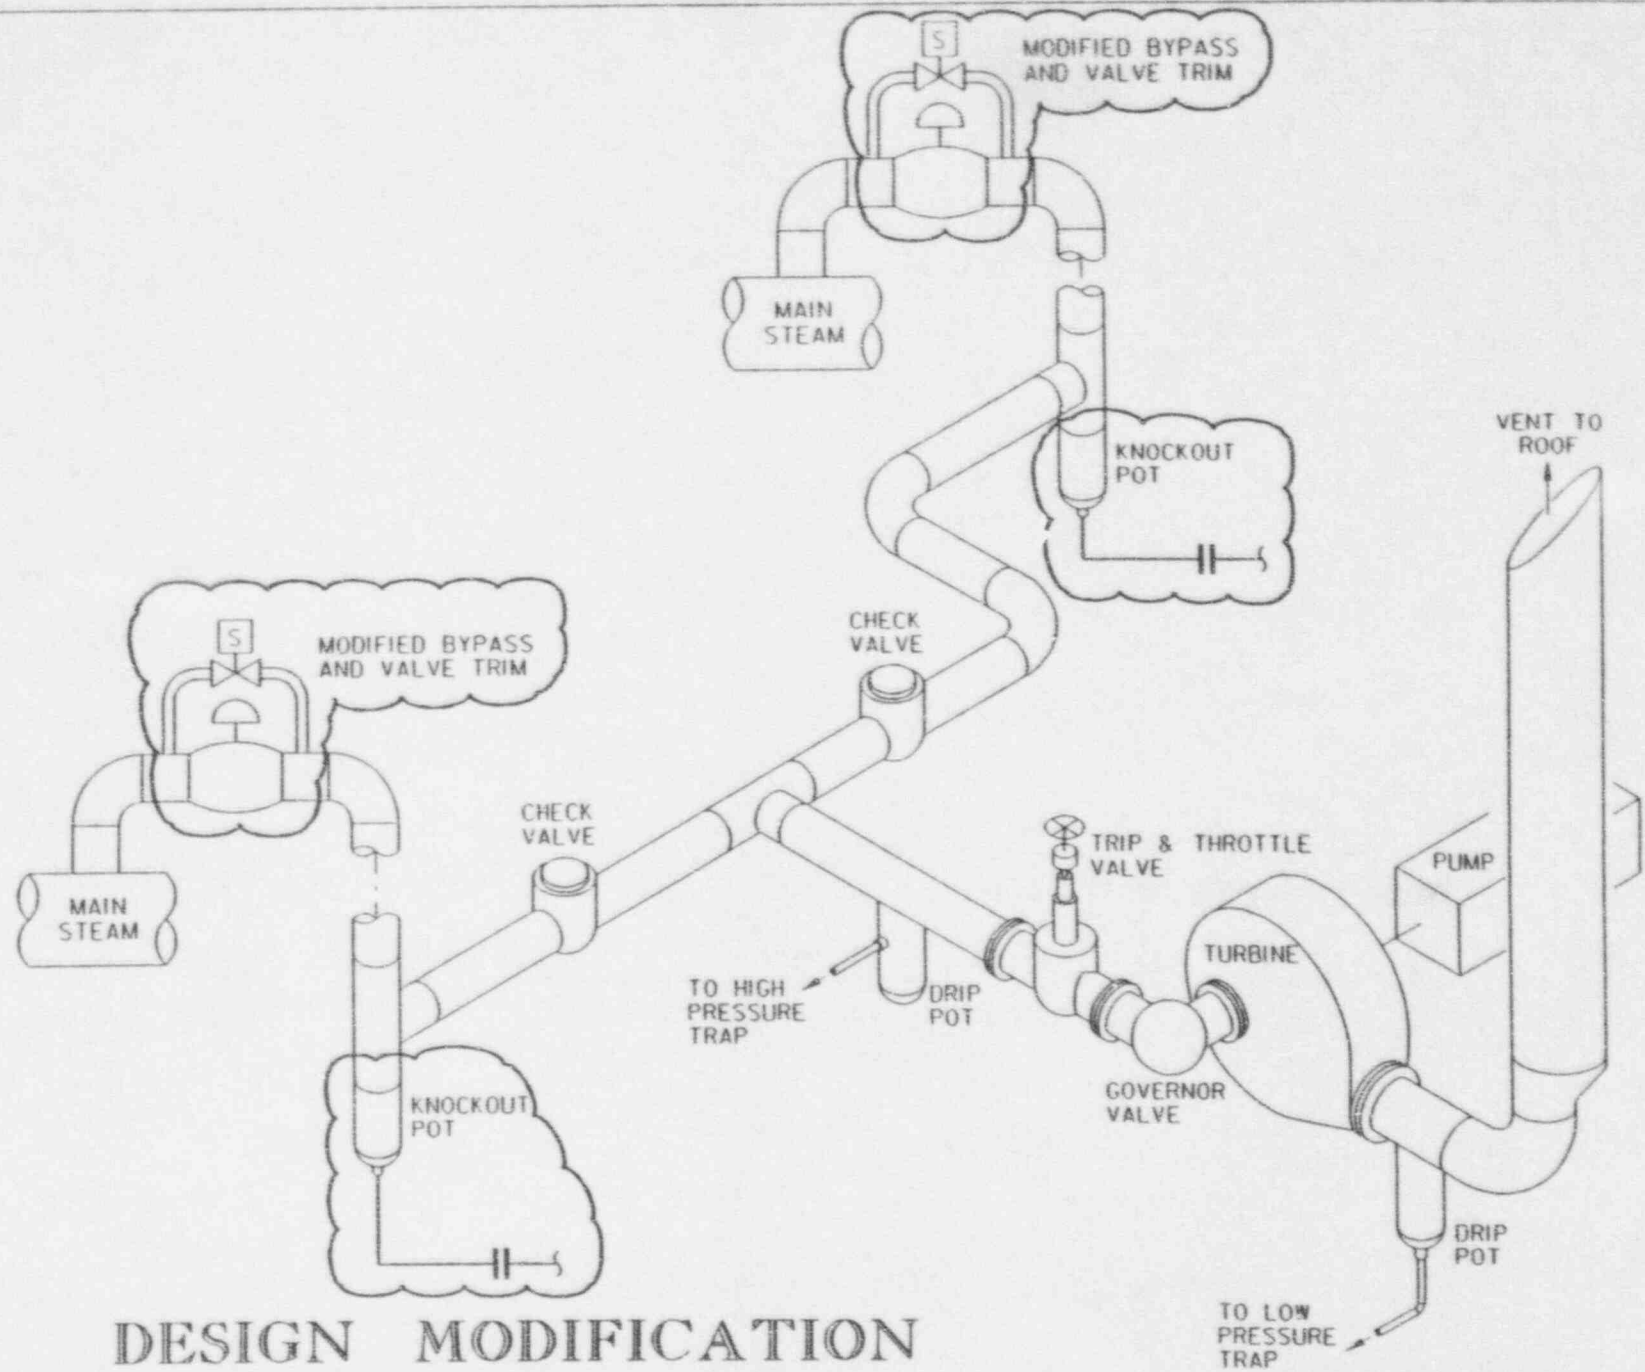
SKETCH NO. 8

DESIGN MODIFICATION
 OPTIONS 3 & 5

Scope: The steam admission line piping will be modified to install a run tee and a drain pot in selected sections of the piping run to dynamically remove condensate from the lines during cold start conditions. The condensate will be continuously drained during standby, startup and steady state operation.
