August 31, 1984

VIRGINIA ELECTRIC AND POWER COMPANY
NORTH ANNA POWER STATION UNIT NOS. 1 AND 2
RESPONSE TO I.E. BULLETIN 84-03

NORTH ANNA POWER STATION
RESPONSE TO IEB 84-03
REFUELING CAVITY WATER SEAL

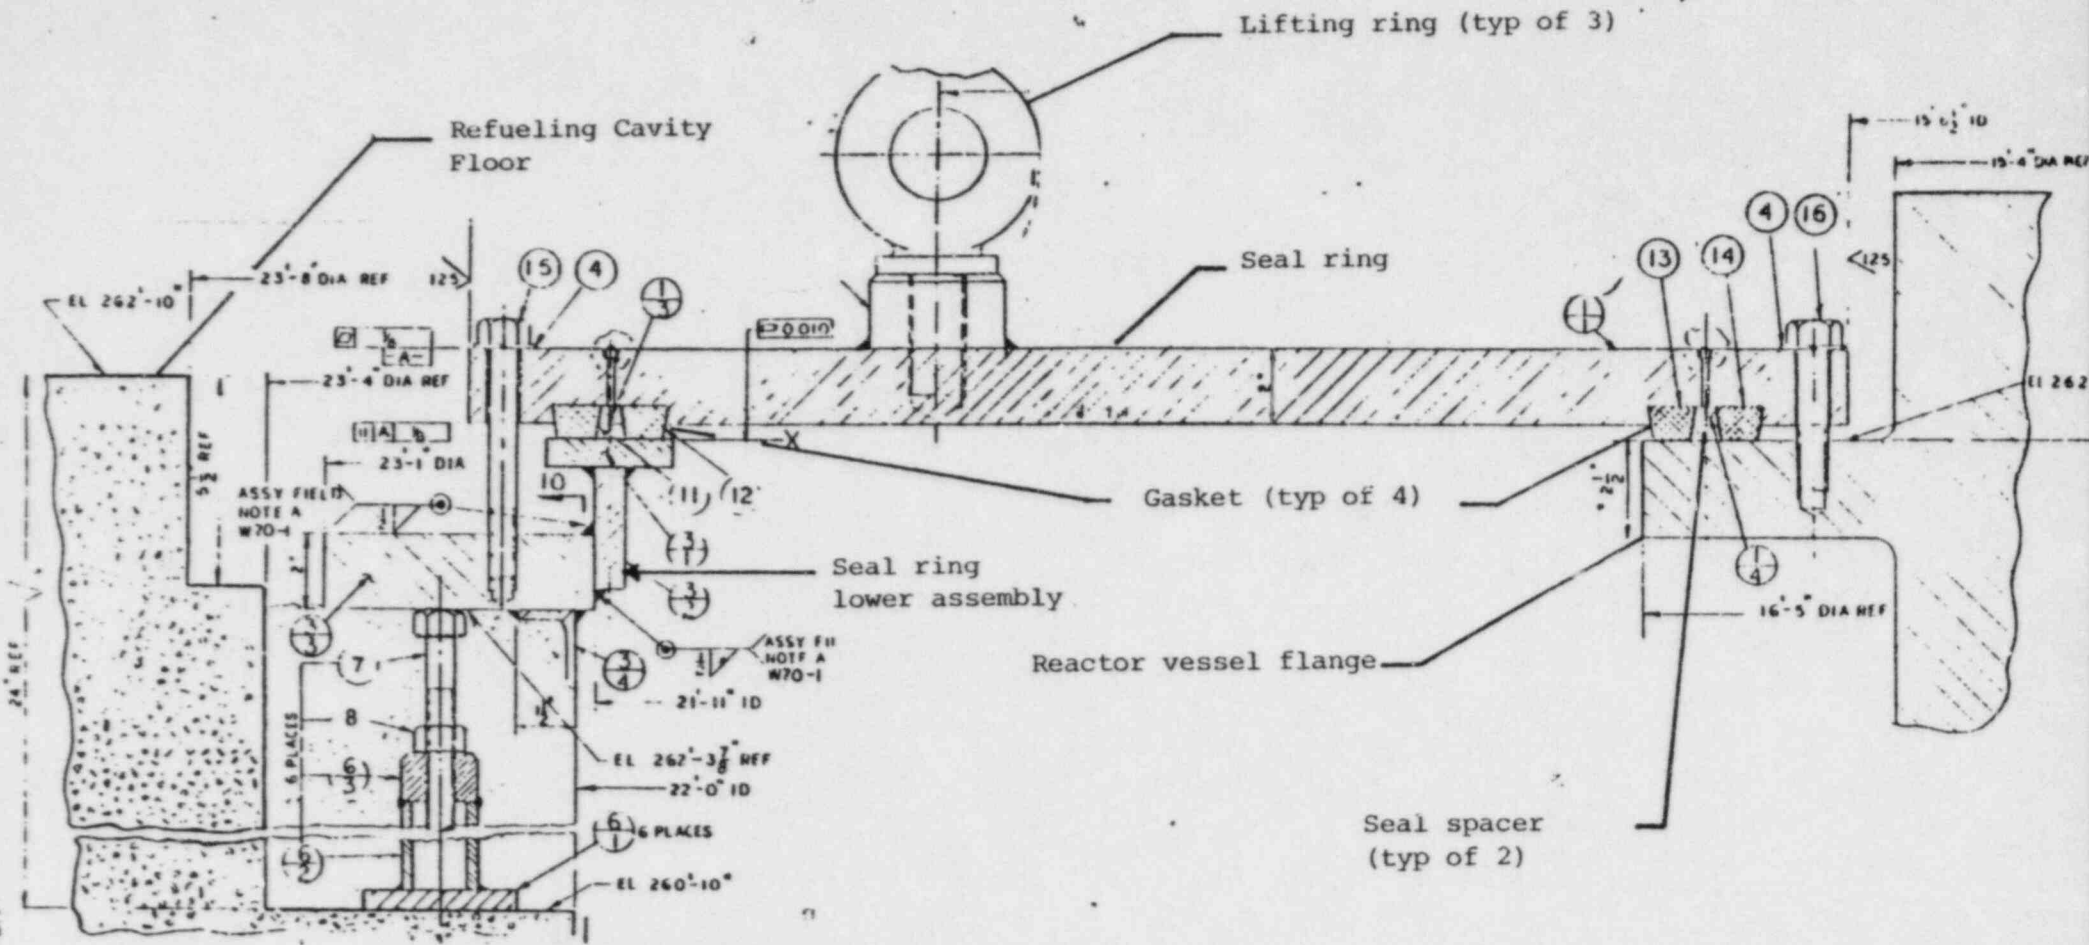
Figure 1. Refueling Cavity Water Seal - North Anna Units 1 and 2

The refueling cavity seal assembly at North Anna Units 1 and 2 consists of a 2 inch thick carbon steel annular plate and neoprene gaskets as shown in Figure 1. The inner edge of the seal ring rests on the reactor vessel flange and is secured by thirty six 0.75 inch diameter bolts torqued to 100 ± 10 ft. lbs. The outer edge rests on the seal ring lower assembly, which is a permanent fixture in the refueling cavity floor, and is secured in the same fashion. Each of these sealing surfaces utilizes redundant neoprene gaskets which are trapezoidal in shape and firmly held in place by a bolted seal spacer. These gaskets are deformed by the hydrostatic load of the water in the refueling cavity and the torquing of the seal ring bolts to provide for leaktight integrity. This is verified prior to flooding the refueling cavity by the performance of a pressure drop test on each set of gaskets. This test consists of applying an air pressure of 20 psi between each set of gaskets and verifying essentially no pressure drop after 30 minutes.

The refueling cavity seal assembly is designed to retain its integrity under the hydrostatic load imposed by 30 feet of refueling cavity water concurrent with a seismic event.

In a postulated accident consisting of a complete loss of all gaskets, the hydrostatic pressure of the refueling water will force the seal ring against the reactor vessel flange and the seal ring lower assembly. In this event, some leakage from the refueling cavity is expected due to minor seal plate flatness irregularities, however this leakage would be minor and much less than the minimum make up capacity provided by the Chemical and Volume Control System (150 gpm). Additional makeup capacity is provided by the Refueling Purification pumps (400 gpm) and/or Low Head Safety Injection pumps (3000 gpm) taking suction from the Refueling Water Storage Tank. Due to the redundancy of the seal assembly design, a partial gasket failure would only result in minor leakage. A failure of one or several of the 72 bolts, which secure the seal ring, will not result in excessive leakage due to the hydrostatic load of the refueling cavity water. A failure of the annular plate (seal ring) is not considered plausible.

On Unit 2, the refueling cavity seal gaskets were replaced prior to entering MODE 6.

As a result of this I.E. Bulletin, a new abnormal procedure has been written, approved and is in place for both North Anna Units 1 and 2. This procedure was written to further amplify the corrective actions to be taken on a decreasing refueling cavity water level, including makeup, movement of fuel and isolation of the fuel transfer tube.
