U.S. NUCLEAR REGULATORY COMMISSION  
REGION IV

NRC Inspection Report No. 50-482/92-06

Facility Name: Wolf Creek Generating Station (WCGS)

Areas Inspected: Nonroutine, announced special inspection of the circumstances and activities associated with the noise event that occurred at the WCGS on February 28, 1992.

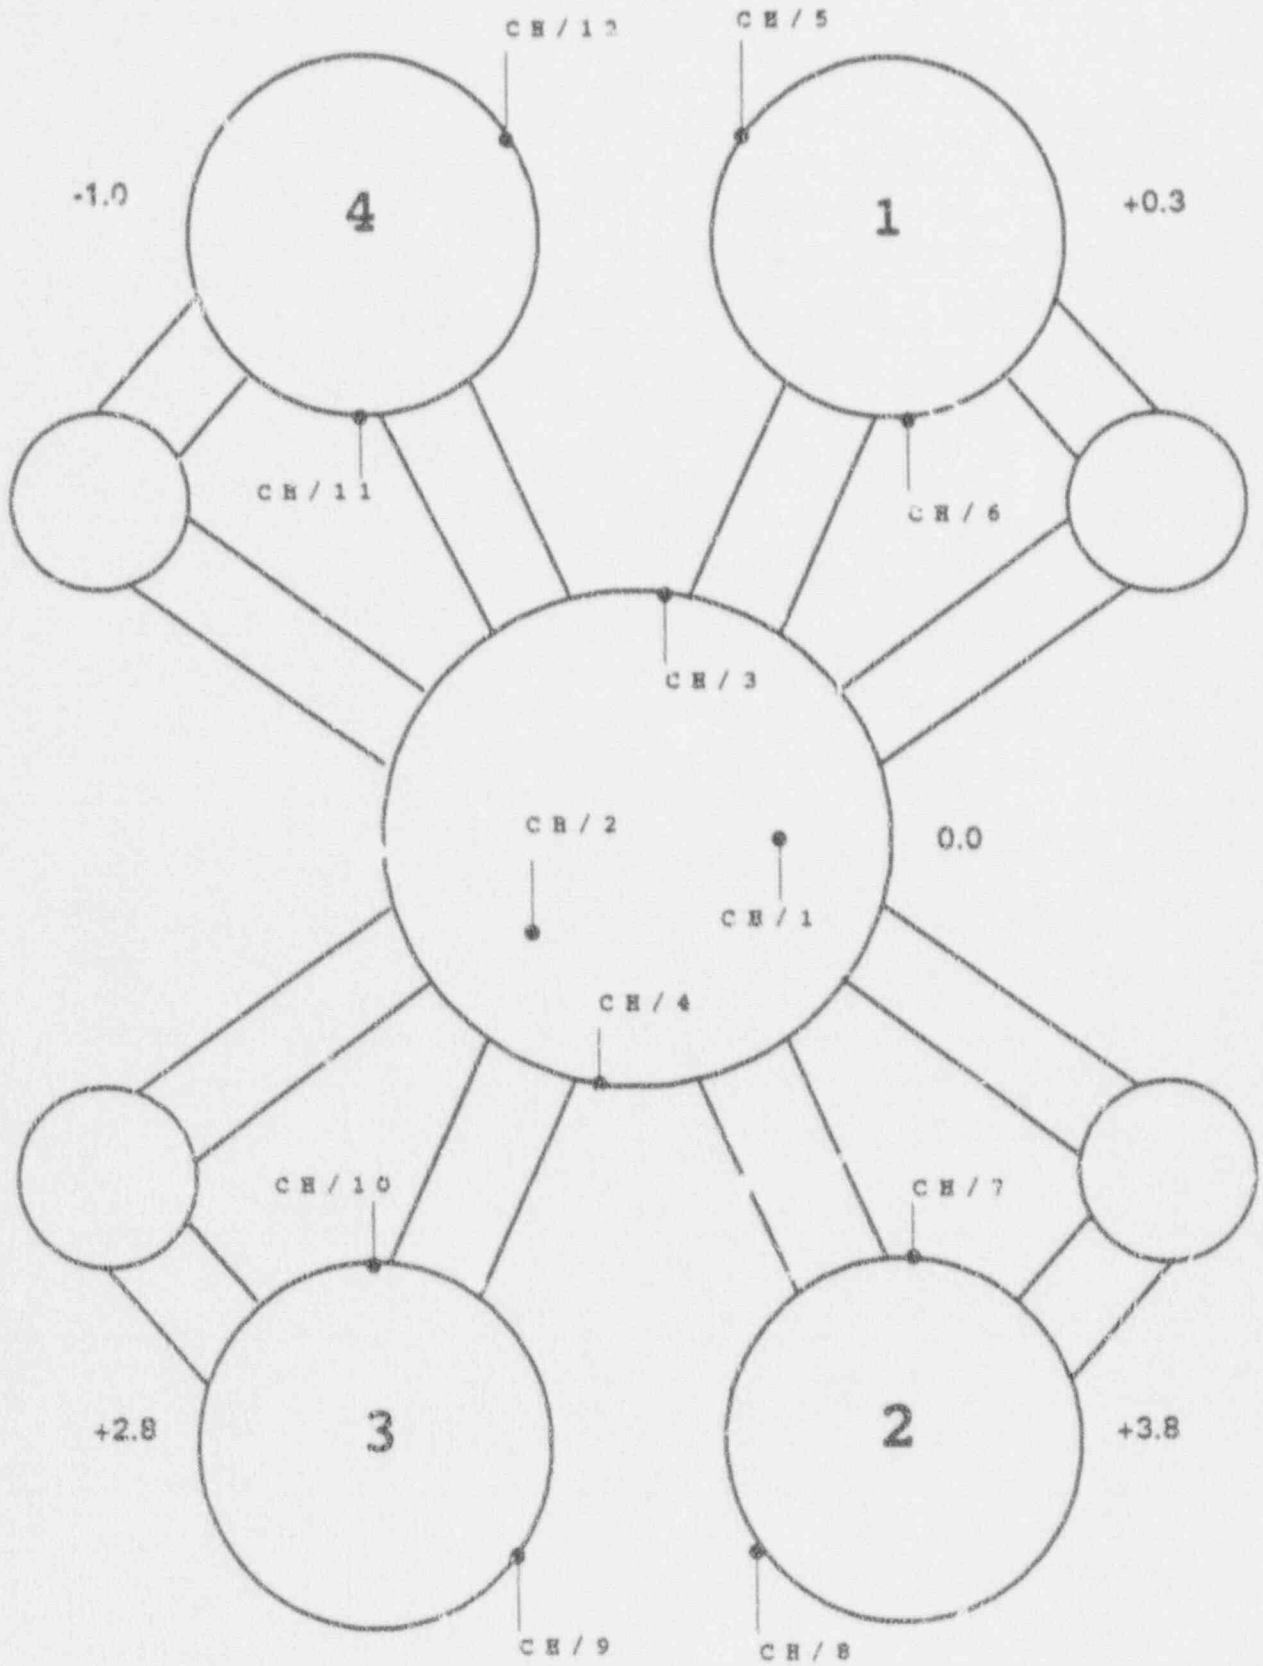
# LPM SENSORS

- **No Loose Parts in Reactor Vessel or Steam Generators**
  - **Timing**
  - **Repetition Rate**
  - **Signal Character**
  - **Initiation Mechanism**
  - **Integrity Checks**
- **Timing Traces Suggest 3/92 Event Initiated in Reactor Coolant Loop 4**

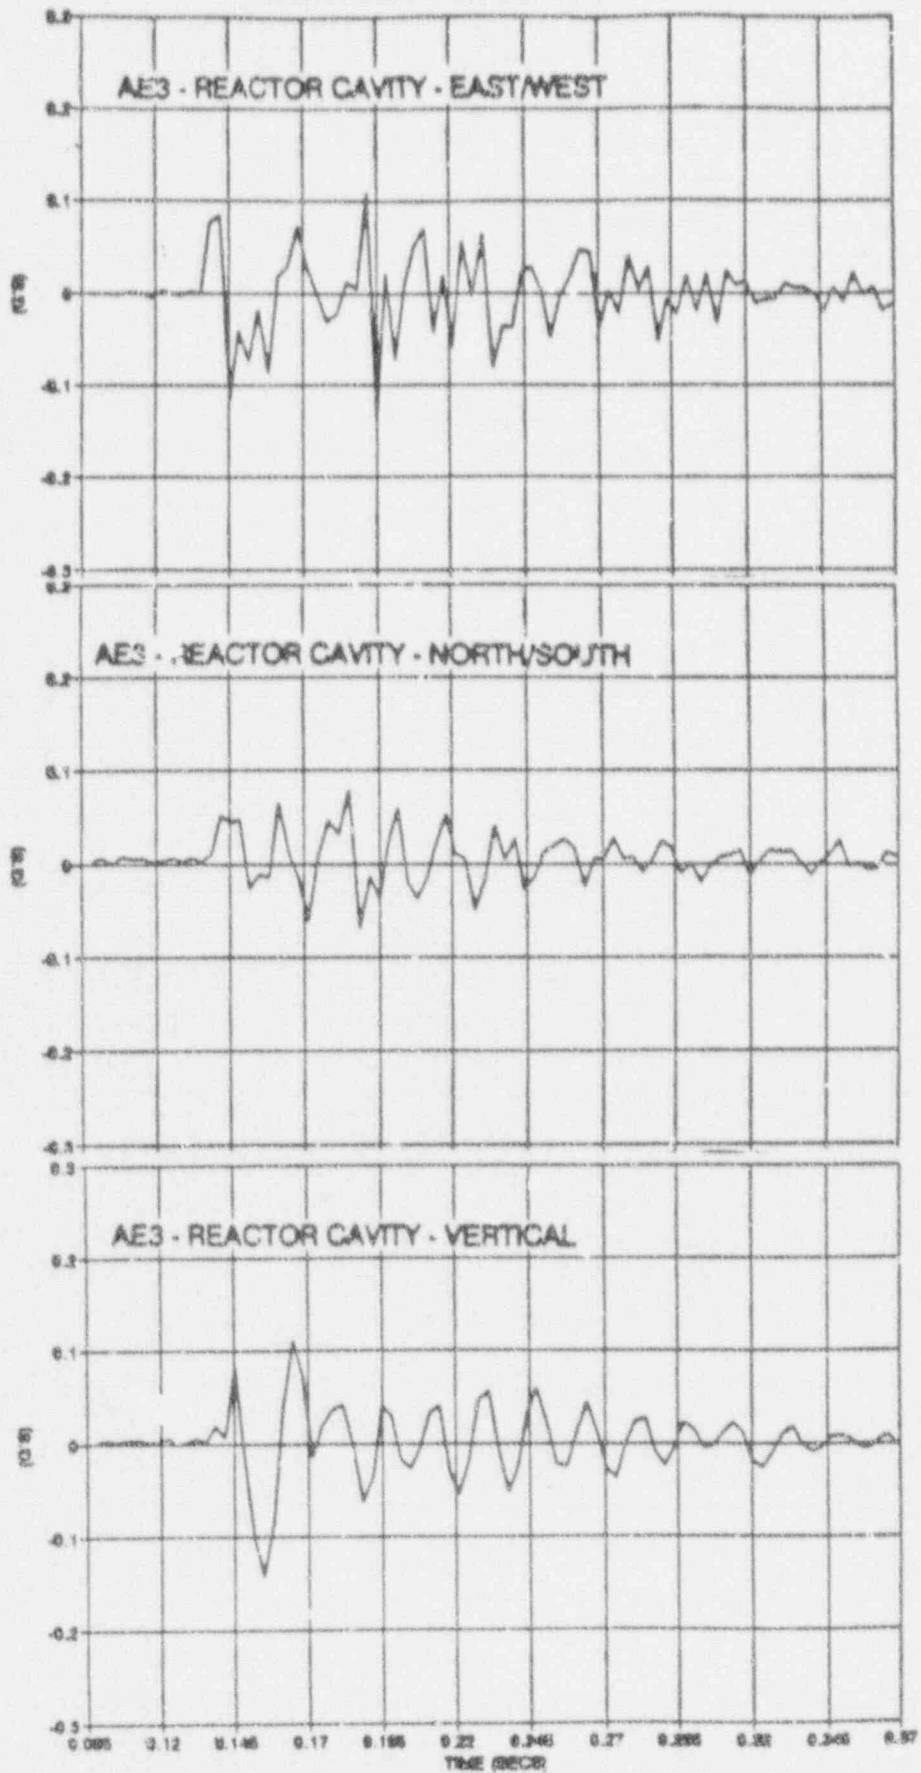
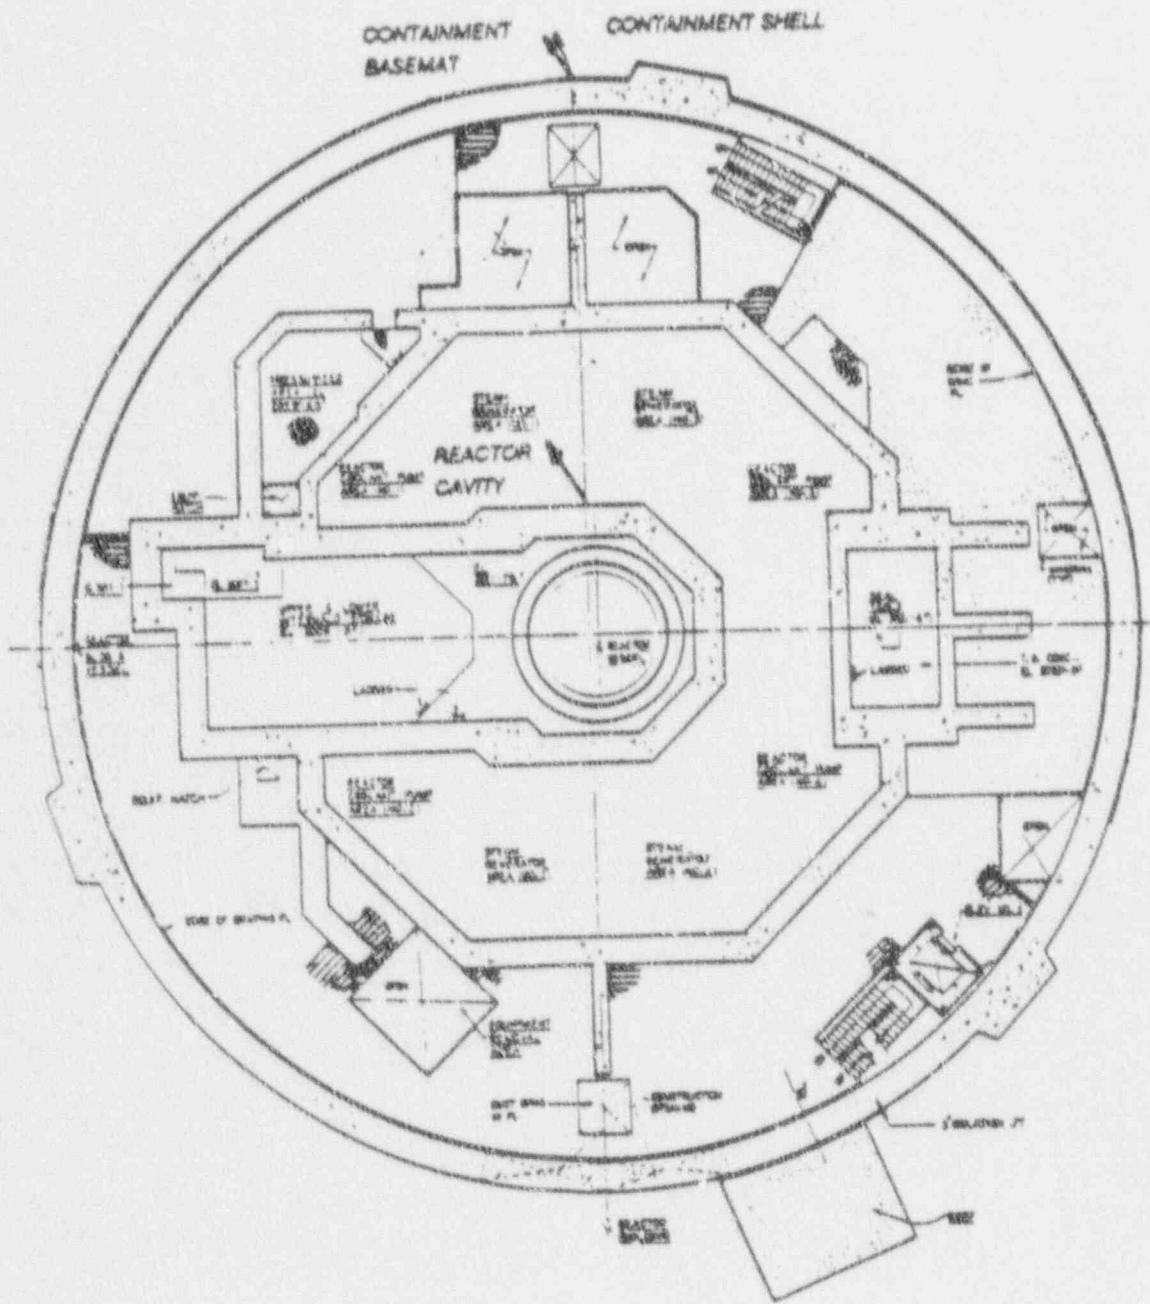
# DIRECTION OF INITIAL DISPLACEMENT

- o LOADS PRIMARILY TRANSMITTED TO THE SHIELD WALL
- o INITIAL MOVEMENT TOWARD WEST-SOUTHWEST
- o NO STRUCTURAL DISTRESS IS INDICATED

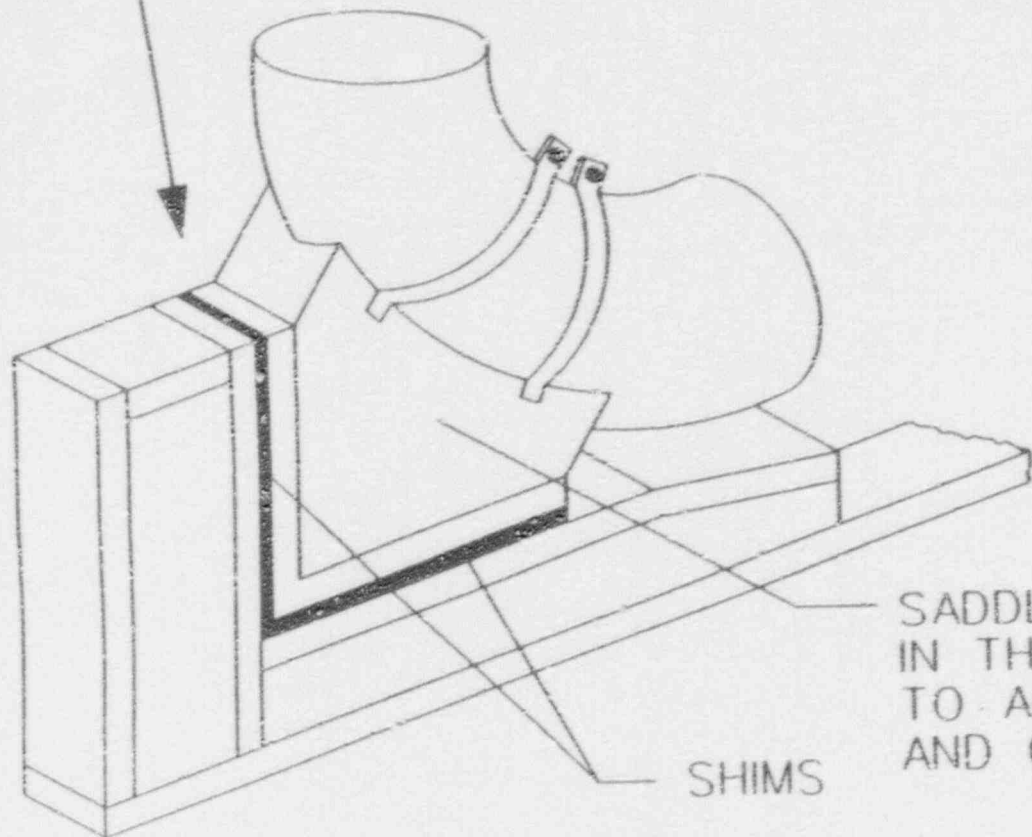
# SADDLE SUPPORT

SADDLE BLOCK ALLOWS MOVEMENT  
IN THE DIRECTION OF THE ARROWS  
TO ACCOMODATE THERMAL EXPANSION  
AND CONTRACTION OF PIPING

**An inspection of the shims in the crossover leg pipe whip restraint revealed evidence of hard contact.**

**To eliminate this as a cause, the shims were removed and milled to restore the desired clearance.**
