Prairie Island Nuclear Generating Plant

Inadvertent Opening of Supply Disconnect Switch to Safeguards Electrical Bus 15

LICENSEE EVENT REPORT (LER)

TITLE (4)
Inadvertent Opening of Supply Disconnect Switch to Safeguards Electrical Bus 15

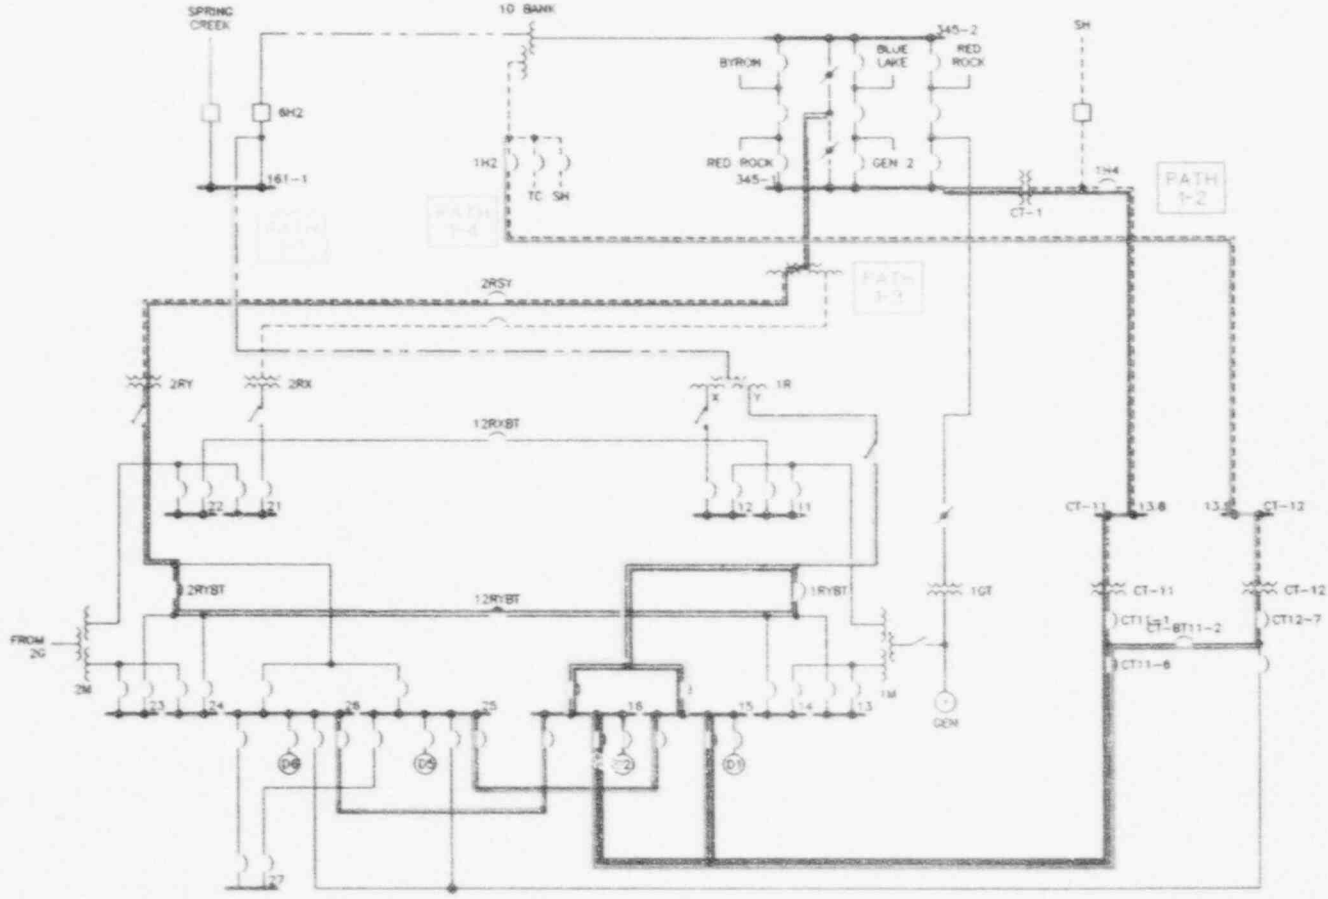
FIGURE 1

At the time of the event, decay heat removal was being supplied by 12 RHR Pump (EIS Component Identifier - P) (Train B). As shown on Figure 1, the following sources of power were being maintained available for Bus 16 (Train B): CT11, bus tie to Unit 2 Train B, and D2 safeguards diesel generator (EIS Component Identifier - DG). The following sources of power were being maintained available for Bus 15 (Train A): CT11, bus tie to Unit 2 Train A, and D1 safeguards diesel generator. The loss of 1R as a source to Train A did not affect the availability of any of the other sources available to Trains A or B. No interruption of decay heat removal occurred. When the 1RY C phase disconnect switch was opened, the control room noticed some dimming of lights and received numerous annunciators. Some 480V loads were lost. No 4160V loads were being supplied via this bus at the time. Normal voltage was restored to the 4160V and 480V busses in about 5 minutes and 26 seconds. During this time, 11 FHR Pump was not available. Thus, the planned degree of defense in depth for decay heat removal was reduced during this 5 minutes and 26 second period. Damage to the 1RY-C phase disconnect switch was minimal, requiring only cleaning of contacts. A limited scope analysis assuming that Bus 15 power was restored but subsequently that all decay heat removal was lost and that all inventory makeup to the RCS failed yielded a conditional core damage probability of less than 1E-6. For these reasons, there was no adverse effect on the health and safety of the public.

SOURCES TO UNIT 1 SAFEGUARDS BUSES
