SUBJECT: RECENT SOLENOID-OPERATED VALVE
EXPERIENCES INVOLVING MAINTENANCE AND
TESTING DEFICIENCIES

AEOD Technical Review Report

TR Report No.: AEOD/T92-04
Date: June 1992
Evaluator/Contact: H.L. Ornstein

**SUBJECT: RECENT SOLENOID-OPERATED VALVE EXPERIENCES
INVOLVING MAINTENANCE AND TESTING DEFICIENCIES**

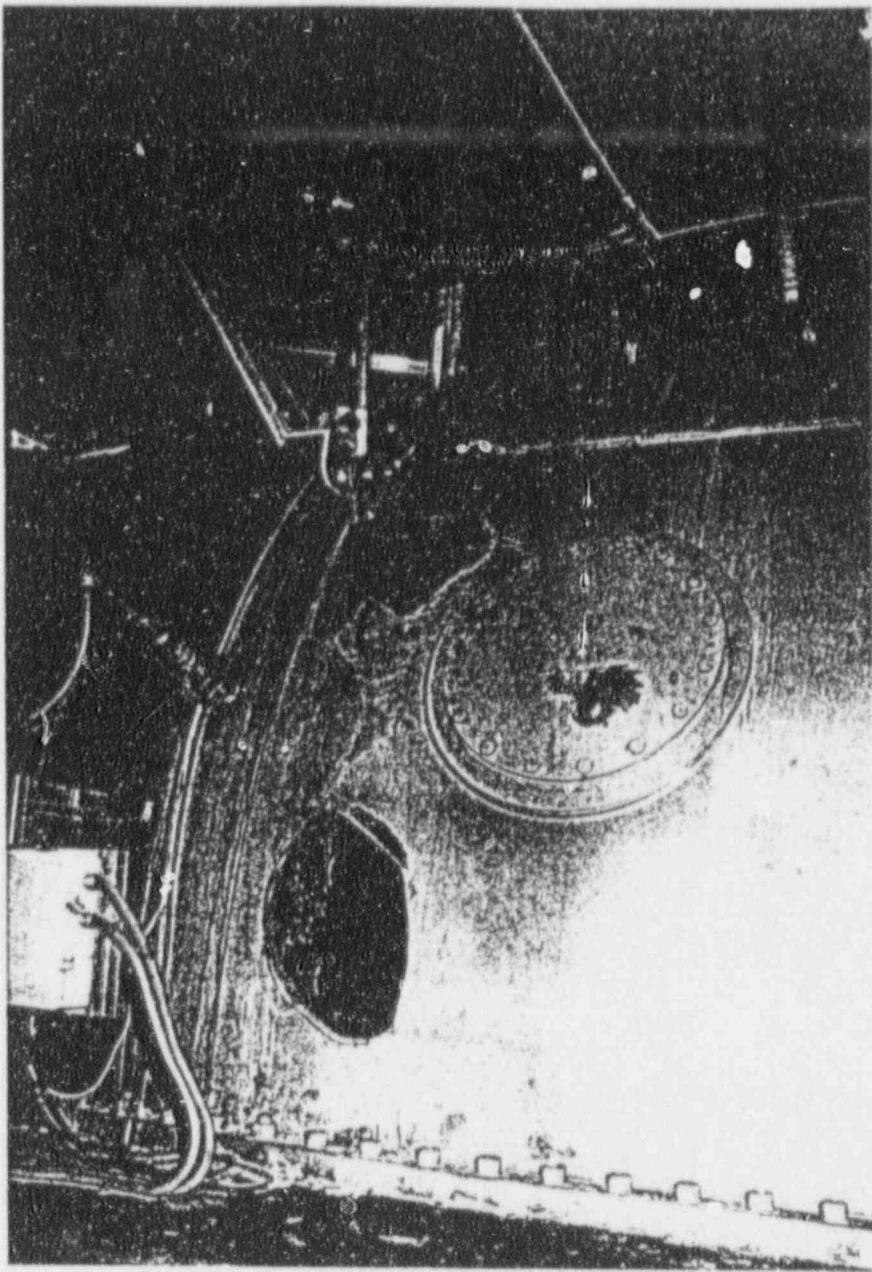
Figure 1 Turbine Casing
Salem Unit 2

Although it did not involve any "safety-related" systems, one of the most costly common-mode SOV events in the United States was the turbine overspeed event which occurred at Salem Unit 2 on November 9, 1991. That event involved the failure on demand of three solenoid-operated valves in the turbogenerator's overspeed protection control system. Those three SOV failures resulted in major damage to the turbine and generator; condenser failures; lube oil and hydrogen fires; and a hydrogen explosion. The turbine speed was estimated to be 2900 rpm (vs. 1800 rpm rated speed). Turbine missiles penetrated the turbine casing, and some missiles traveled over 100 yards. Figures 1 and 2 show some of the damage. The event resulted in an extended outage expected to be about six months with a cost estimated at over 100 million dollars.

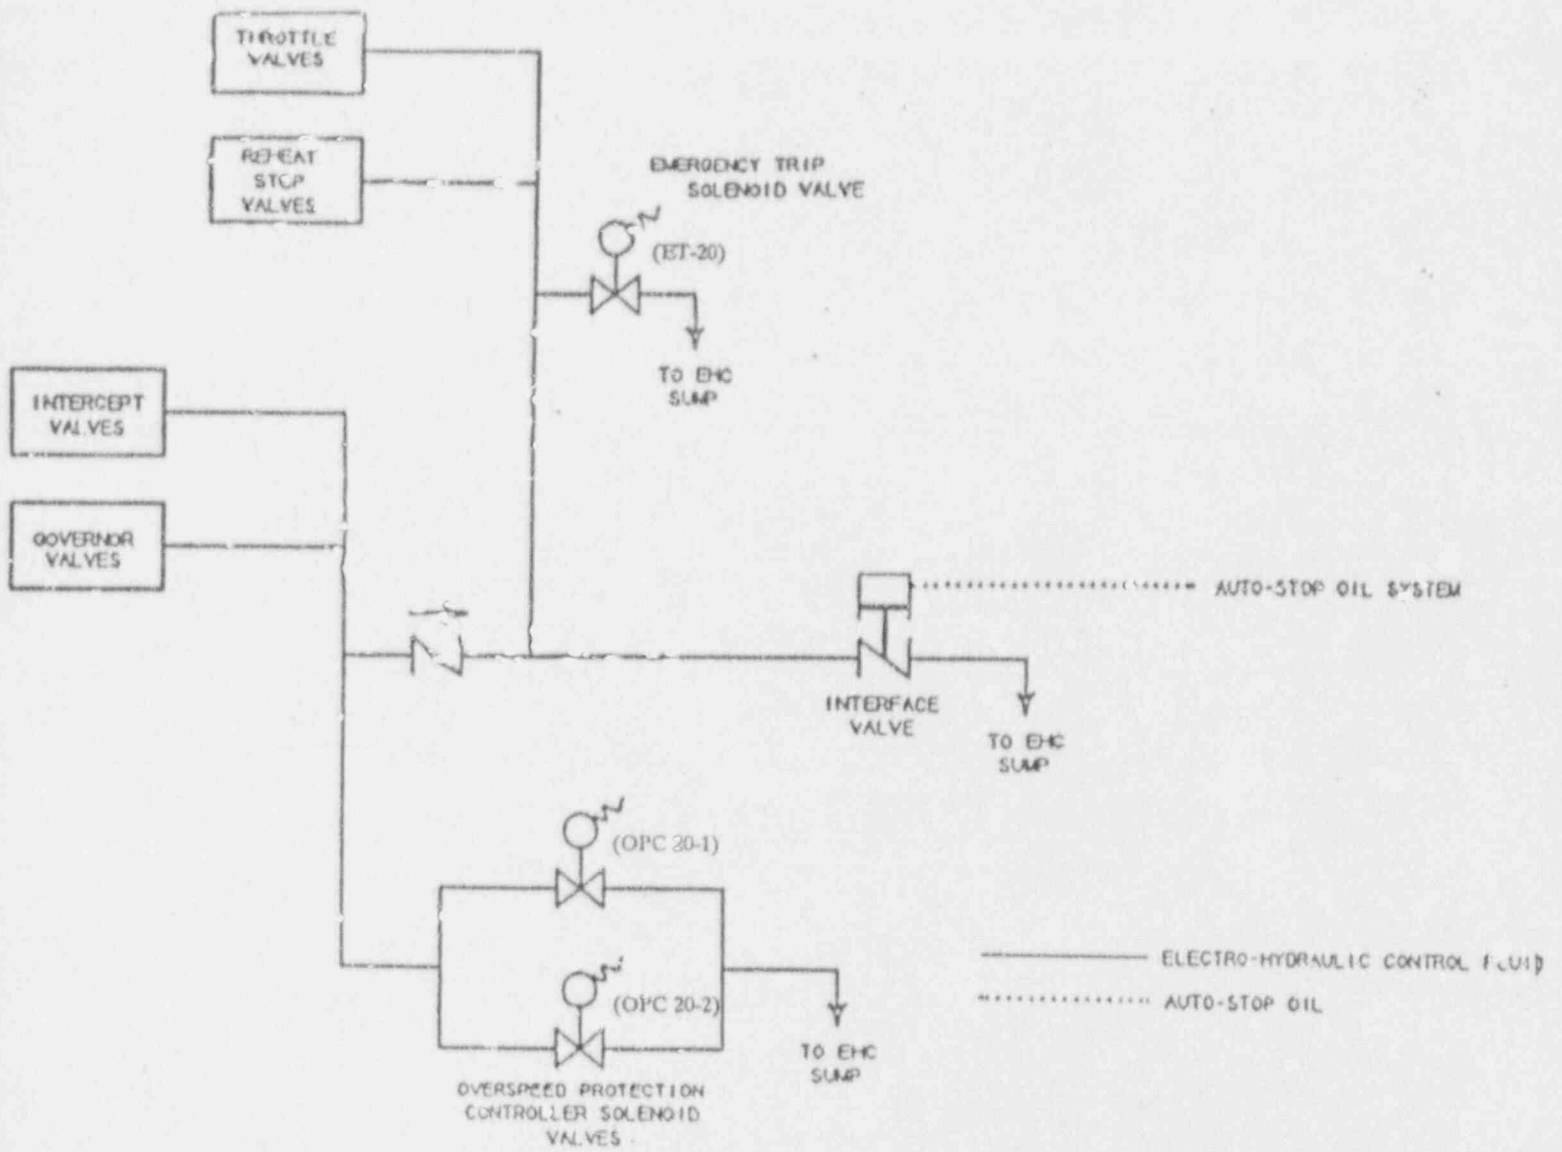
Figure 3 Turbine Electro-Hydraulic Control System
Salem Unit 2

being conducted was not capable of revealing the malfunction or degradation of one of two parallel overspeed protection controller SOVs (OPC 20-1 or OPC 20-2 shown in Figure 3). A successful test would confirm that at least one of those two SOVs was operating properly. An unsuccessful test would indicate failures of both SOVs. The operators performing the test in October were puzzled when the surveillance test showed that both SOVs were inoperable. They repeated the test a second time and had the same results. The operators discussed the test failures with other station personnel and they collectively concluded that the SOVs could not both have failed, and that something must have been wrong with the test procedure. It is highly probable that both SOVs did not fail at once in October 1991. It is quite likely that one SOV had failed earlier (and had been undetected), and that the second SOV had undetected degradation, and it failed at the time of the surveillance test. Three weeks later, on November 9, 1991, the main turbine overspeed protection system was tested. However, in addition to the two undetected failed SOVs, a third SOV which was being tested also failed (SOV ET-20 shown in Figure 3). Had either of the first two SOVs been operable (OPC 20-1 or OPC 20-2), one of them would have actuated upon failure of the third SOV (ET-20), and a simple turbine trip would have occurred without any damage.
