BRUNSWICK STEAM ELECTRIC PLANT, UNIT NO. 2
DOCKET NO. 50-324/LICENSE NO. DPR-62
NUREG-0619 FEEDWATER NOZZLE AND SPARGER EXAMINATION RESULTS

BRUNSWICK STEAM ELECTRIC PLANT, UNITS 1 AND 2
NRC DOCKET NOS. 50-325 & 50-324
OPERATING LICENSE NOS. DPR-71 & DPR-62
NUREG-0619 FEEDWATER NOZZLE AND SPARGER EXAMINATION RESULTS

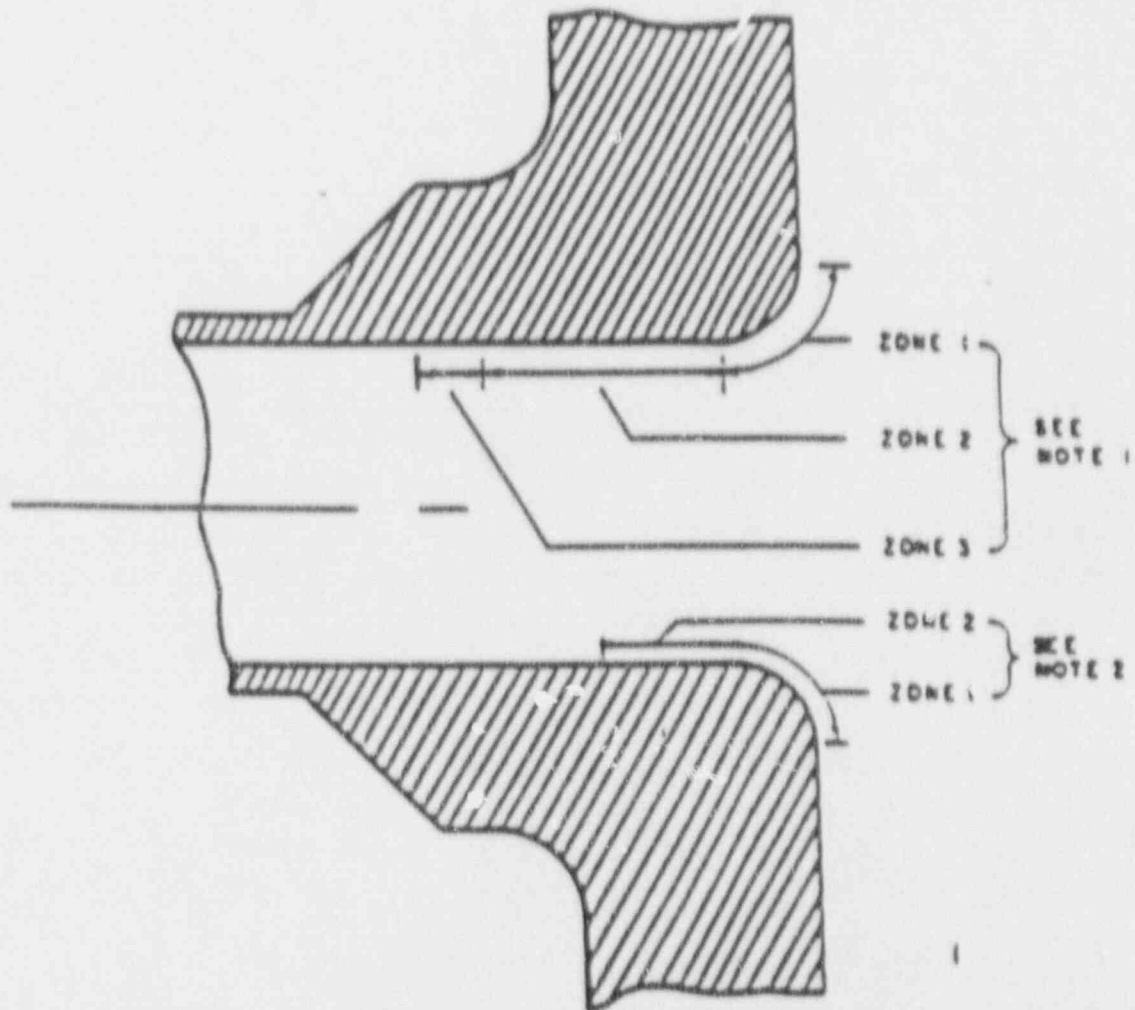
FIGURE 1

NOZZLE EXAMINATION ZONES

- 1 FEEDWATER NOZZLES REQUIRE ZONES 1, 2, 3 PER NUREG 0619
- 2 ALL OTHER NOZZLES EXCEPT FEEDWATER REQUIRE ONLY ZONES 1 & 2
