BRUNSWICK STEAM ELECTRIC PLANT, UNIT 2
NRC DOCKET NO. 50-324
OPERATING LICENSE NO. DPR-62
NUREG-0619 FEEDWATER NOZZLE AND SPARGER EXAMINATION RESULTS

FEEDWATER SPARGER
CIRCUMFERENTIAL CRACKING EVALUATION
FOR BRUNSWICK UNITS 1 AND 2
General Electric Report GE-NE-523-112-1191
November 1974

FEEDWATER SPARGER
CIRCUMFERENTIAL CRACKING
EVALUATION FOR
BRUNSWICK UNITS 1 AND 2

BRUNSWICK STEAM ELECTRIC PLANT UNIT 2
NINETH REFUELING OUTAGE - OCTOBER, 1991
INVESSEL VISUAL INSPECTION (IVVI)
INSPECTION REPORT AND VIDEO REVIEW

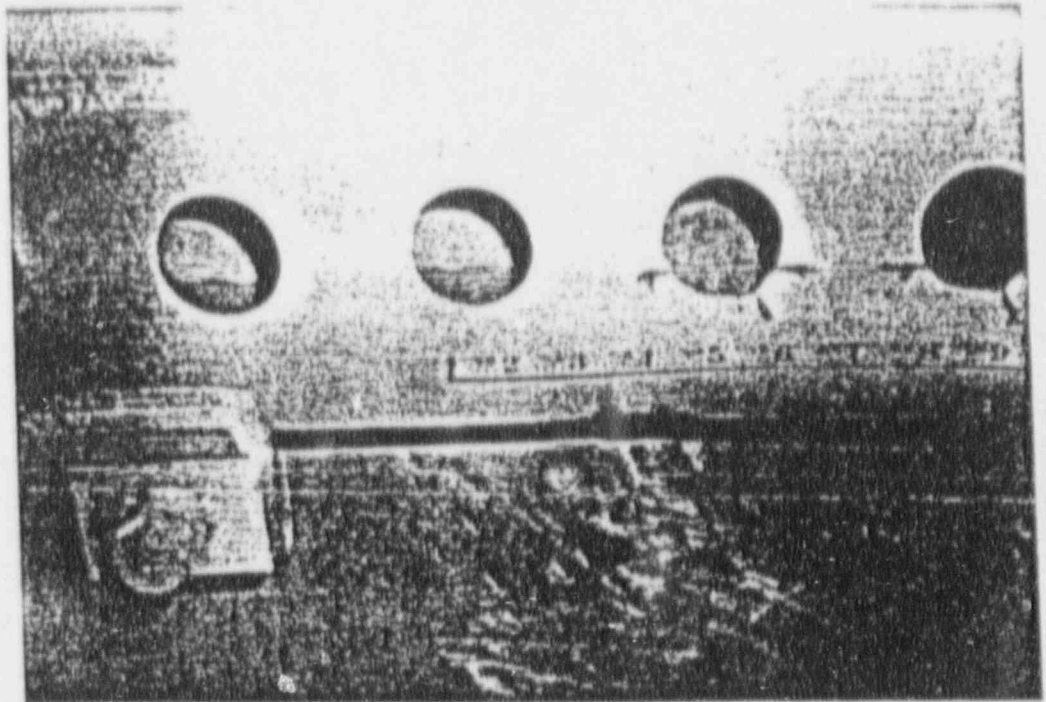
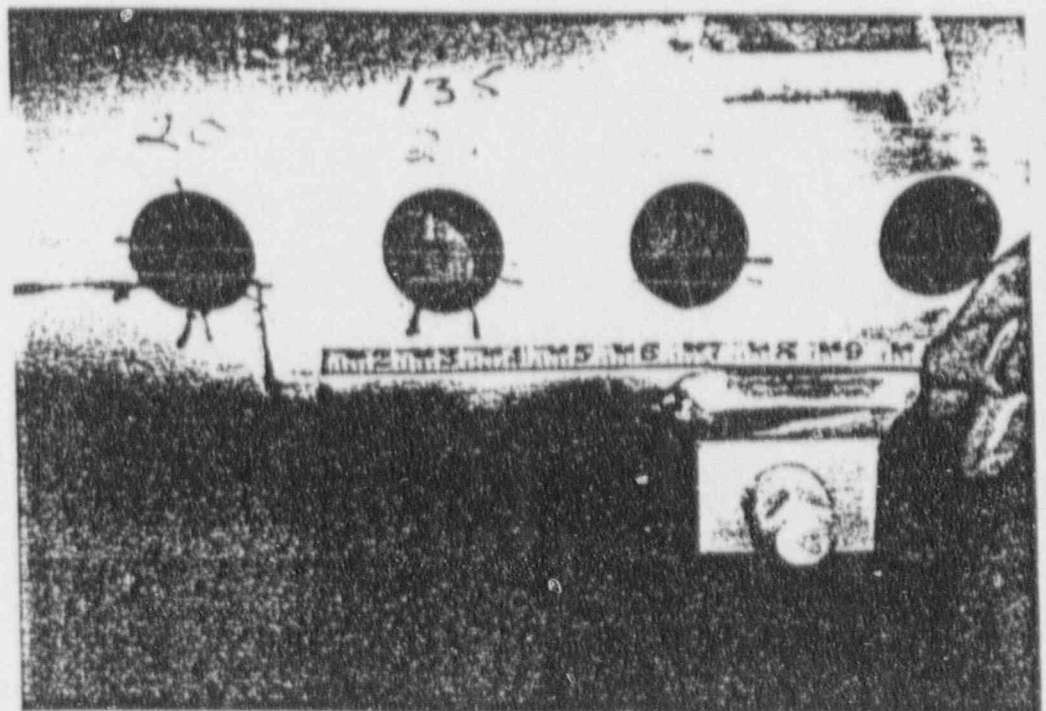
135° HOLE # 17, & 18

- The Unit 2 inspection showed the longest circumferential crack to be about 2 inches long. Comparison of inspection results from this outage and the previous outage for one of the cracks indicates that no significant crack growth occurred during the last cycle.

Figure 2-1. Results of 1989 Sparger PT Inspection

The circumferential welds were LP tested and ultrasonically tested (UT). The LP tests show the longest crack to be 2 inches. The UT results show that the crack lengths inside the spargers are no more than the LP indications on the outside surfaces. Comparison of a crack length measured during the last outage and during this outage shows that no significant crack growth has occurred.

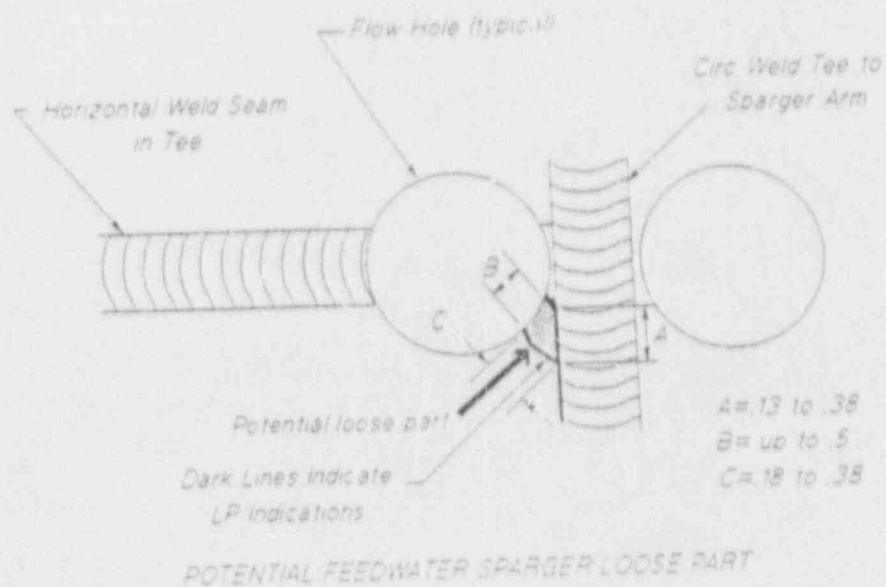
1. No relevant indications were found on the nozzle inner blend radius.
2. Crack growth continues on the flow holes but no pieces have separated. Note: The pieces did not separate during the hydrolase cleaning operation using a 20,000 psi plus hydrolaser unit prior to the examination. In addition to the horizontal piece between the flow holes which has been previously addressed by GE, the size of other potential loose pieces is as shown. The largest of which has also been previously addressed by GE.
