U. S. NUCLEAR REGULATORY COMMISSION
REGION 1

Report Nos. 92-13
92-12

Facility: Beaver Valley Power Station, Units 1 and 2

Inspection Period: April 19 - May 25, 1992

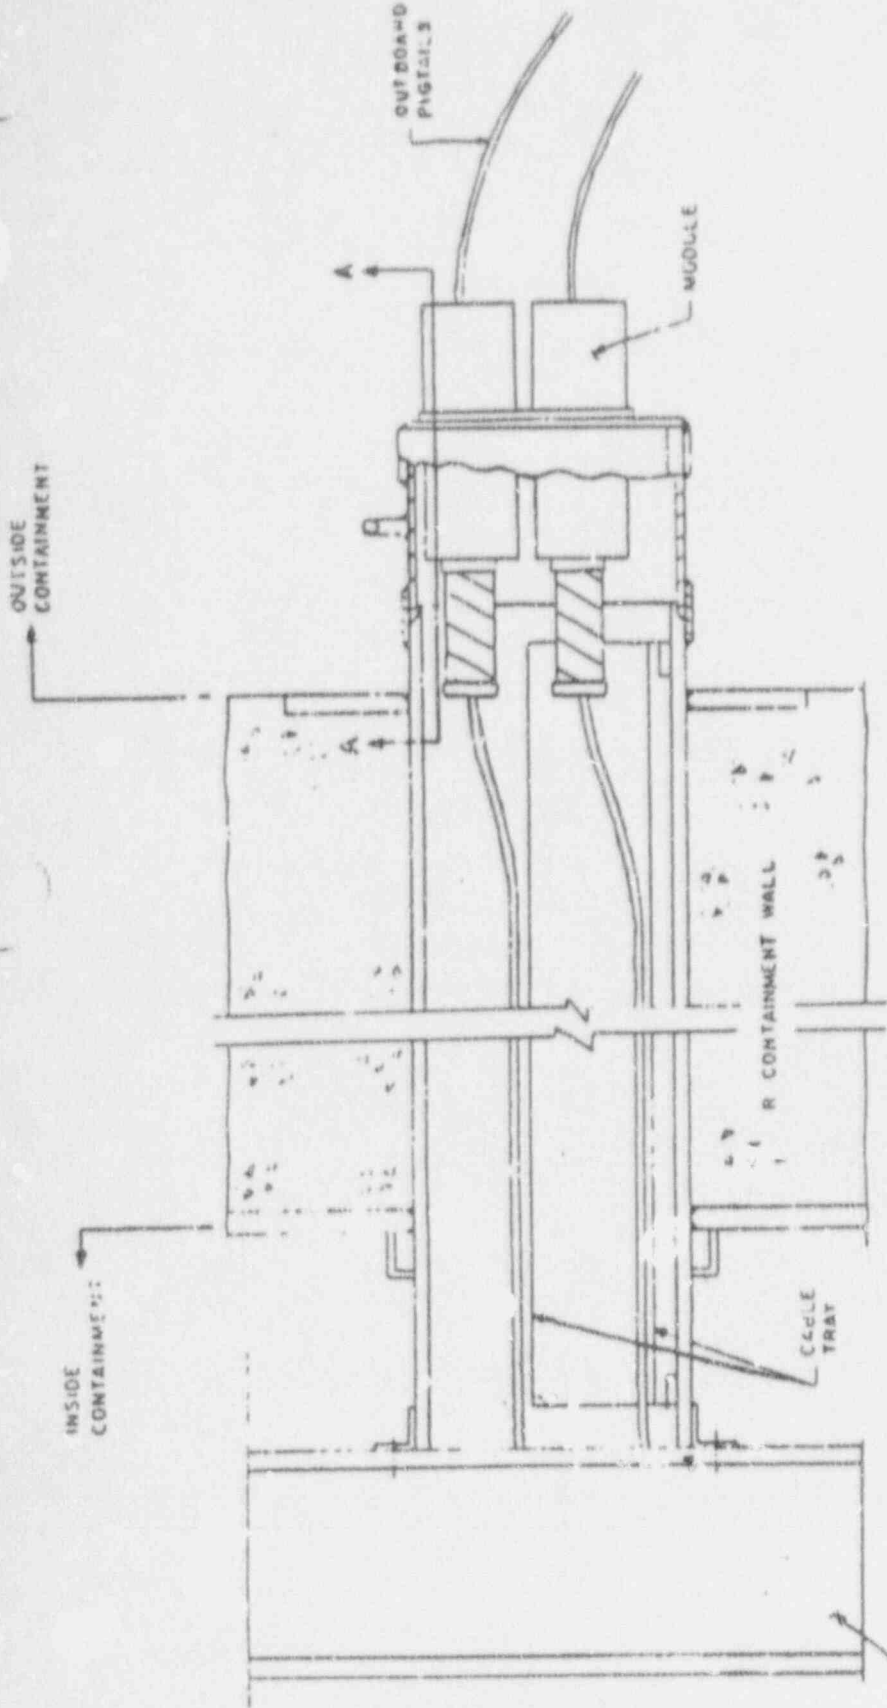
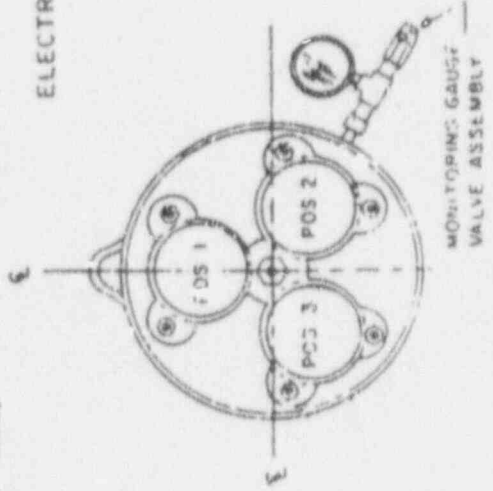
TYPICAL
ELECTRICAL PENETRATION ASSEMBLY

The temporary installation of electrical penetration 2RCP-11E is acceptable for refueling and does not violate the intent of technical specification 3.9.4, provided that the penetration maintains a gas tight seal against the maximum differential pressure for Mode 6. This is consistent with other utilities' interpretations and certain NRC personnel. The penetration, if it had been installed to maintain a gas-tight seal, would not have provided a pathway from containment to the outside atmosphere. Once the penetration seal fails, then the requirements of technical specification 3.9.4 must be met. It should be noted that this leakage was not a "direct path" to the outside atmosphere and would have been filtered under a hypothetical radiological release.

The condition, when electrical penetration 2RCP-11E did not conform to the requirements of technical specification 3.9.4 existed for 7.5 hours (best estimate) and less than 72 hours (worst case). The violation was not easily discovered due to the following factors:

- 1) Immediate corrective action was taken by shift outage manager. After discovering the leaking electrical penetration, fuel movement was immediately halted once a fuel assembly was placed in a safe position.
- 2) Electrical penetration differential pressure was reduced.
- 3) Electrical penetration 2RCP-11E was cleaned, sealed, Q/C inspected and type B leak tested, to restore it to pre-outage condition.

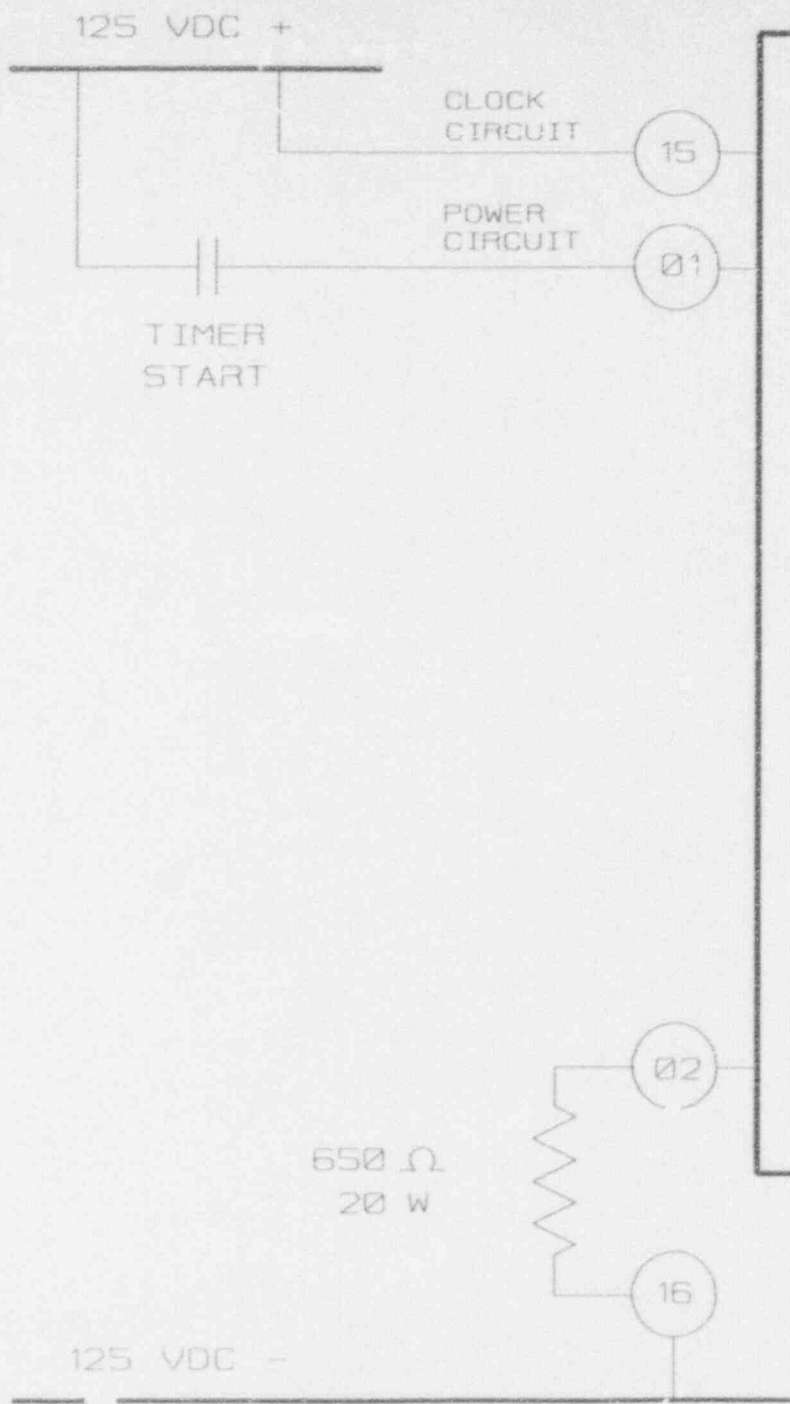
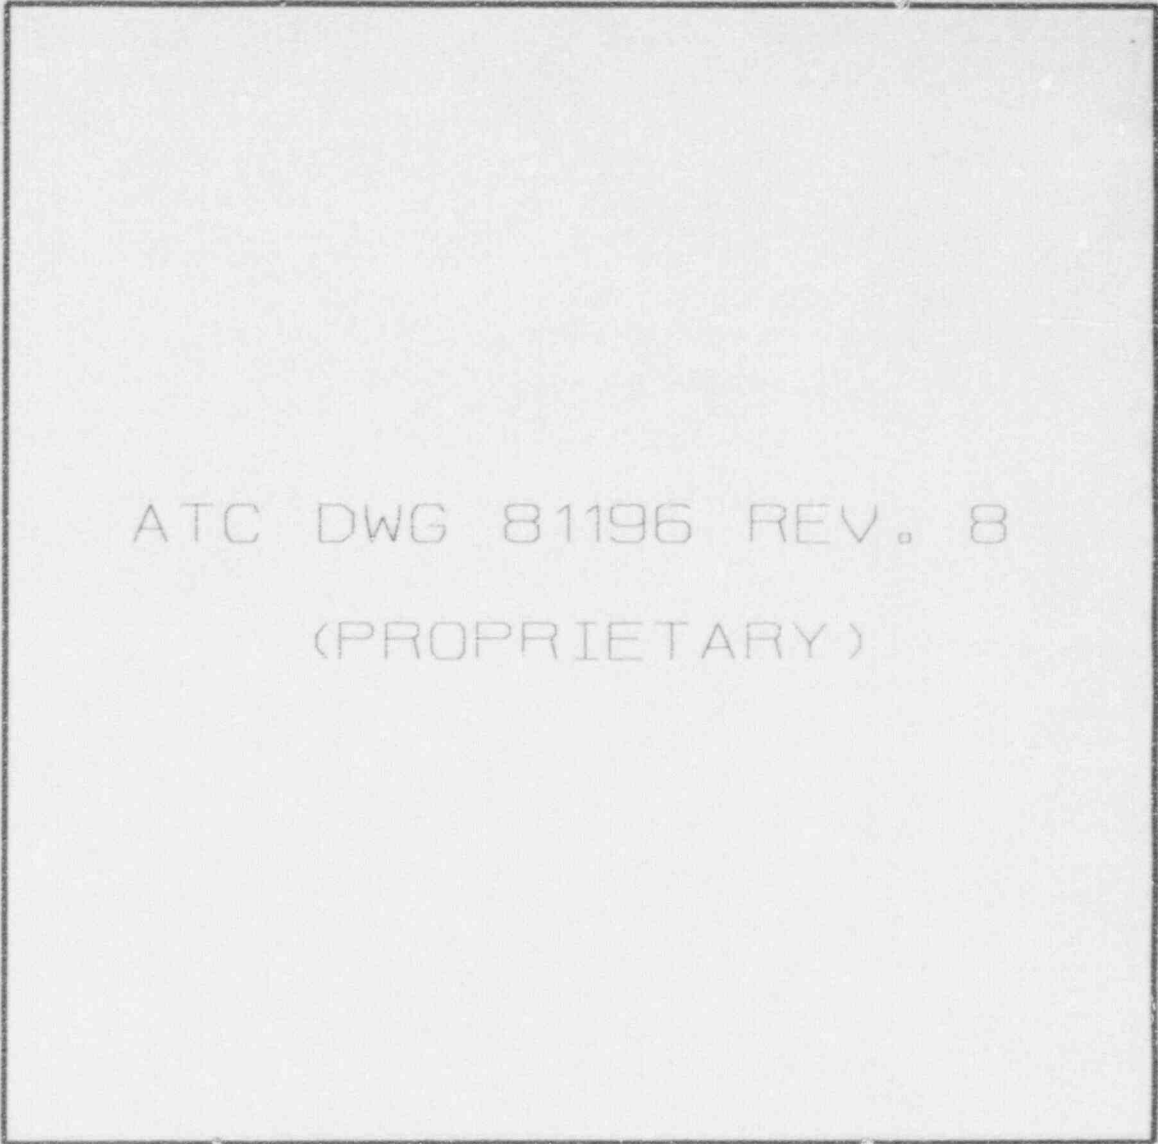
AUTOMATIC TIMING AND CONTROLS CO.
SERIES 365 LONG RANGER TIMER
(FAILED CONFIGURATION)

A revision to the circuit was recommended by the original vendor and was accepted with minimal retesting of the proprietary circuitry. The qualified circuit had been tested in the 125 VDC application; and the original vendor indicated that the rewired configuration would not affect the operation.

Following identification of the relay problems and an engineering review of the failures, Design Change Package (DCP) 1870 was issued to modify the relay installation by replacing the failed relays and eliminating the possibility of further relay overheating failures. The relays for EDG 2-1 were replaced on April 2, 1992.

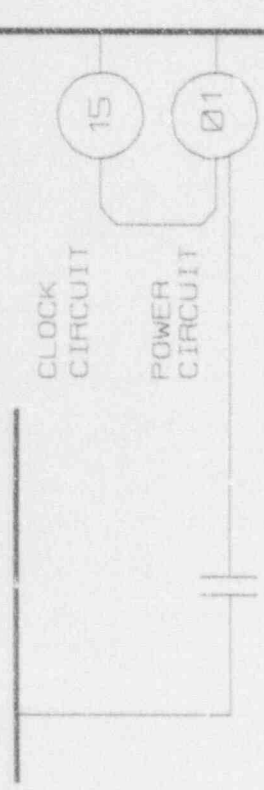
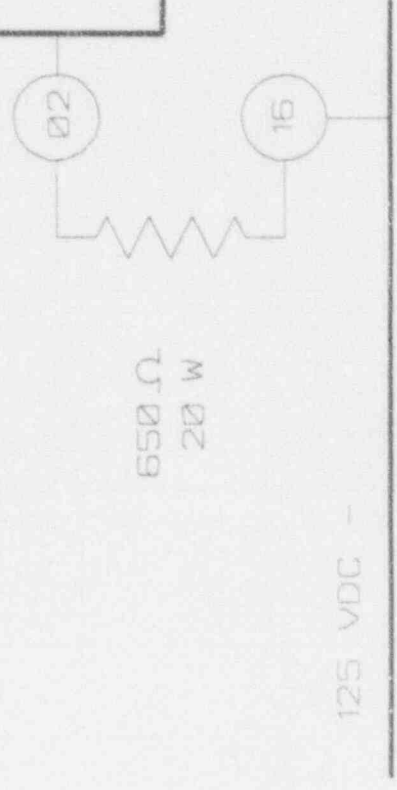
AUTOMATIC TIMING AND CONTROLS CO.
SERIES 365 LONG RANGER TIMER
(CORRECTED CONFIGURATION)

The circuit was bench tested to verify improved and repeatable tolerances to the calibration requirements. The post installation testing and pre-operational functional testing exercised the circuit in the rewired configuration and provided no indication of a circuit deficiency.
