Sequoyah Nuclear Plant

Unit 1 Cycle 7 Refueling Outage

RESULTS OF STEAM GENERATOR TUBE INSERVICE INSPECTION
(AS REQUIRED BY TECHNICAL SPECIFICATION SECTION 4.4.5.5.b)

RESULTS OF C-3 STEAM GENERATOR TUBE INSPECTIONS AND
RESULTS OF INVESTIGATIONS CONDUCTED TO DETERMINE
CAUSE OF TUBE DEGRADATION AND CORRECTIVE MEASURES
(AS REQUIRED BY TECHNICAL SPECIFICATION SECTION 4.4.5.5.c)

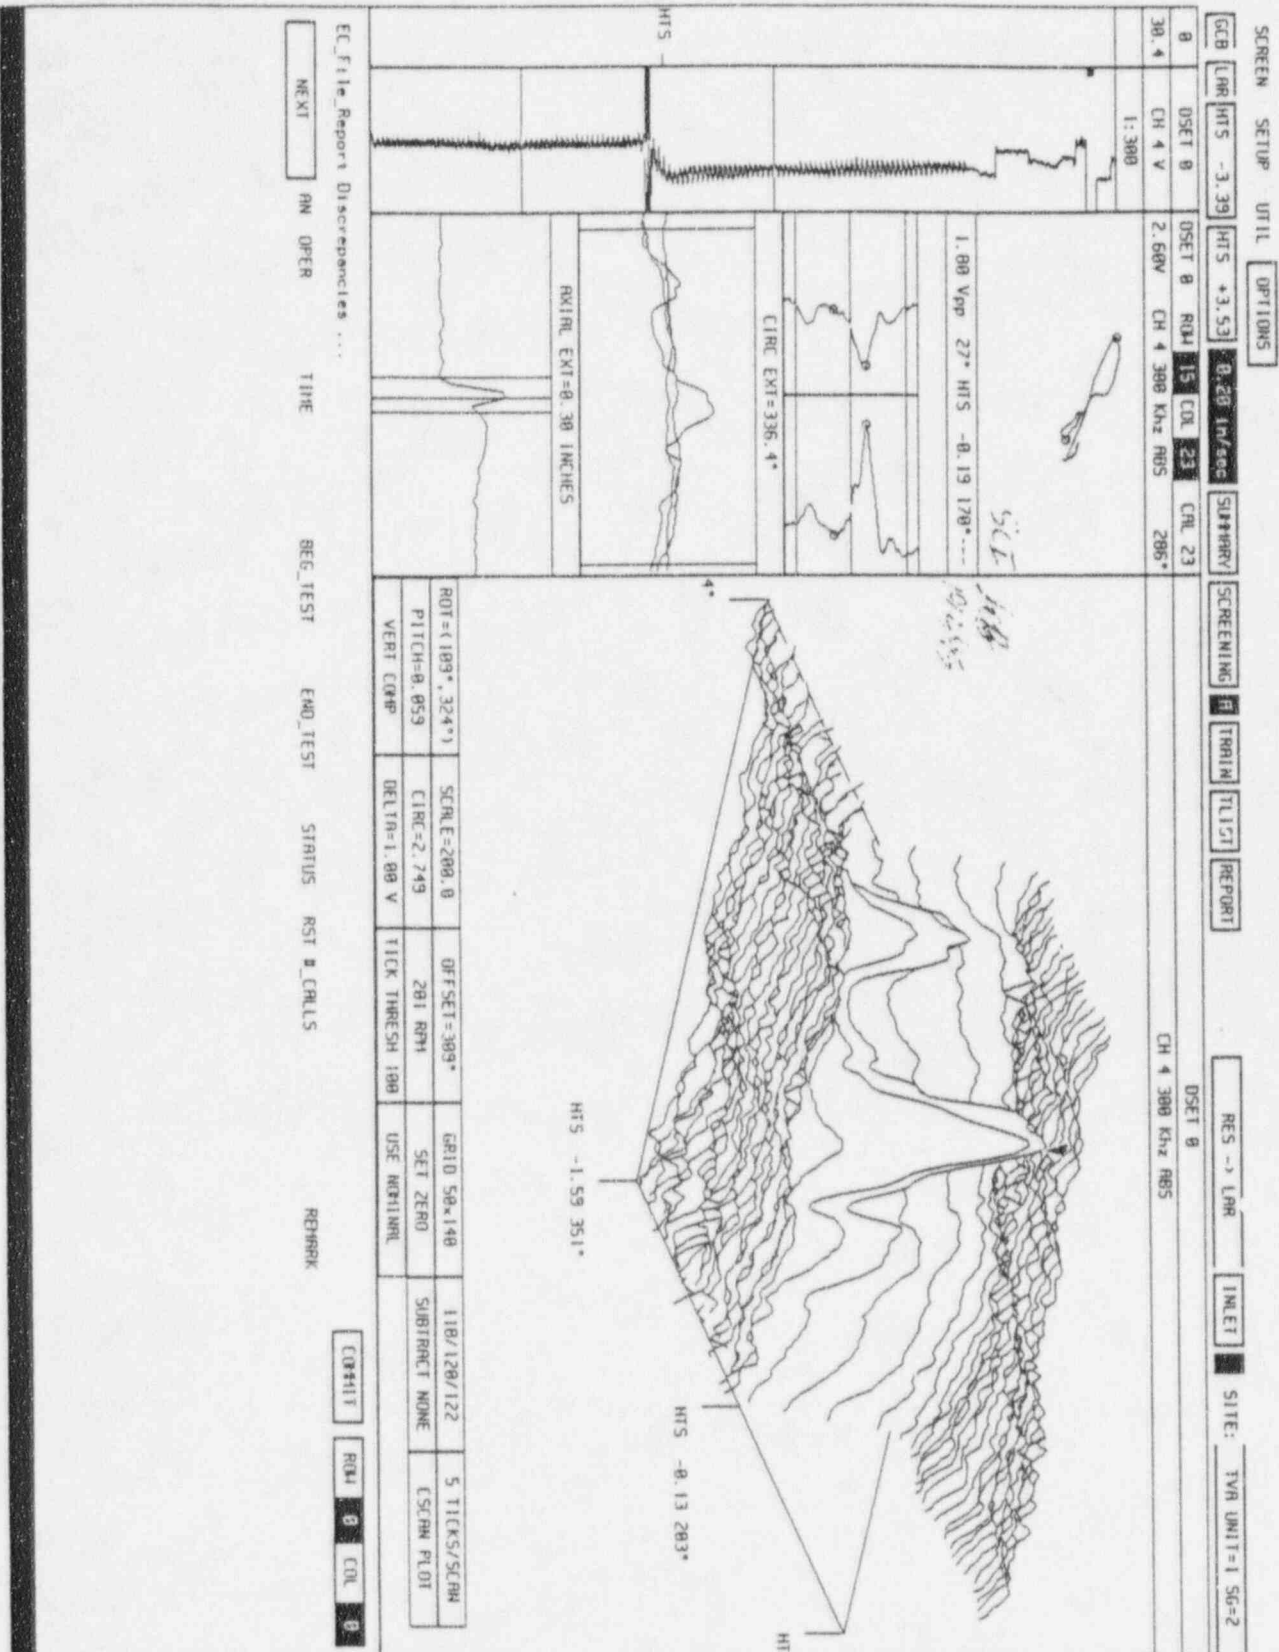
FIGURE 1
ROW 15 COL 23 SG 2

One tube (R15 C23) was pulled from Steam Generator 2 for a top of tubesheet inside diameter (ID) circumferential indication. The TTS region fractured during the tube pulling process. Field eddy current data (3 coil RPC) for the TTS region of R15 C23 determined an ID circumferential indication measuring 336° circumferential extent. The +Point probe measured the same location to have multiple circumferential indications with a total circumferential involvement of 316°. Figure 3 is the crack profile by blind NDE (3 coil RPC) verses actual destructive examination results. NDE results show good correlation with metallurgical Scanning Electron Microscopy (SEM) results.

SEM fractography was performed on the fracture face of tube R15 C23. The ID origin corrosion averaged 26% throughwall around the circumference with a maximum depth of 88%. The corrosion was comprised of 5 separate macrocracks. SEM examinations showed no nearby, separately nucleated, corrosion cracks parallel to the fracture face on the tube ID surface. Depth profiling of the indication is presented in Table 4. This simple corrosion morphology is typical of primary water stress corrosion cracking. There were no markings on the tube OD to identify the TTS relative to the fracture face and significant tube elongation prevented a precise dimensional analysis of the pre-pull fracture face elevation.

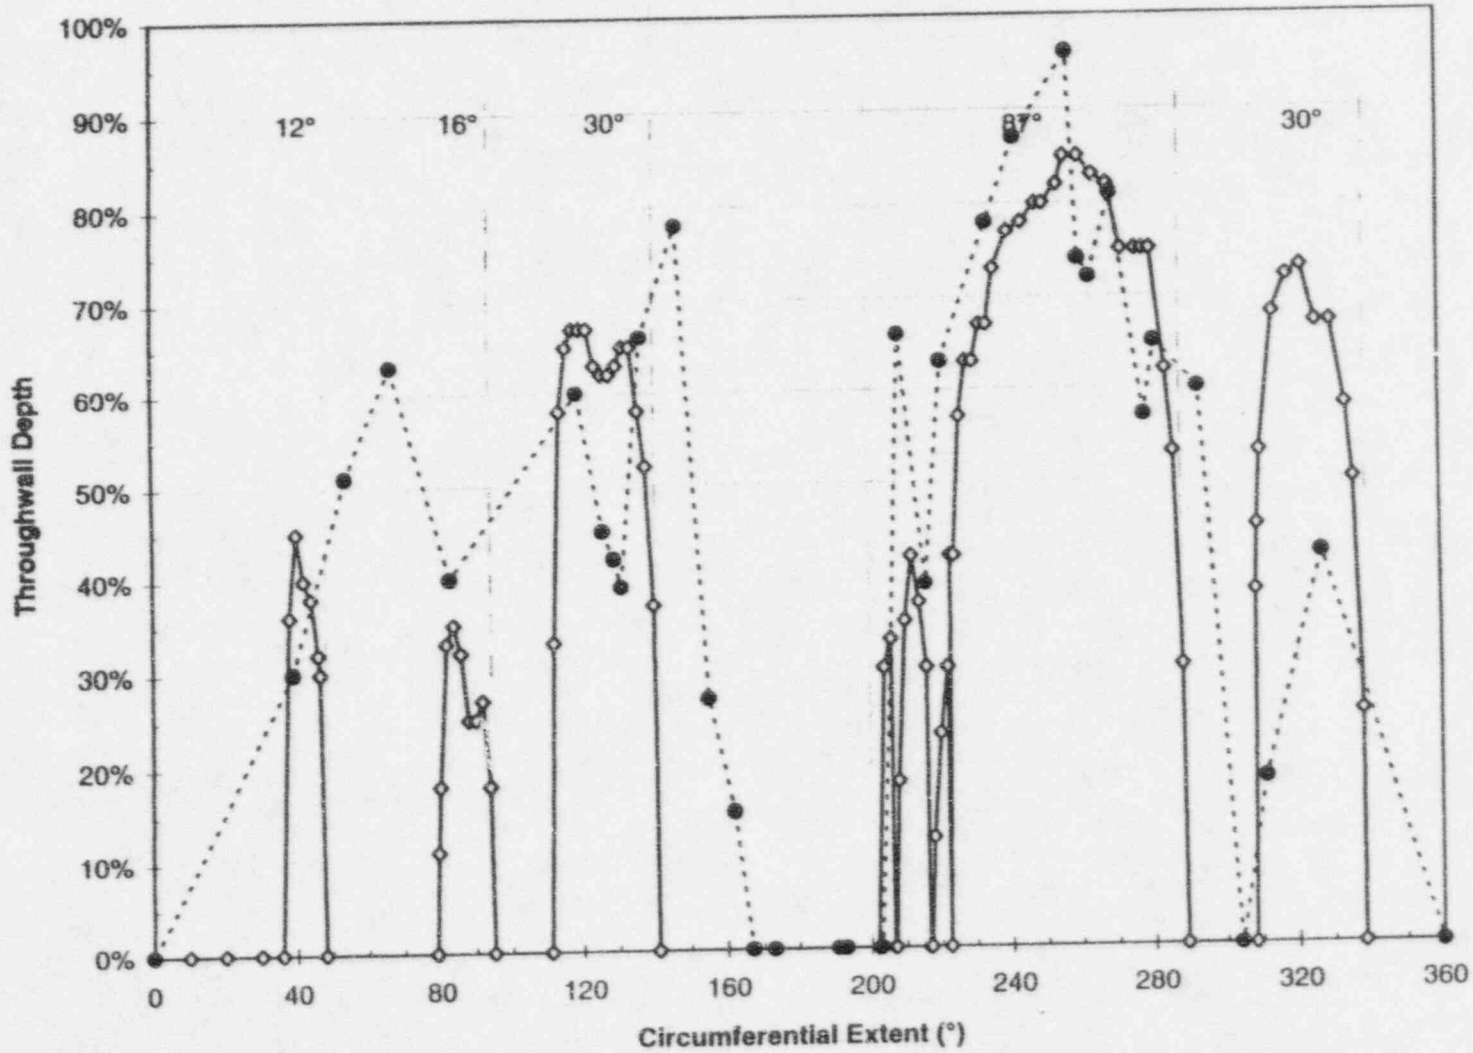
FIGURE 3
ROW 15 COL 23 SG 2

Sequoyah R15C23; Circumferential Crack ,TTS
(As-Read by Analyst)

Average Depth:
Destructive Exam
Crack Lgth: 53.2%
360° : 25.9%
RPC
Crack Lgth: 45.1%
360° : 40.6%
Total Crack Angle:
Destr. Exam 175°
RPC 324°

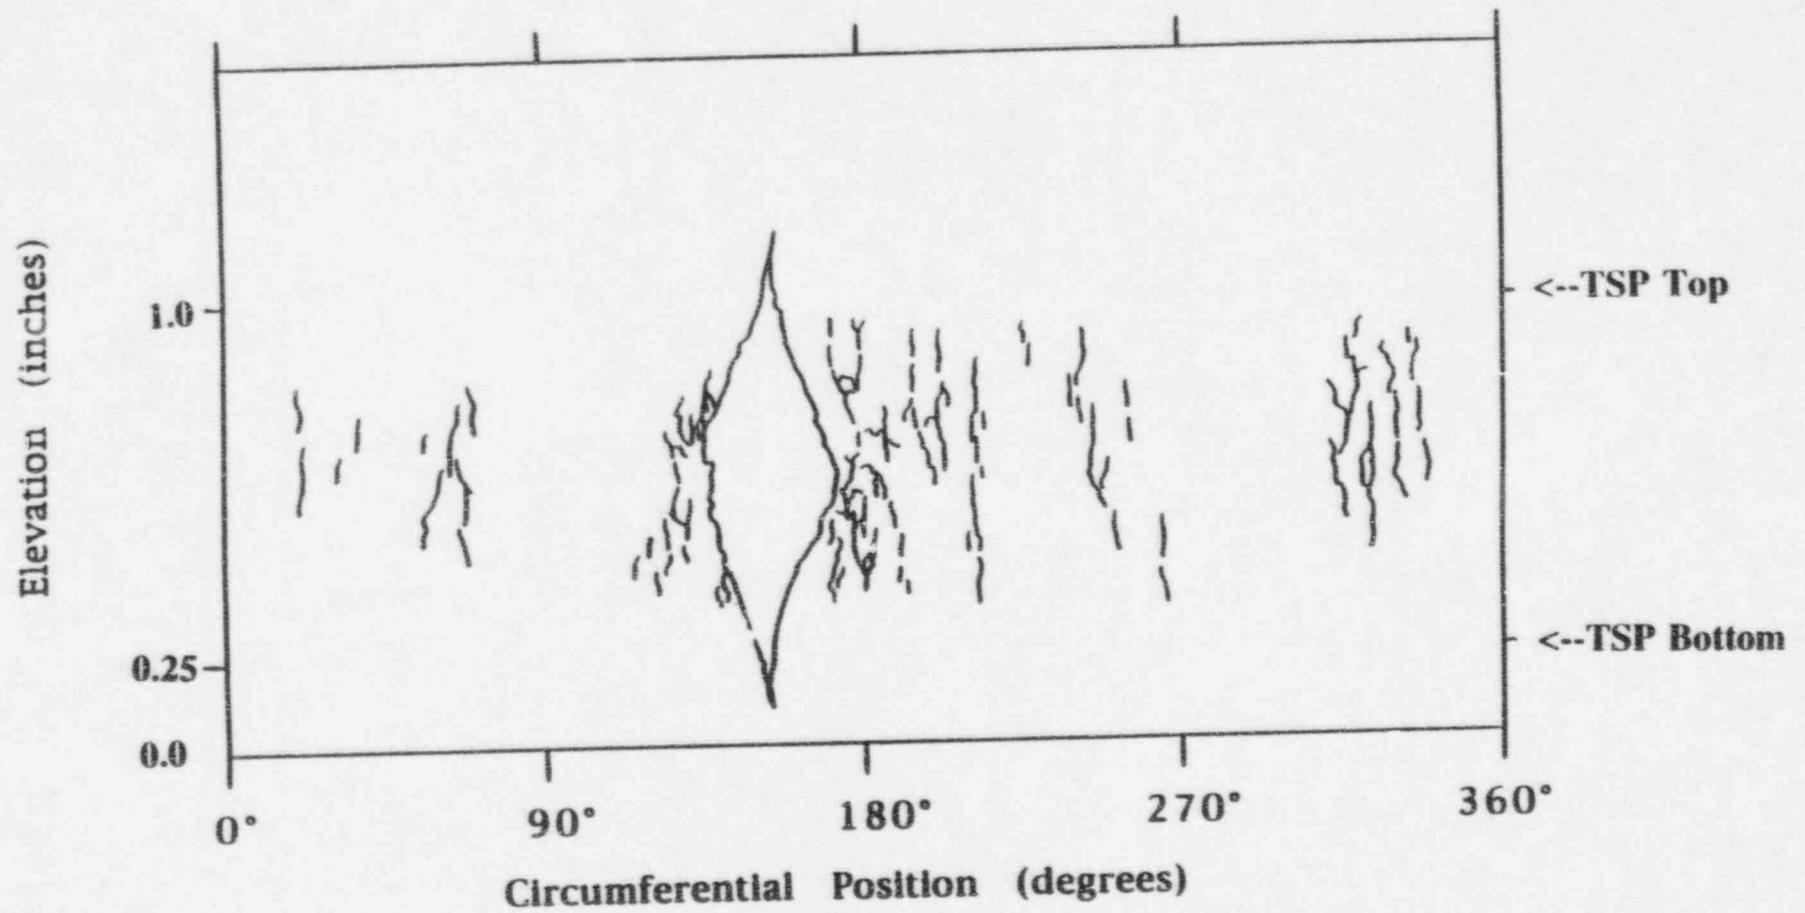
Figure 3-1 Sketch of the OD surface crack distribution found at the first tube support plate (TSP) of Tube R9C55. Also shown is the location of the burst fracture opening. The burst opening extended beyond the TSP crevice region, but the corrosion cracking was confined to the crevice region.

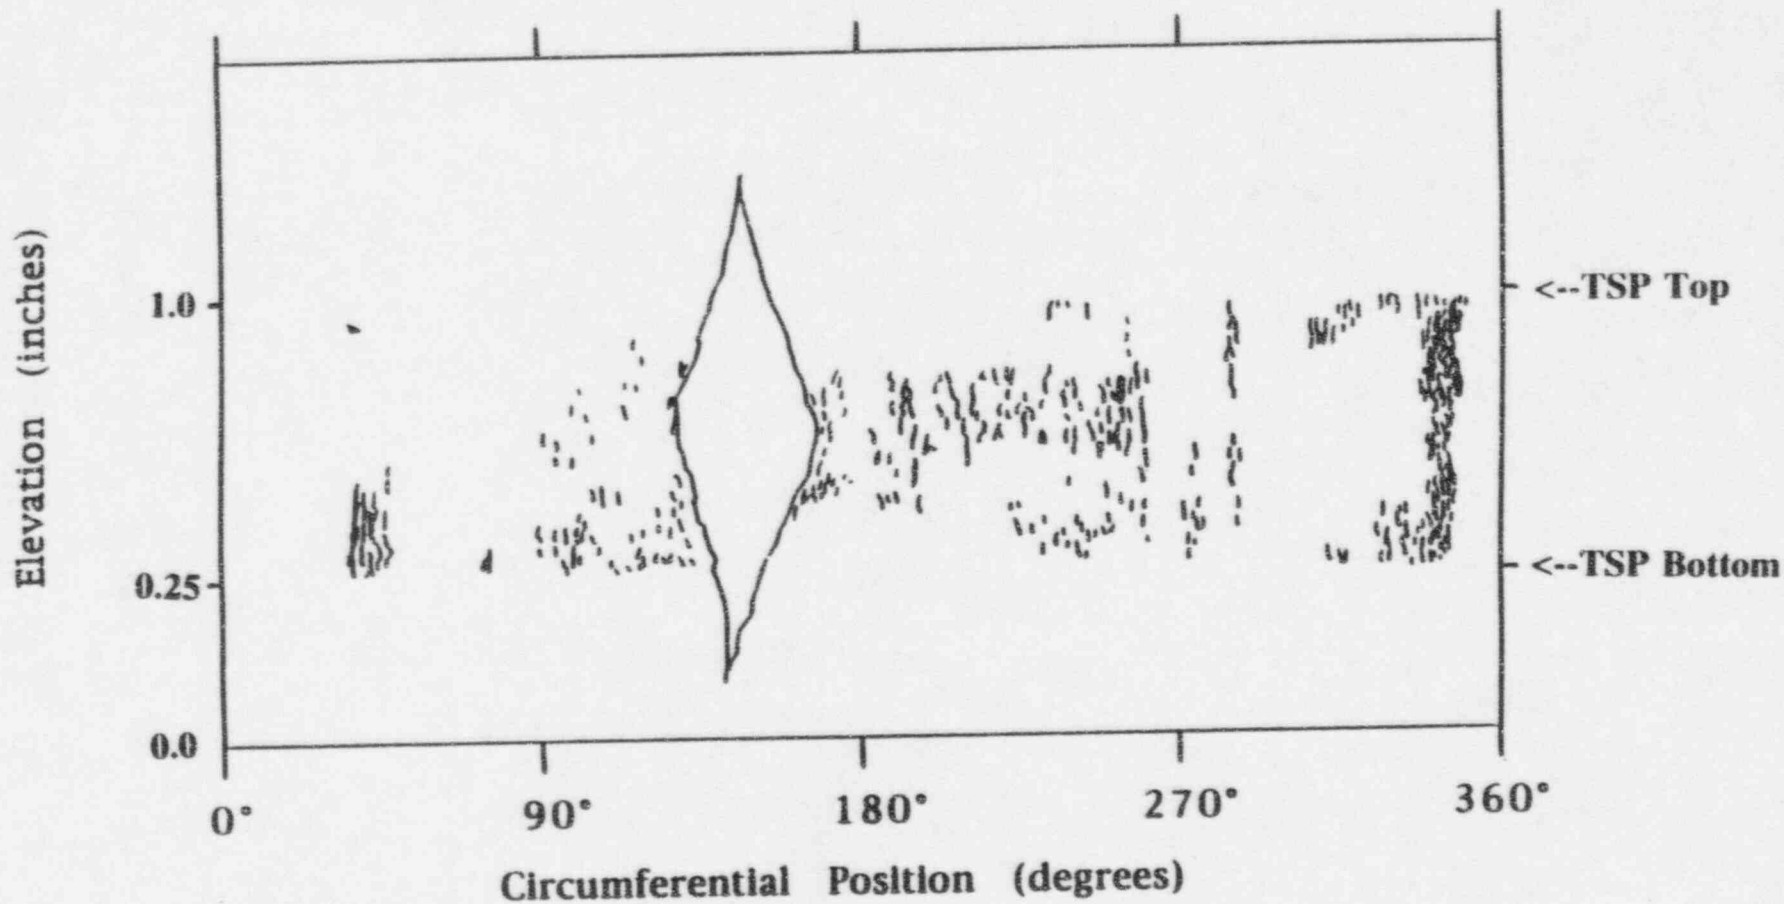
Figure 3-2

Sketch of the OD surface crack distribution found at the second tube support plate (TSP2) of Tube R9C55. Also shown is the location of the burst fracture opening. The burst opening extended beyond the TSP crevice region, but the corrosion cracking was confined to the crevice region.

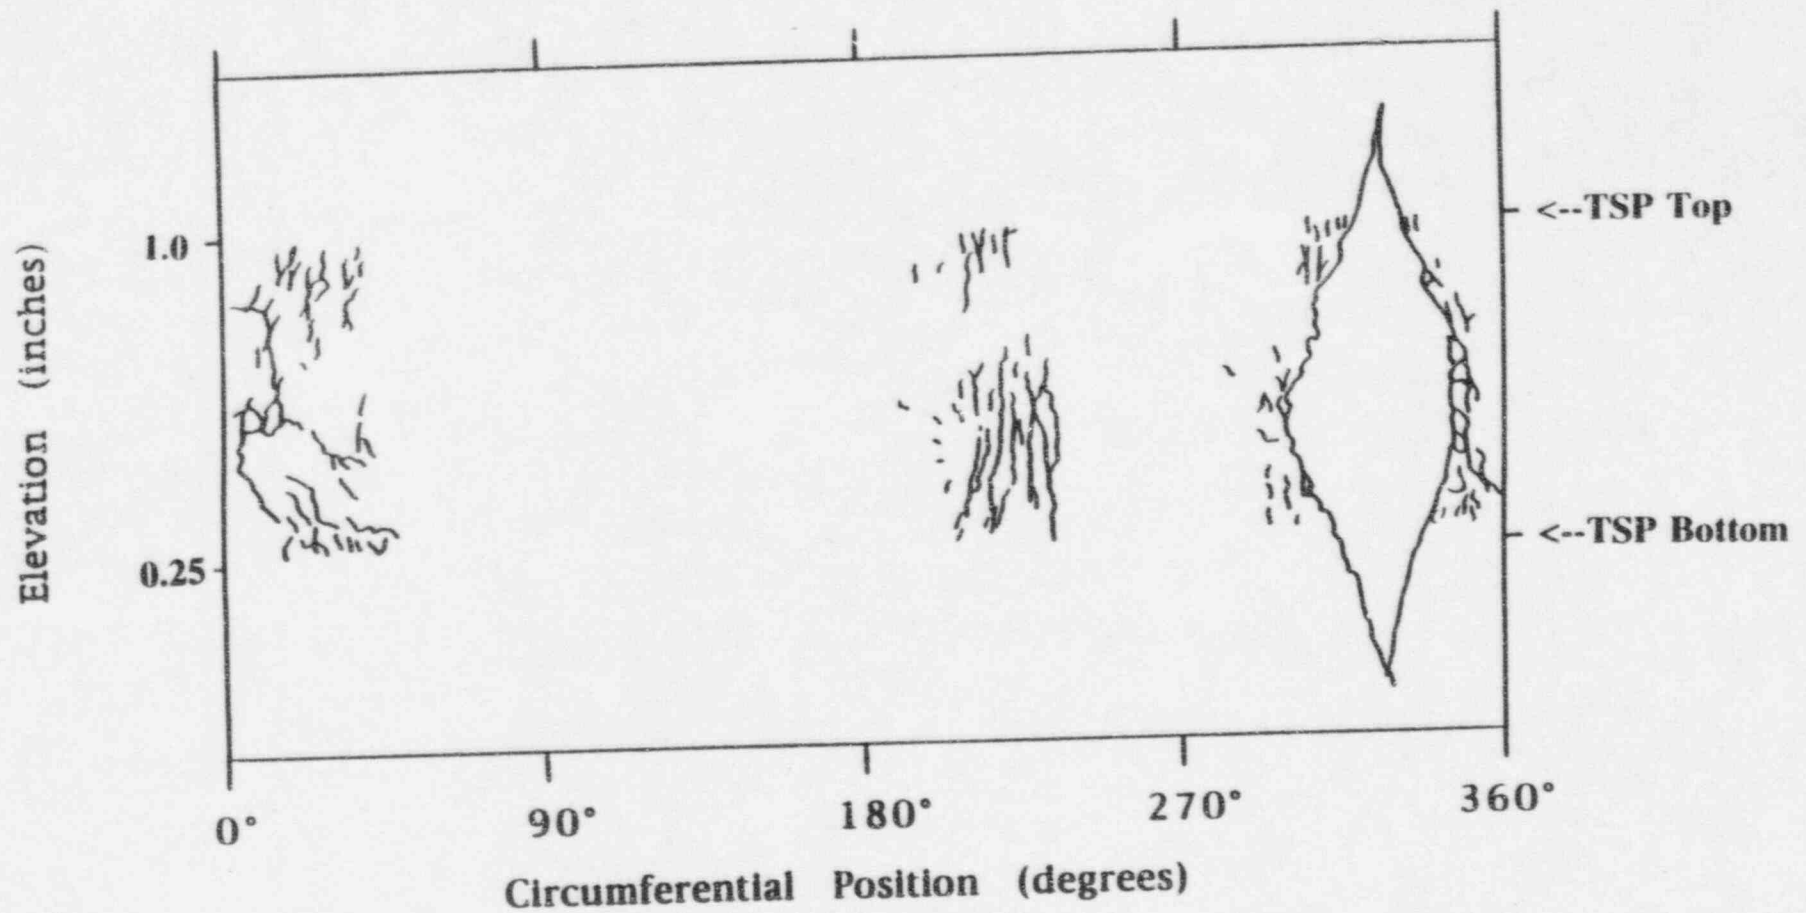
Figure 3-3 Sketch of the OD surface crack distribution found at the first tube support plate (TSP1) of Tube R11C51. Also shown is the location of the burst fracture opening. The burst opening extended beyond the TSP crevice region, but the corrosion cracking was confined to the crevice region.

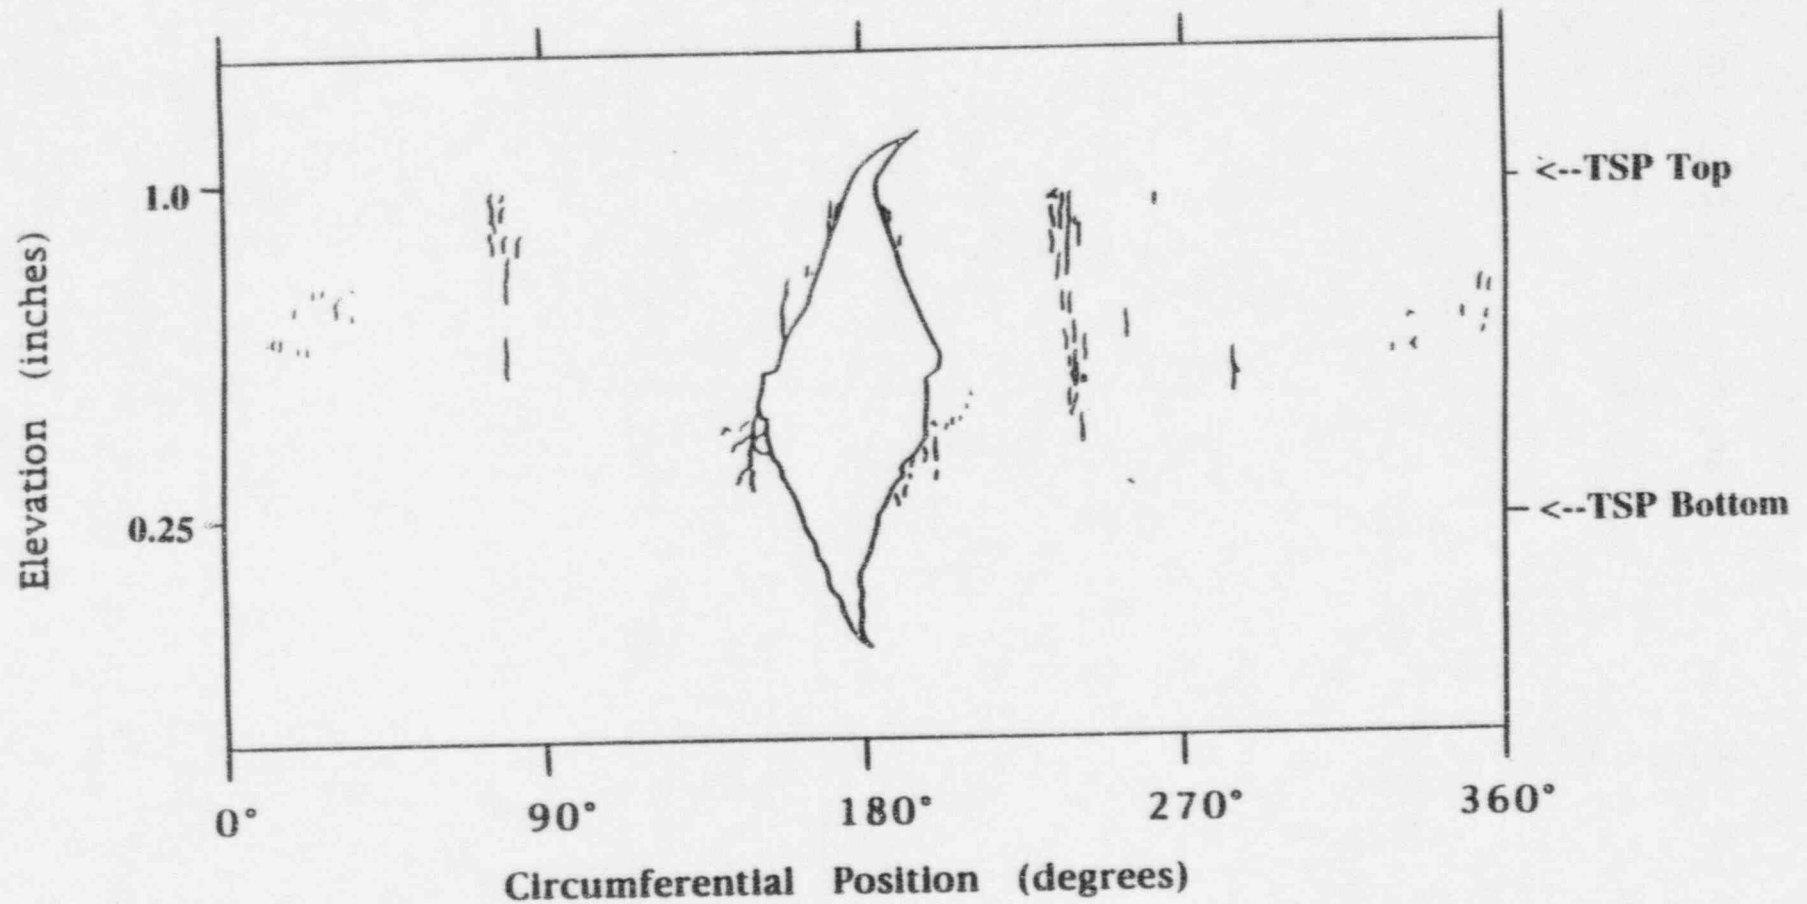
Figure 3-4 Sketch of the OD surface crack distribution found at the second tube support plate (TSP2) of Tube R11C61. Also shown is the location of the burst fracture opening. The burst opening extended beyond the TSP crevice region, but the corrosion cracking was confined to the crevice region.

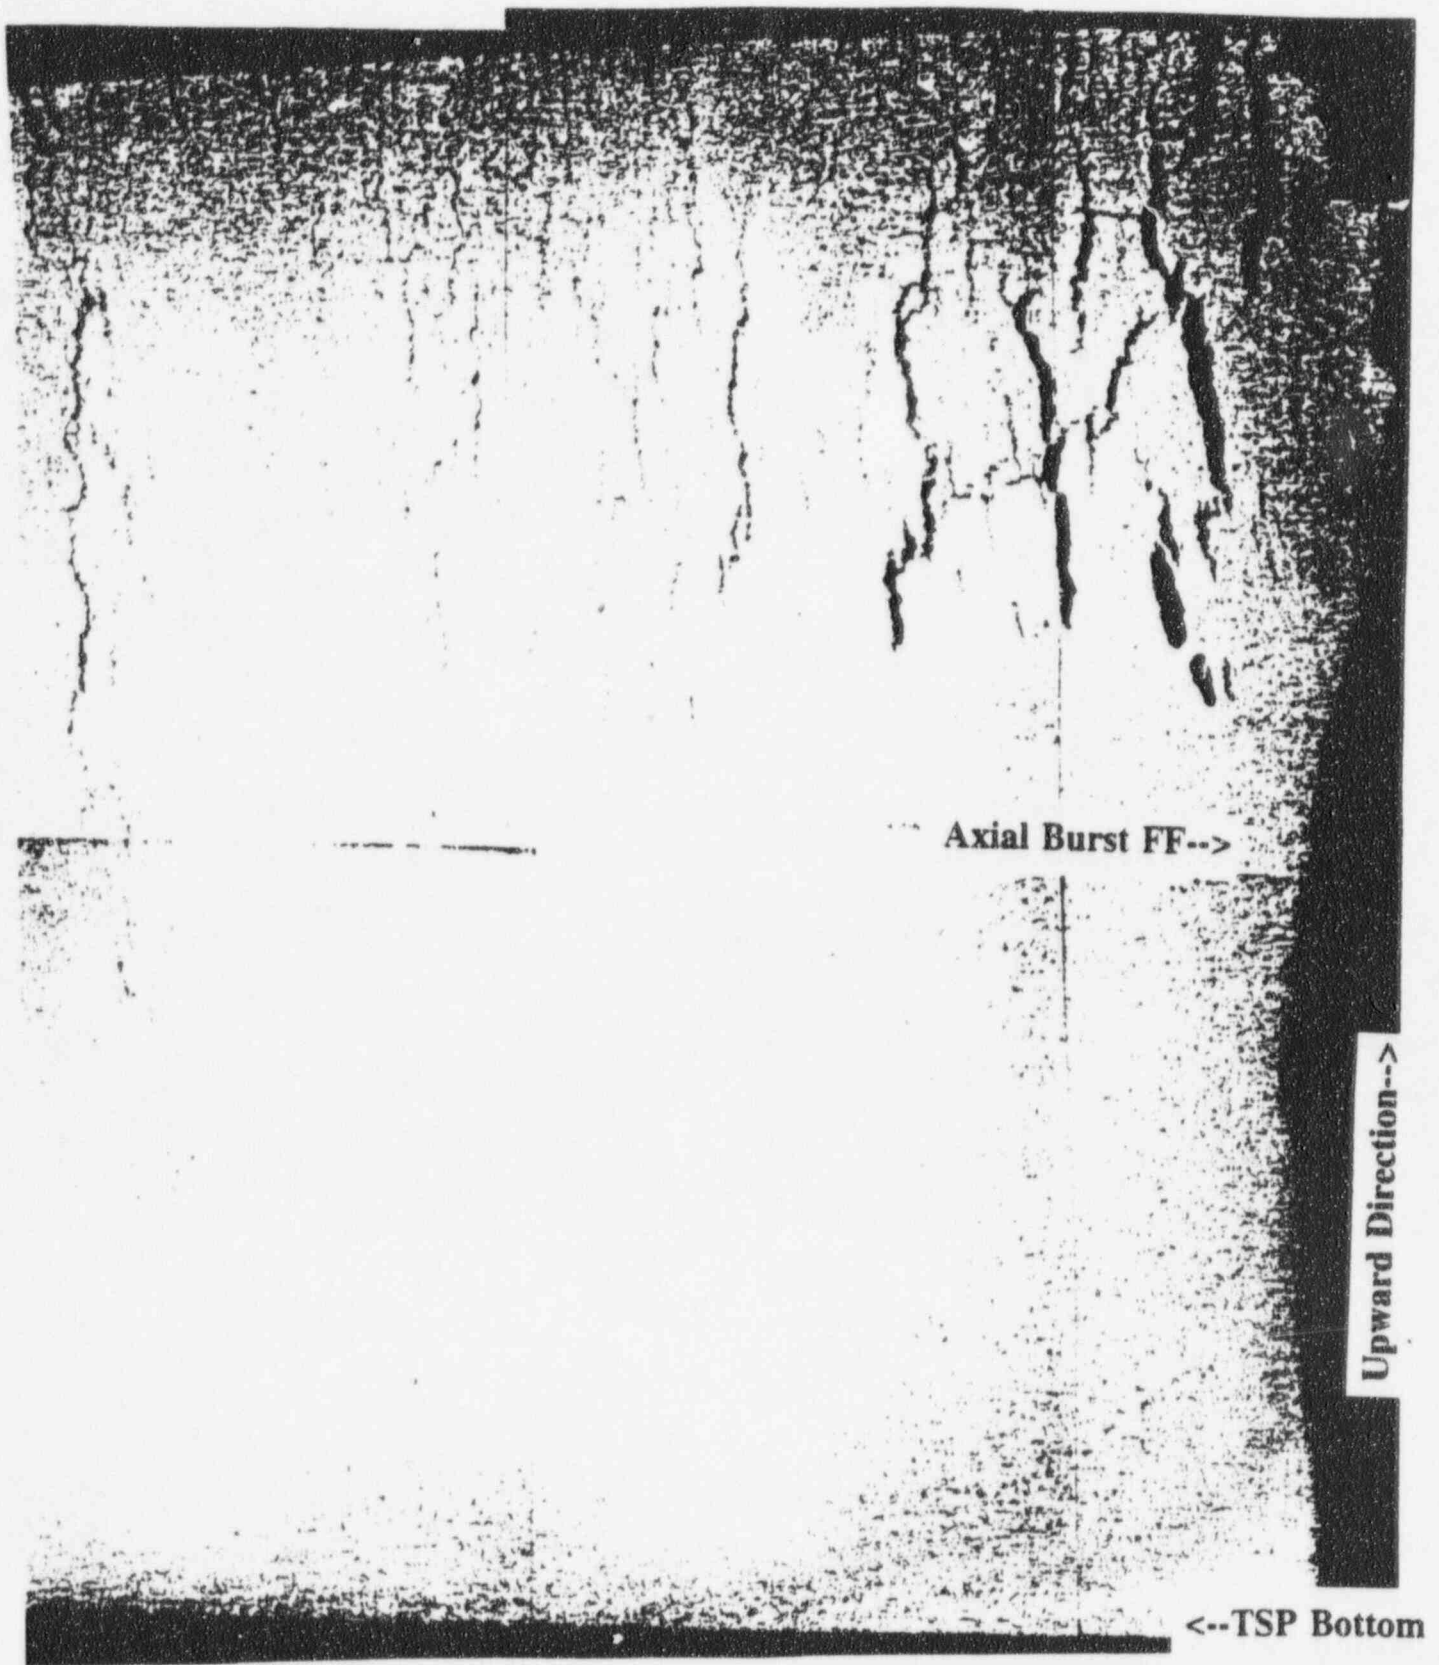
Figure 3-5 OD radial metallography showing intergranular cellular corrosion (ICC) present along with the more dominant axial intergranular stress corrosion cracking (IGSCC) at the first tube support plate (TSP1) of Tube R9C55. 16X Mag. 10% depth

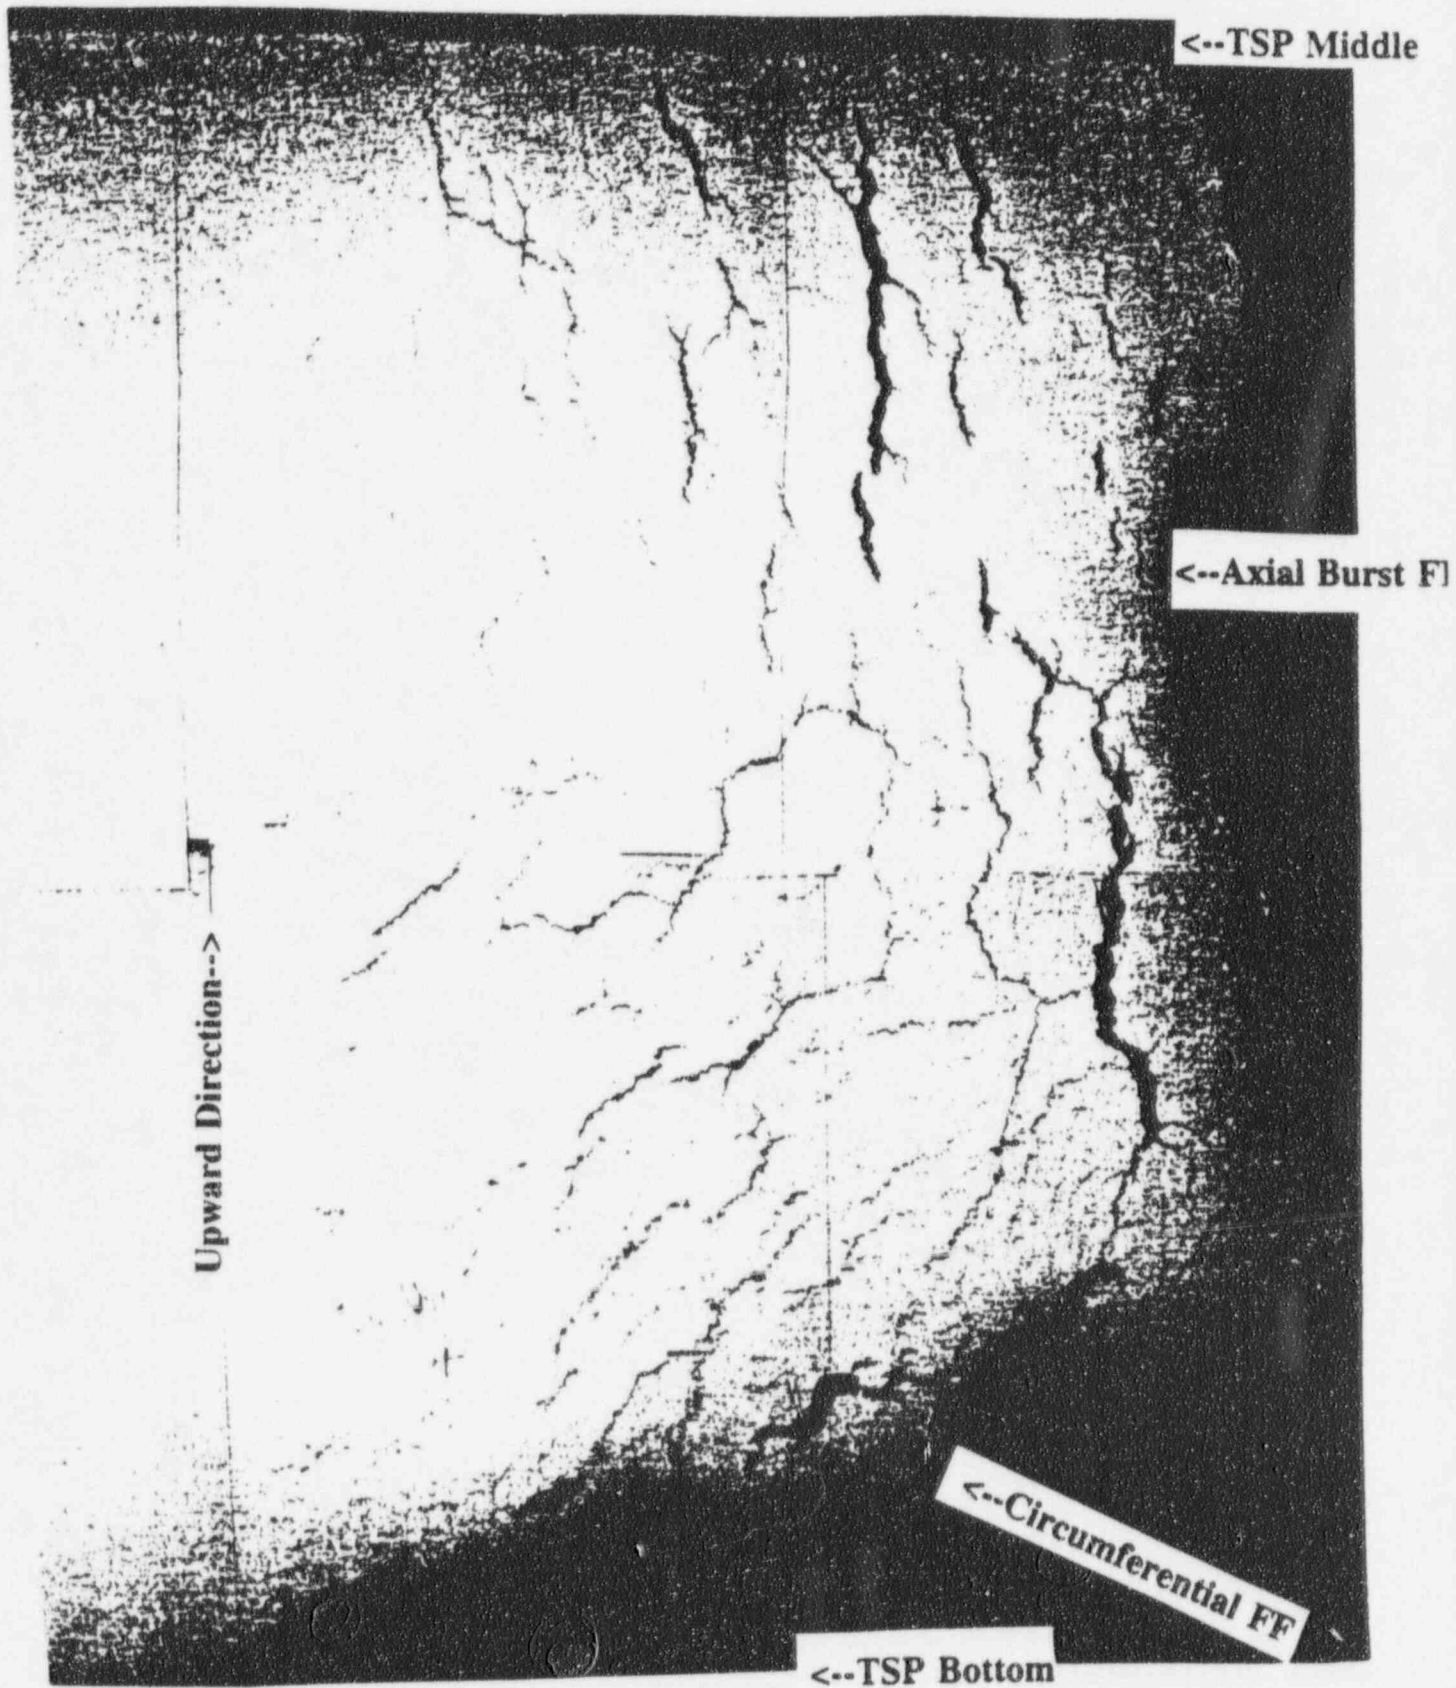
Figure 3-6 OD radial metallography showing intergranular cellular corrosion (ICC) present along with the more dominant axial intergranular stress corrosion cracking (IGSCC) in the middle of the first tube support plate (TSP1) of Tube R11C61 and along with the more dominant circumferential cracking near the bottom of the TSP crevice region. 16X Mag. 10% depth

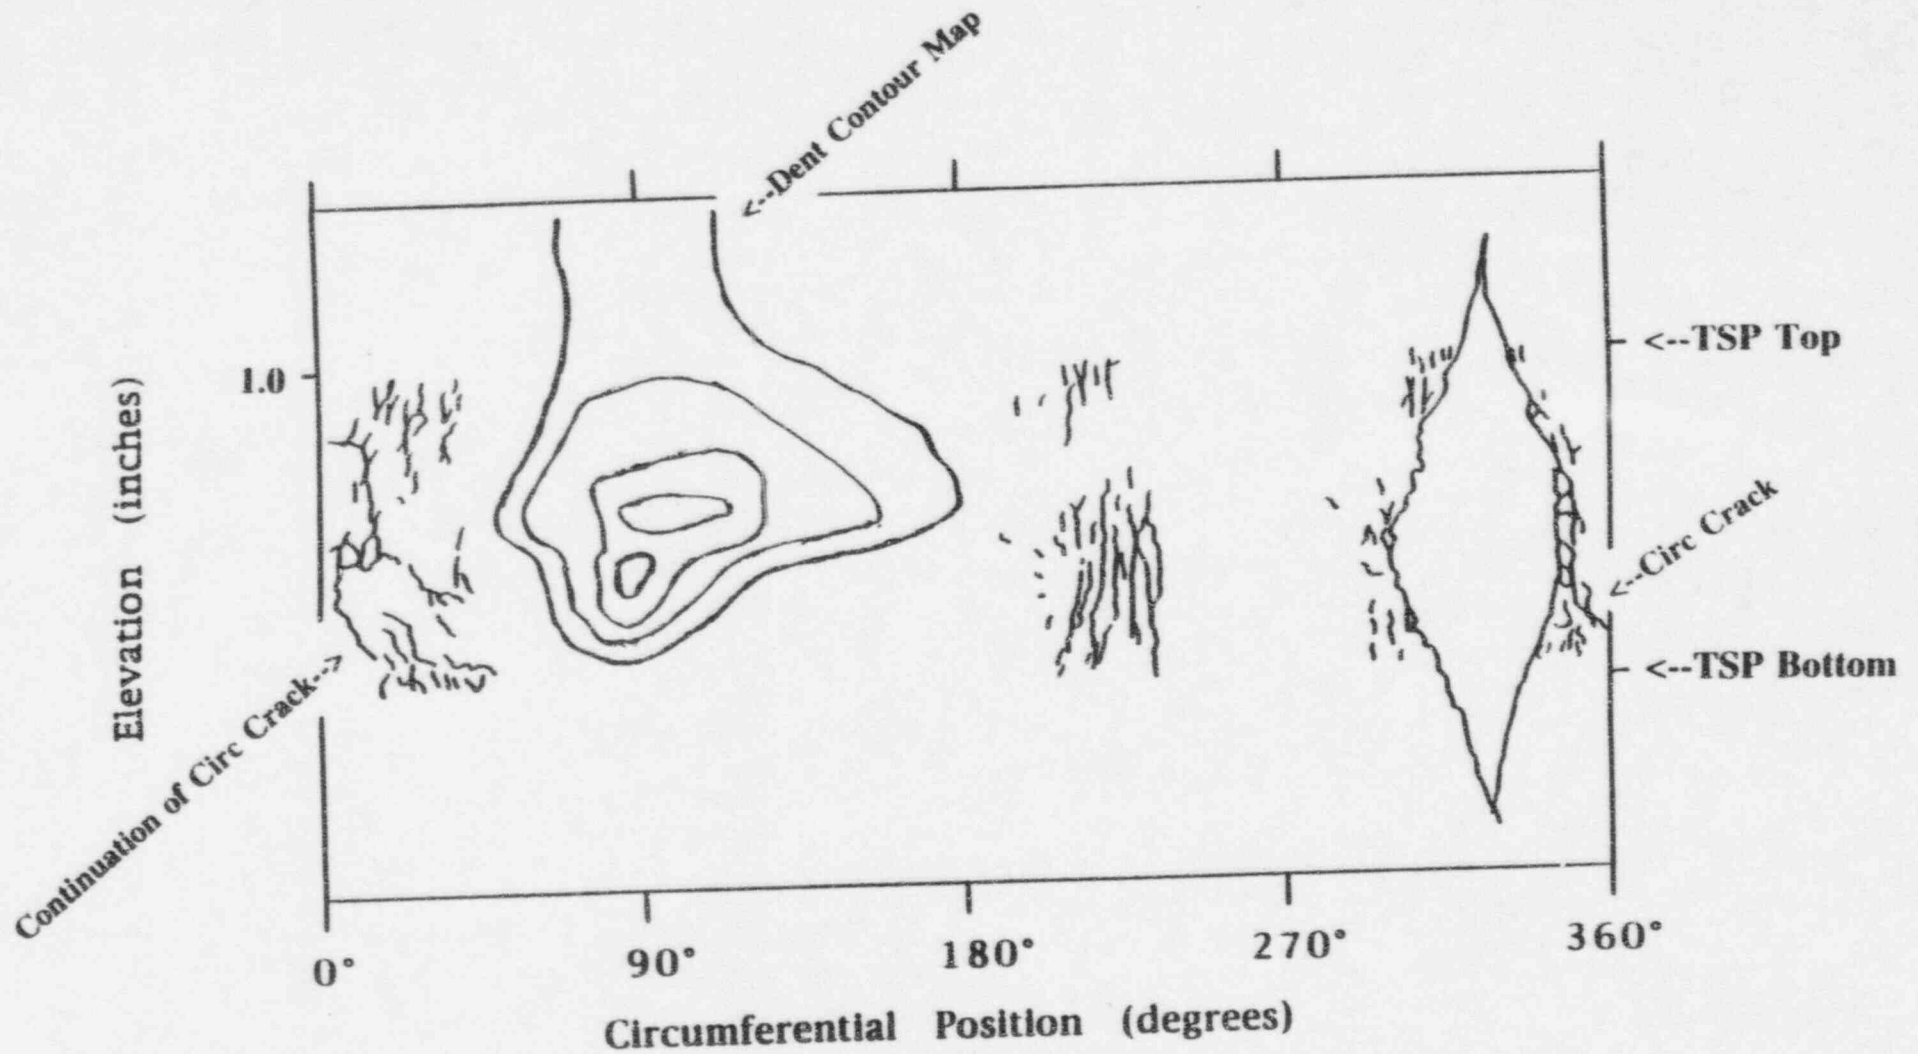
Figure 3-7 Sketch of the OD surface crack distribution found at the first tube support plate (TSP1) of Tube R11C61. Also shown is a contour map of the dent showing its location relative to the observed corrosion.

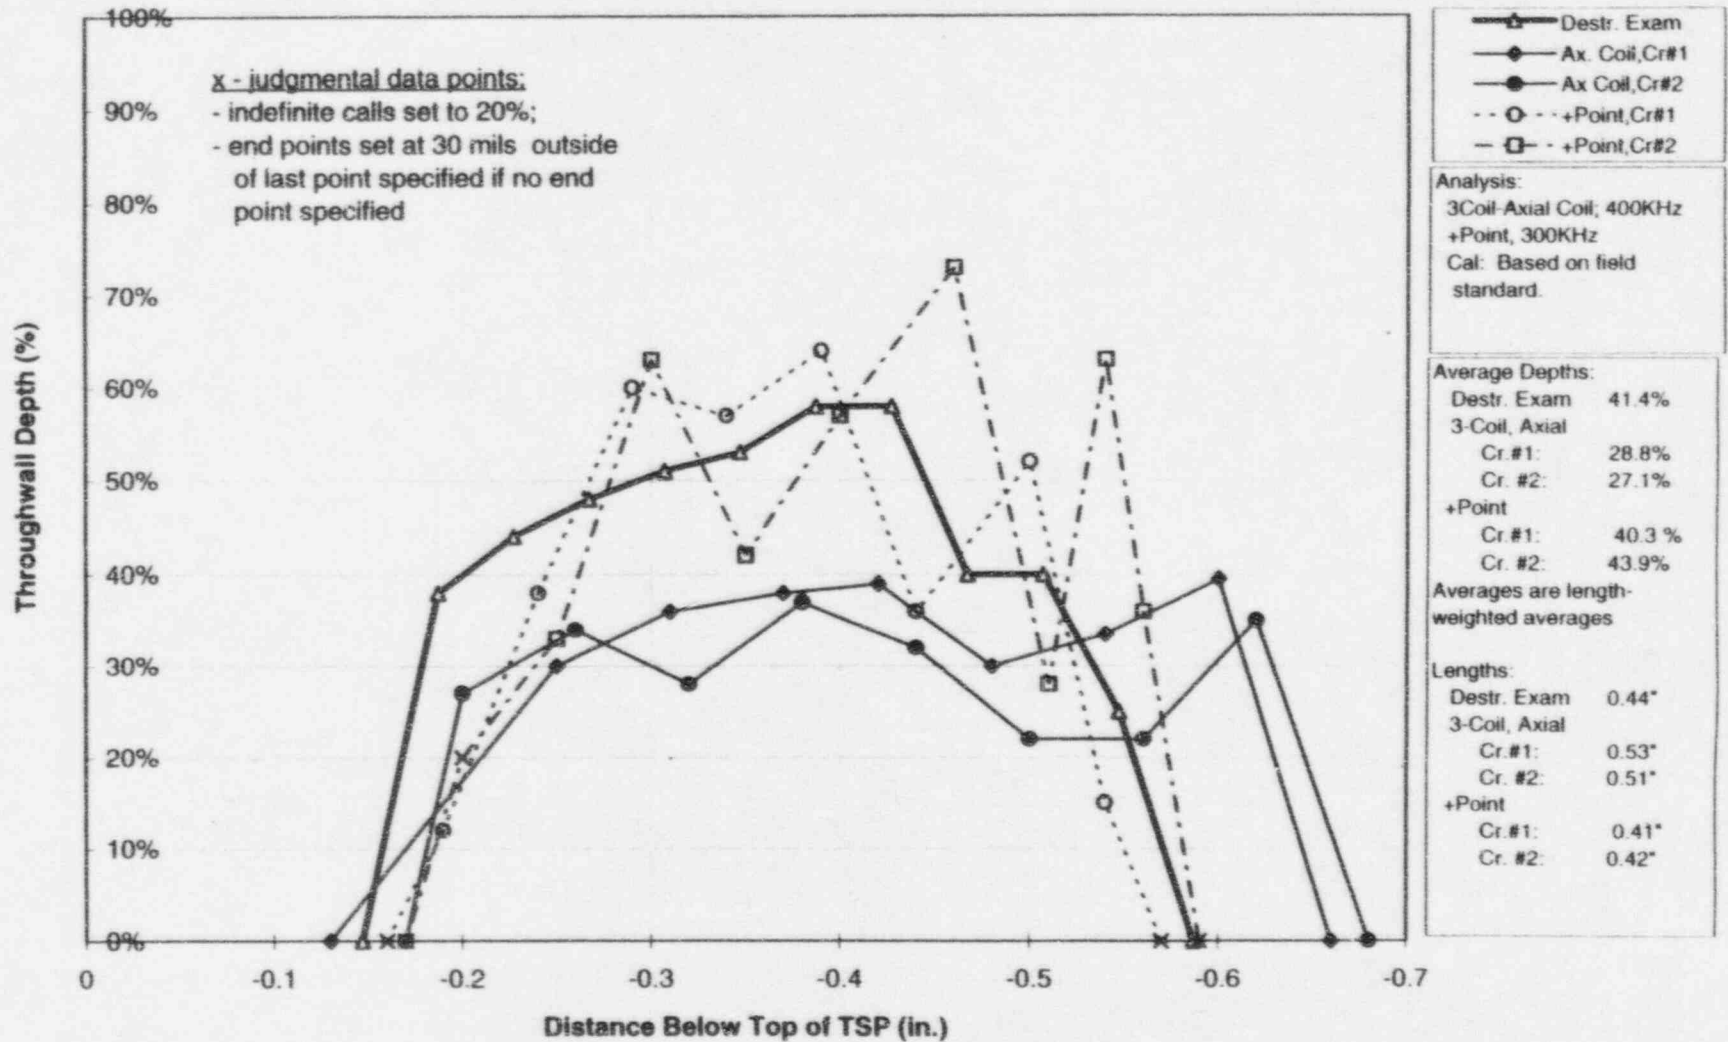
Figure 3-8
Sequoyah R9C55, TSP 1; Axial ODSCC Cracks

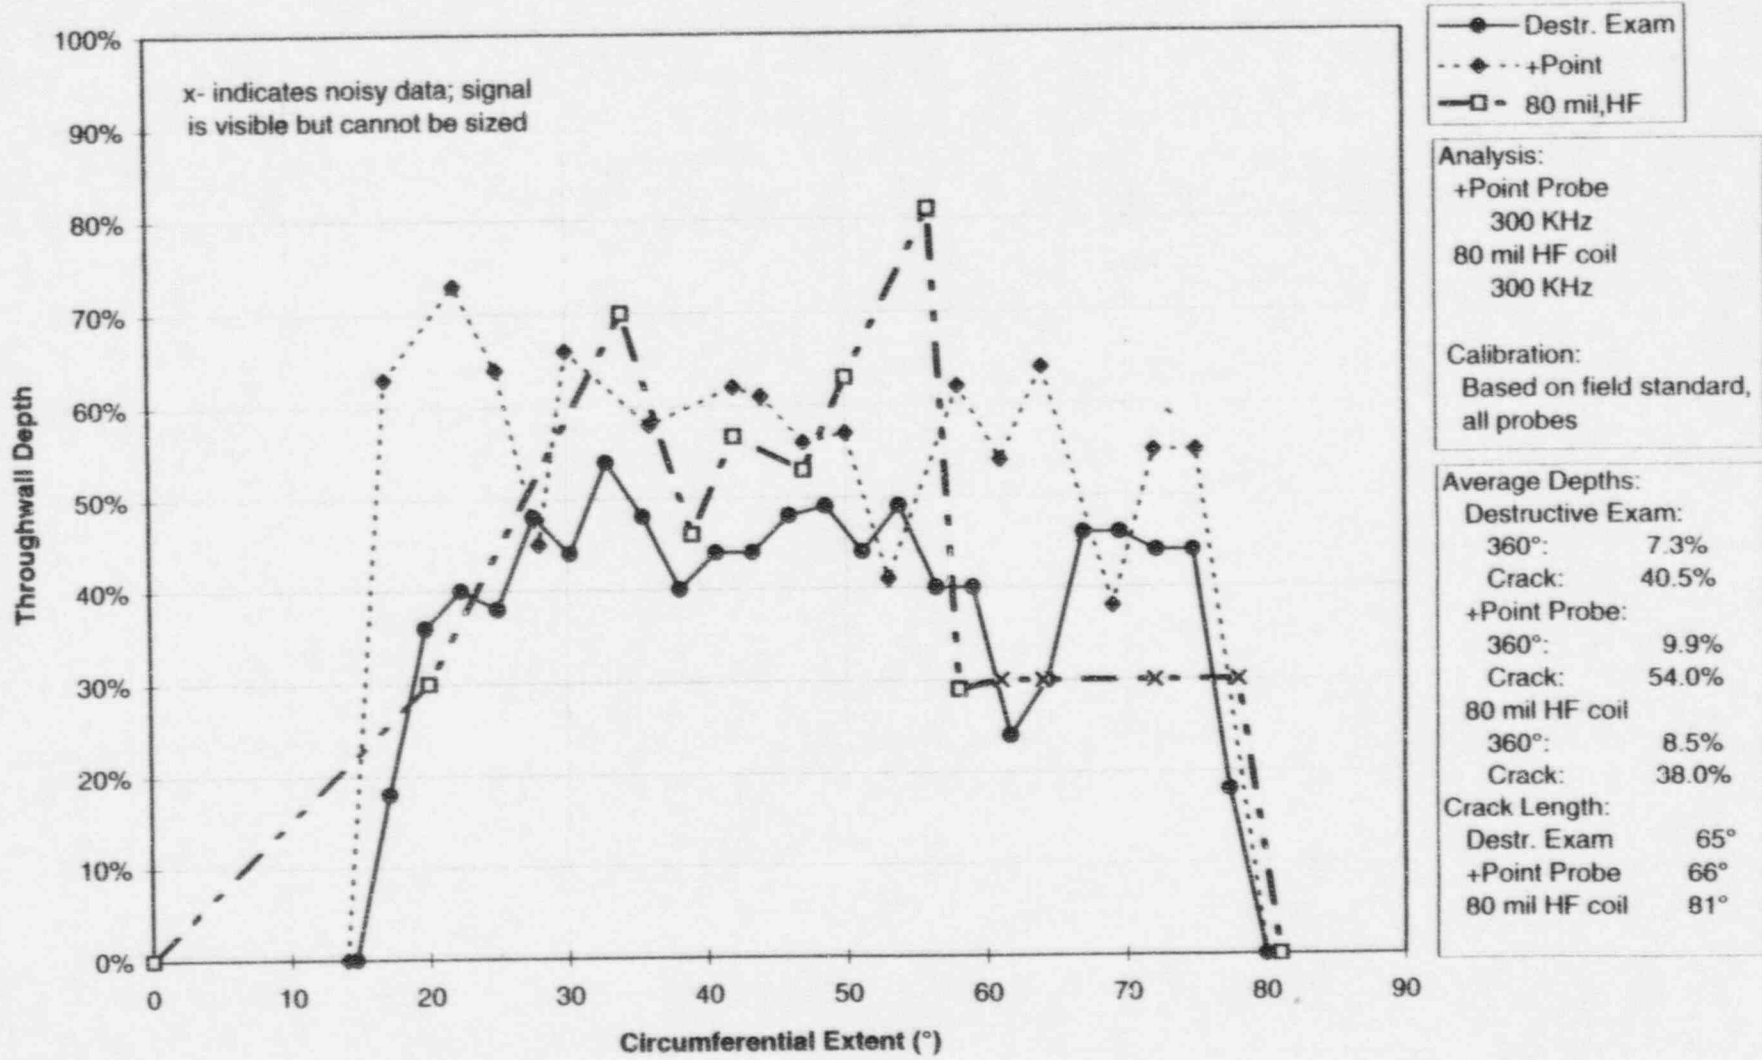
Figure 3-9
Sequoyah R11C61 - 1H; Circumferential Crack Profile Evaluation
