SUBJECT: SUPPORTING DOCUMENTS FOR THE CATAWBA LOSS OF OFFSITE POWER
 EVENT (FEBRUARY 6 - 8, 1996)

CATAWBA NUCLEAR STATION
LOSS OF OFFSITE POWER EVENT
FEBRUARY 6 - 8, 1996

COOLDOWN CURVES

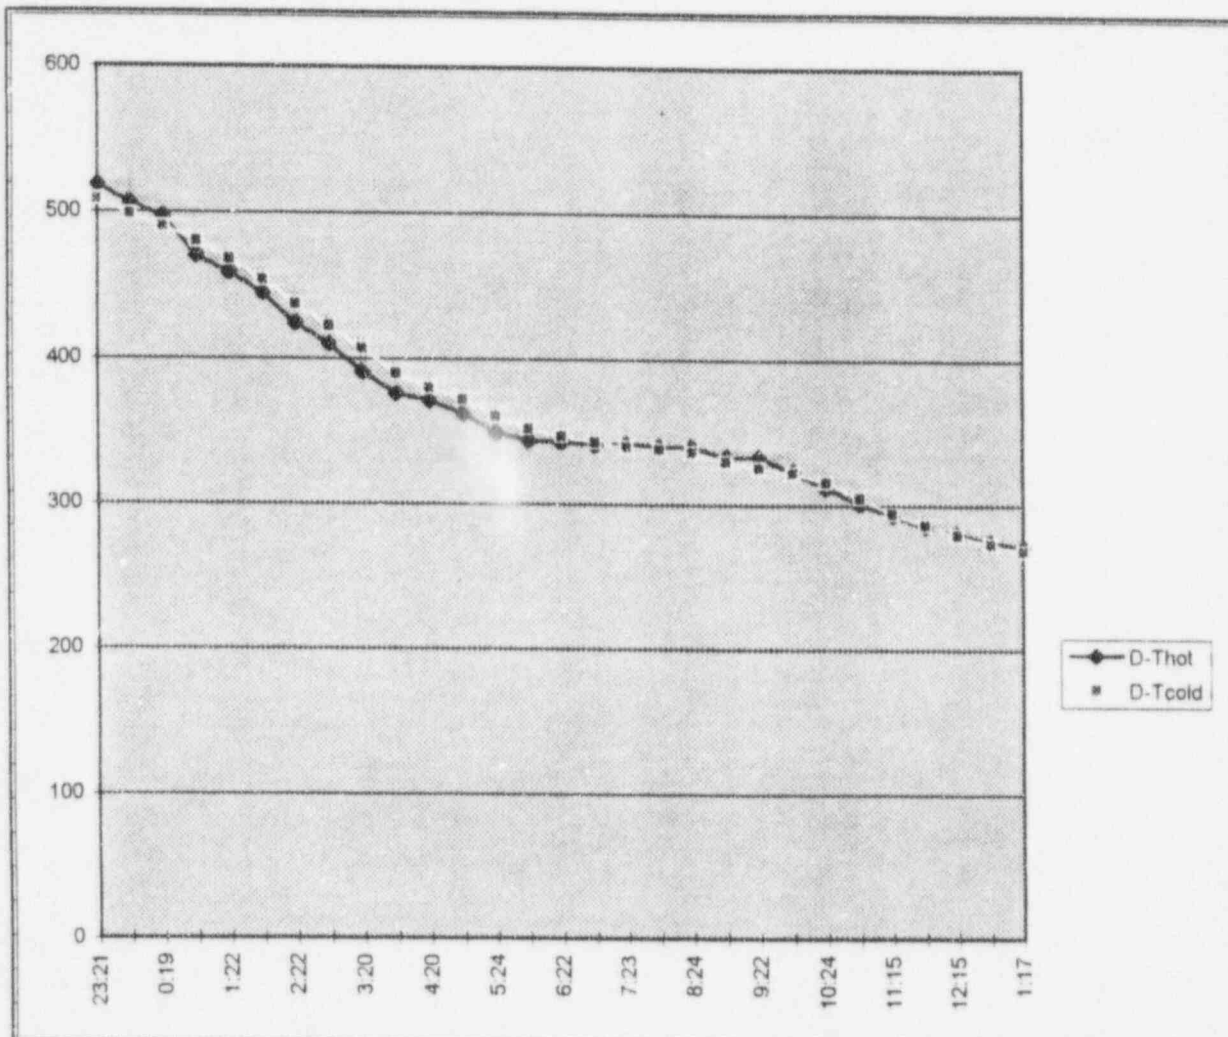
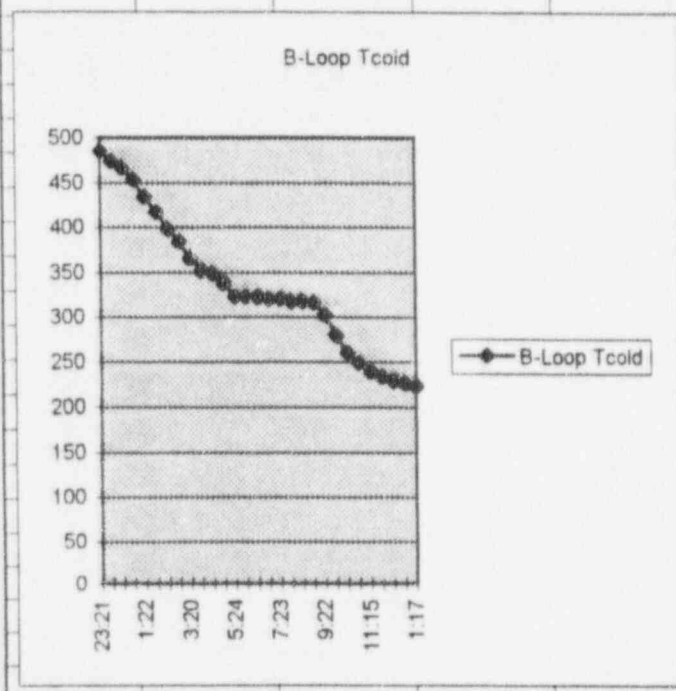
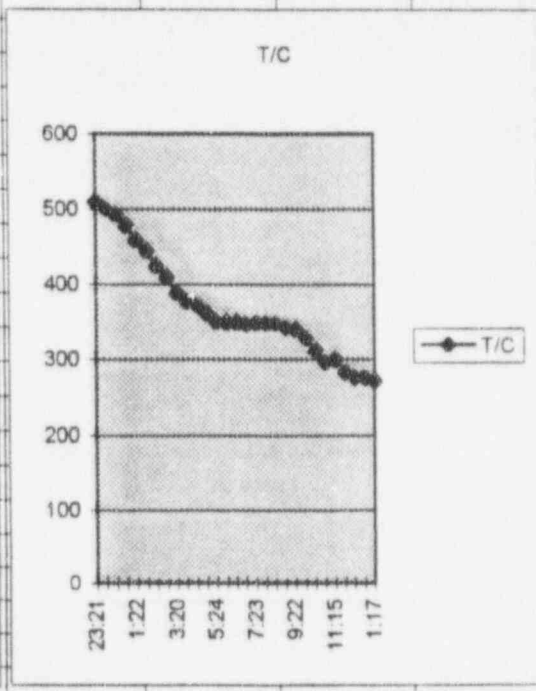
- 2212 2D Loop concern is PORV still not available, so could potentially see voiding in that SG if pressure drops too low. Licensee has established an $\approx 50^{\circ}\text{F/hr}$ cooldown rate.

0445 Unit 2 entered Mode 4. Cooldown rate decreased to $\approx 20^{\circ}\text{F/hr}$ to maintain RCS T-hot temperature in the range of $300\text{-}350^{\circ}\text{F}$ while performing surveillances on LTOP.
