PHILADELPHIA ELECTRIC COMPANY

September 17, 1984

SUBJECT: Peach Bottom Atomic Power Station
Fire Protection Modifications Progress Report

Revised to Account for Proposed Alternative Shutdown System
(This Report Supersedes the May, 1984, Report)

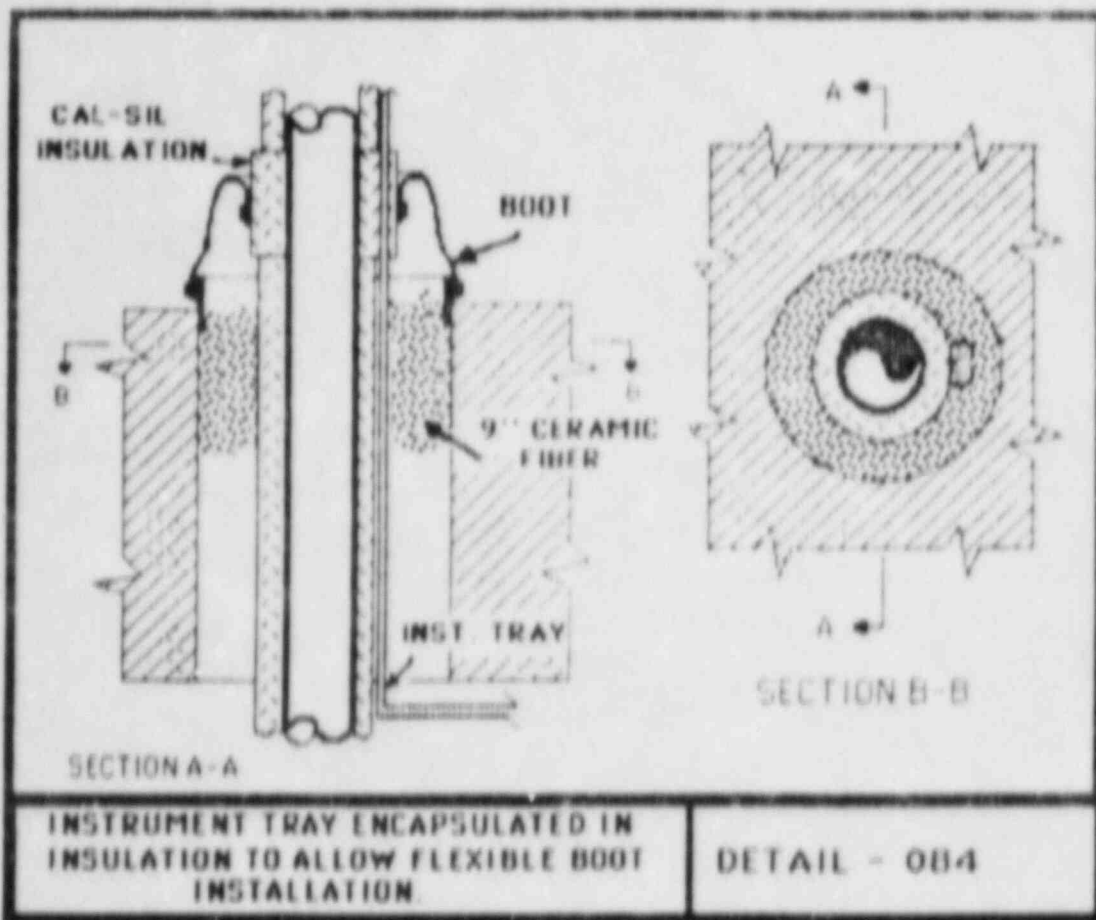
PSD # 024

Location: Units 2 & 3 North & South Isolation Valve rooms Elevation
135'-0" floor penetrations (Rooms 203, 204, 248 and 249).
Condition prior to Upgrade:

all penetrations are sleeves containing a large insulated
pipe and an instrument tray penetrating the barrier. On
the 'A' side (isolation valve room) the instrument tray
Description of Upgraded Penetration Seal: (Pg. 2)

The perimeter of the pipe insulation was built
up to encapsulate the instrument tray so that
the sealing ring area is tight without voids. This
is considered an acceptable seal since both sides
of the barrier are non hazardous with negligible com-
bustible loading (0.00 hrs both sides).

runs parallel and close to the pipe. On the 'B' side (torus room) close to the barrier, the instrument tray turns and runs perpendicular to the pipe preventing the installation of a flexible boot on this side.

On the 'A' side the instrument tray is encapsulated
in calcium-silicate insulation at the barrier to
allow the installation of a flexible boot on this side.
Justification: (Pg. 2)

and 9" of ceramic fiber within the barrier. The 'B' side remains open. See detail 084.

1. AT FLOOR VERIFY
 - a) INSTRUMENT TRAY IS ENCAPSULATED IN CAL-SILICATE ABOVE THE FLEXIBLE BOOT SEALING RING ON THE PIPE SO THAT NO VOIDS ARE AROUND THE SEALING SURFACE
 - b) SEE APPLICABLE BOOT DETAIL FOR INSPECTION CRITERIA
 - c) IF ONLY KADWOOL (WHITE CERAMIC FIBER) OR NELSON FLAME STOP PUTTY (ORANGE) IS INSIDE THE PENETRATION OPENING AND A BOOT IS NOT IN PLACE, CHECK THE CONST. DIVISION TEMPORARY SEAL LOG BOOK TO VERIFY CONTROL
2. ON THE SIDE OPPOSITE THE BOOT (LABELED DETAIL 084 IN THE COMPUTER PRINTOUT), VERIFY THE KADWOOL IS INTACT BY A VISUAL SEARCH FOR LOOSE KADWOOL PERTRUDING FROM THE PENETRATION OR OTHER EVIDENCE THAT MAY INDICATE THE UNPACKING OF THE FIBER IN THE PENETRATION
3. PENETRATION SEAL USE
 - a) 3-HOUR FIRE SEAL

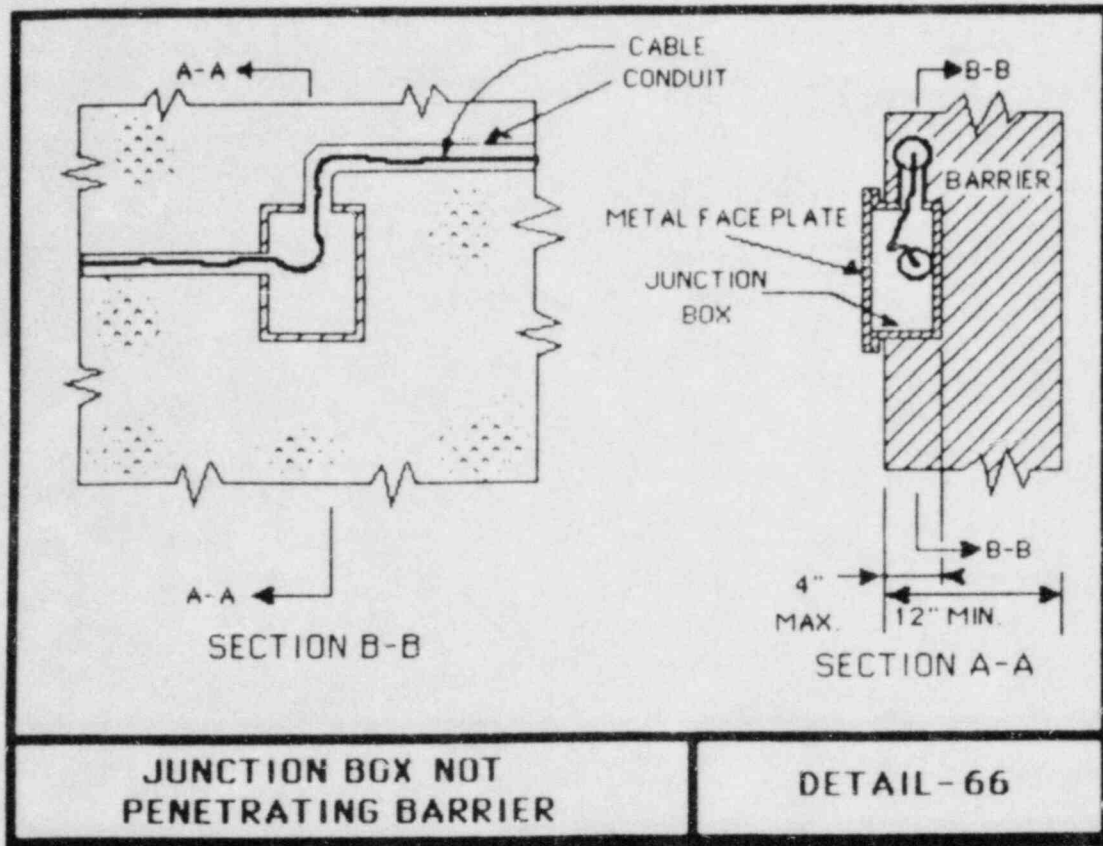
PSD # 066

These items are junction boxes embedded in the wall containing conduits with or without cables. The junction boxes are embedded, but do not penetrate the wall.

The conduits do not penetrate the barrier within a 5 foot radius of the barrier entry point, since the cabling (a combustible source) is in a conduit which

The junction boxes are hermetically sealed. The conduits are also embedded in the barrier, and do not exit the fire barrier on the opposite side within a 5 foot radius of the point at which it enters the barrier.

is embedded in concrete, it is not directly subjected to an open flame. Additionally, the chances that flaming material would be propagated through the barrier via a conduit during the application of a hose stream is considered negligible since the junction boxes are hermetically sealed which would prohibit the introduction of combustible materials internal to the junction boxes.

No seal upgrade was required. See detail 066.

1. VERIFY THAT THE SIDE OF THE BARRIER OPPOSITE THE SIDE DESIGNATED "DETAIL-66" ON THE COMPUTER SCHEDULE CONTAINS NO UNACCOUNTED FOR CONDUIT WITHIN A 5 FOOT RADIUS OPPOSITE THE JUNCTION BOX.
2. VERIFY THAT THE JUNCTION BOX COVER IS SECURELY FASTENED IN PLACE

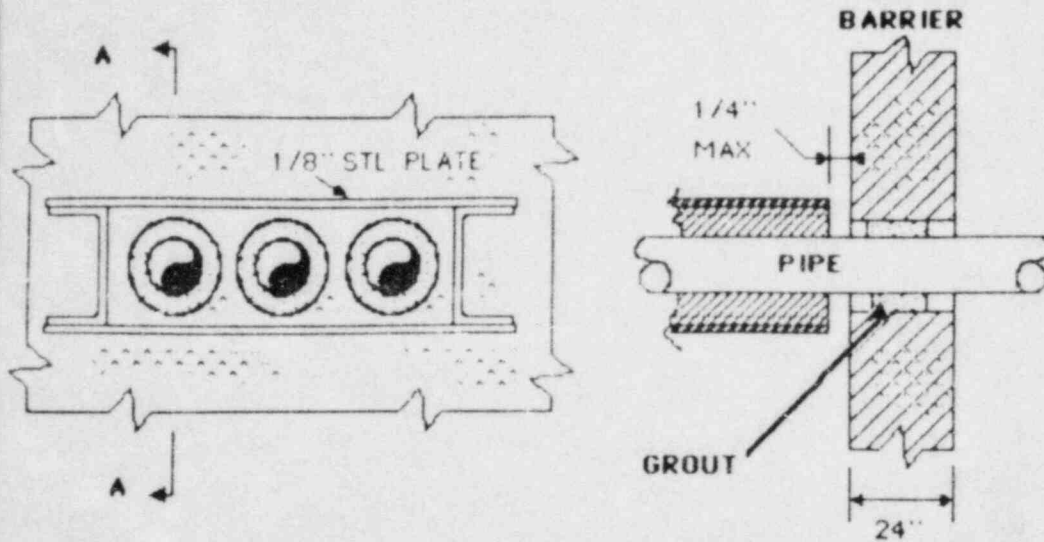
DETAIL - 69

Because of the trays welded construction and the amount of time and effort which would be required to make the penetration available for sealing, an engineering evaluation was conducted. This review found the beginning of the pipe run (ESW booster pump bay north wall) and the last pipe pene- (P82.)

tration (E4 emergency diesel generator bay south wall) to be sealed in grout and in good condition. Additionally, portions of core bores in intermediate barriers were visible above the shrouding. These also were found to be sealed with grout.

Each diesel generator bay is separated by a 24 inch concrete barrier. The annular space around the penetrations of interest appear to be sealed full depth with grout. The steel plating tray or shroud surrounding these pipes, though not hermetically sealed, it is of such construction as to allow a minimal amount of flaming material to reach the barrier. Their location - high in the overhead - also makes the possibility of flaming material transport through the barrier remote. Additionally, passage of flaming material through the barrier at these penetrations when subjected to a hose stream is not considered probable since no direct hose stream path to the penetration exist. Although each diesel generator bay has a combustible loading of 0.63 hrs (38 minutes), for the reasons listed above, the existing seals are considered adequate. In addition, obviously each diesel generator is protected by a total flooding CO₂ system.

SHROUDED CARBOX LINES
(NON-HERMETICALLY SEALED)

1. VERIFY PLATES (TOP AND BOTTOM) ARE INTACT AT BARRIER.
2. VERIFY SOUNDNESS OF GROUT AT BARRIER AS BEST AS POSSIBLE. REJECTION FOR LARGE / DEEP VOIDS OR LOOSE AND CRUMBLY CONDITION

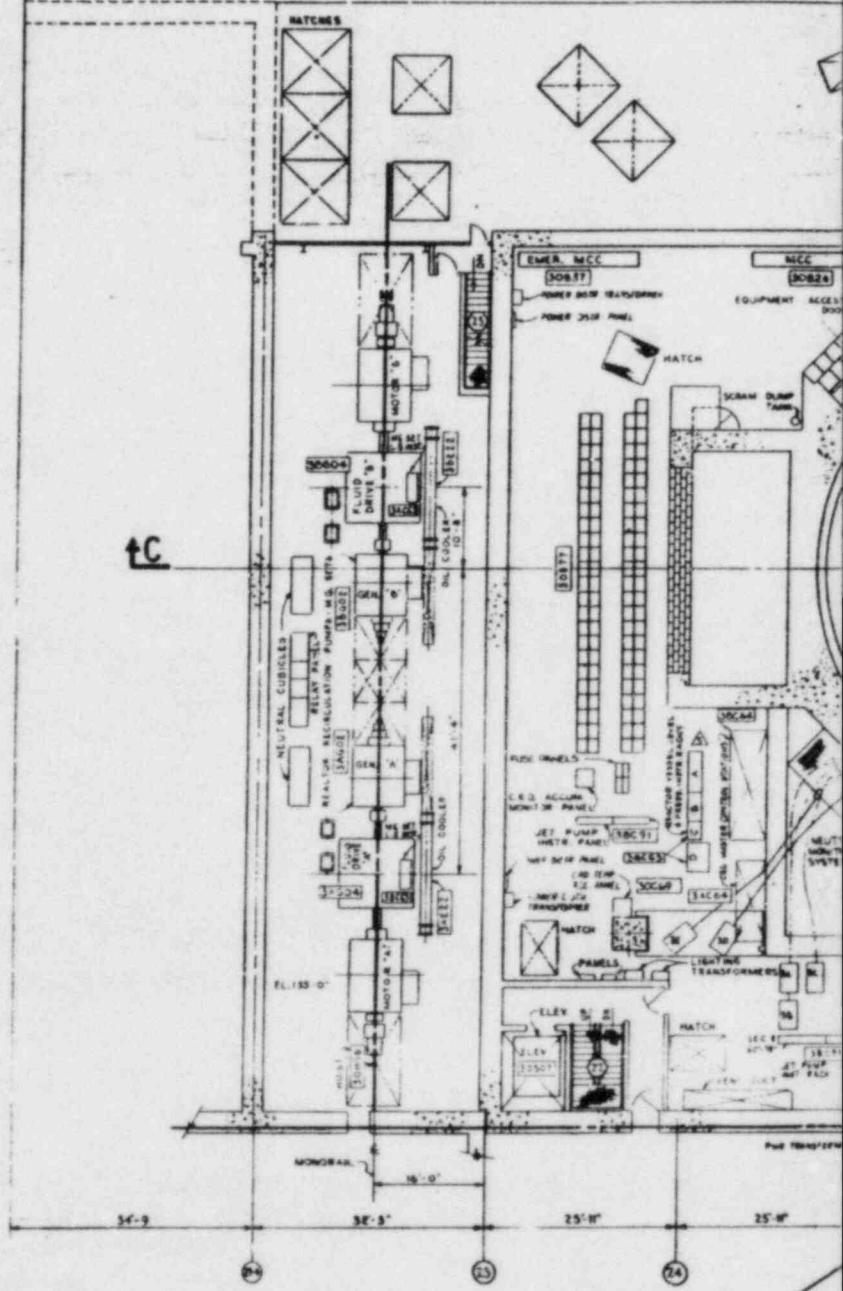
Fire areas 208 and 254, the outboard MSIV Rooms, are each provided with a total of 386 square feet of blowout panel and also are open to the adjacent Reactor Building general access areas by an open labyrinth (see Attachment 5). The blowout panels and open labyrinth are provided for steam venting in the event of a high energy line break. The blowout panels have no fire rating. One panel and also the labyrinth vents from the MSIV Room (fire loading .02 hrs.) to the Reactor Building general access area, El. 135 ft. (fire loading .68 hrs.). The second panel vents into the Moisture Separator Area of the Turbine Building (fire loading .41 hrs.). The labyrinth vents vertically approximately 10' off the floor; therefore, there are no clear openings at grade elevation to the adjacent fire area.

302 ft²
AT AN ELEV.
LOCATED P

Therefore, pursuant to Section 50.12 of the Commission Regulations, we request an exemption from the requirements of 10 CFR 50, Appendix R, Section III.G.2, requiring separation of cables and equipment and associated non-safety circuits of redundant trains by a fire barrier having a 3-hour rating based on the overriding nuclear safety concerns; the fact that the affected equipment in the MSIV Rooms operates early in the shutdown scenario and no spurious actuation in the room can effect valve positioning; and the relatively low combustible loadings, particularly in the outboard MSIV Room.
