Precursors to Potential Severe Core Damage Accidents: 1994 A Status Report

Appendix I

Oak Ridge National Laboratory

**Prepared for
U.S. Nuclear Regulatory Commission**

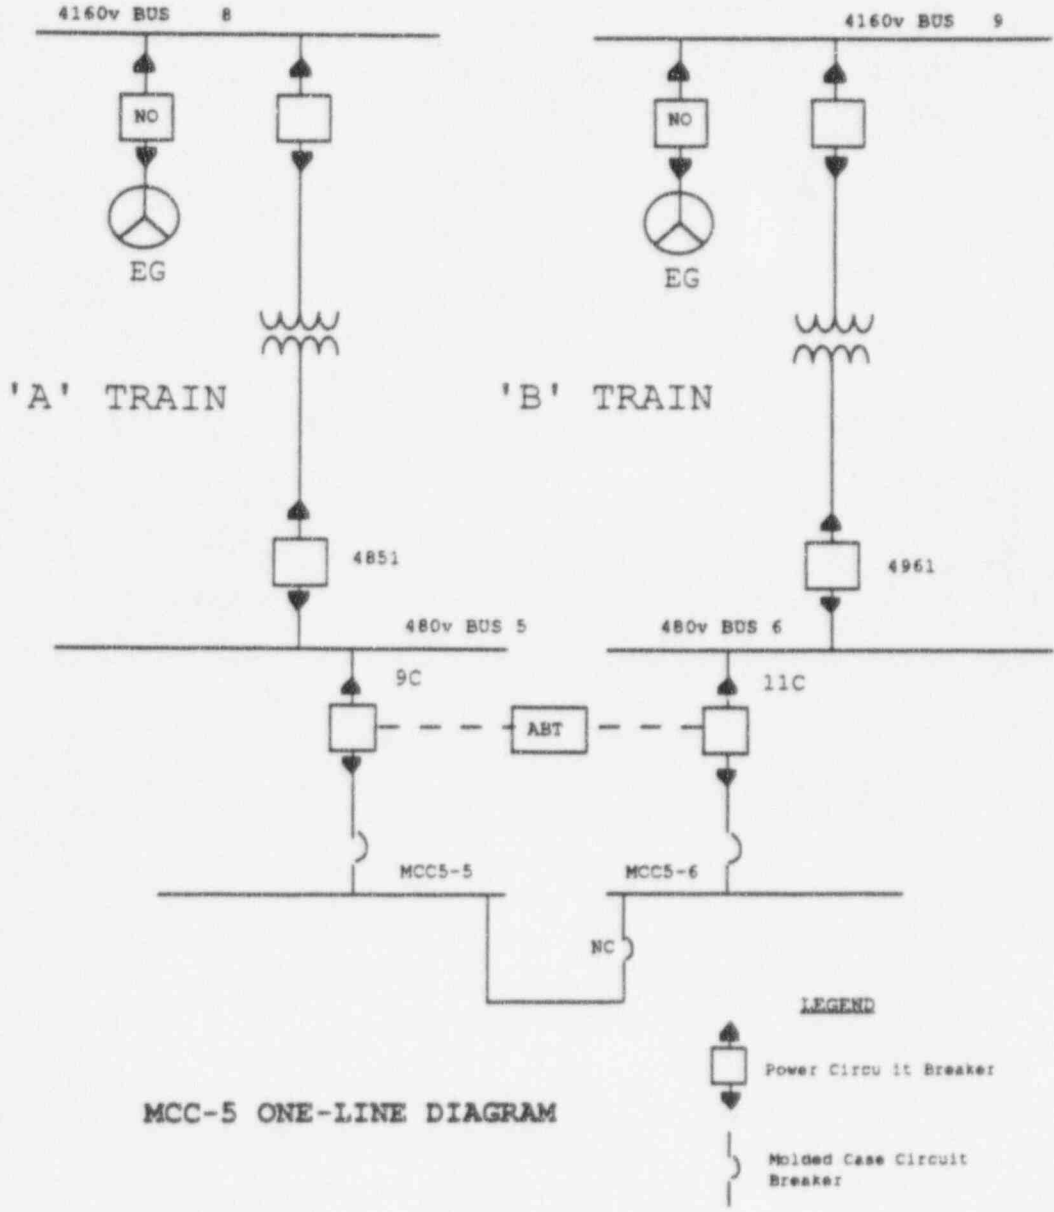
FIGURE 1

MCC-5 ONE-LINE DIAGRAM

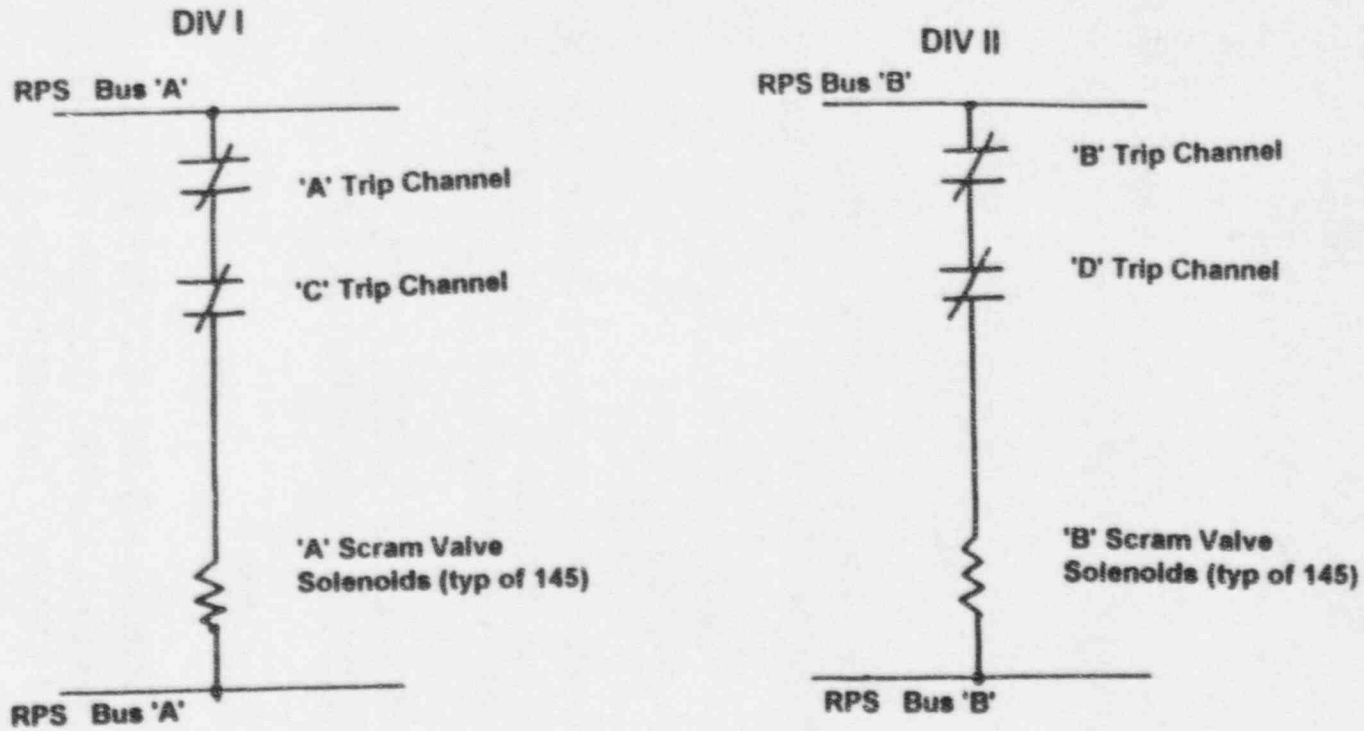
SIMPLIFIED RPS LOGIC CIRCUITRY

Both 'A' and 'B' Scram Valve Solenoids must deenergize to Scram a Control Rod.
