LICENSEE EVENT REPORT (LER)

FACILITY NAME (1) Palisades Nuclear Plant	DOCKET NUMBER (2) 0 5 0 0 0 2 5 5	PAGE (3) 1 OF 0 4
--	--------------------------------------	----------------------

TITLE (4)
Primary Coolant System-Unidentified Leakage > 1 gpm

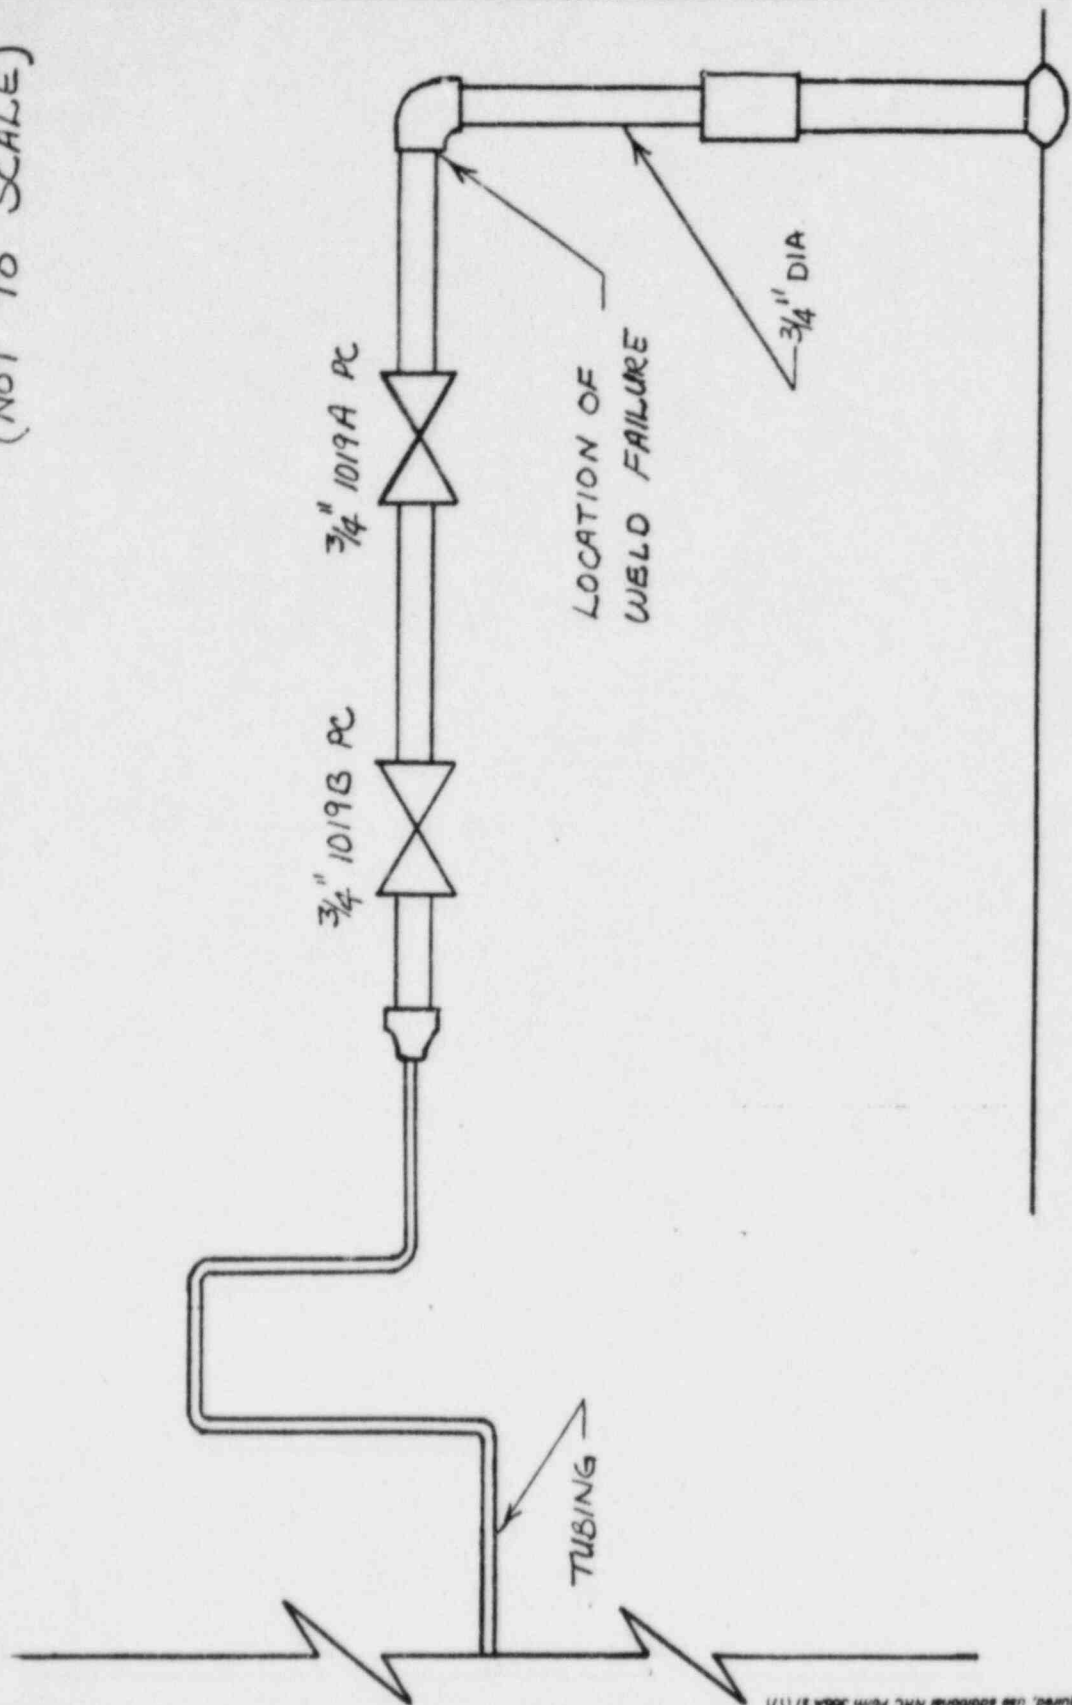
FIGURE 1

Investigation determined the source of the leakage to be from a cracked socket weld in a 3/4 inch PCS loop differential pressure (d/p) sensing line (See Figure 1) [PSP,PSF;AB]. The d/p sensing line is used to measure the pressure drop across the 'A' Steam Generator [SG;AB]. The outputs of the d/p transmitters [PDT;AB] on this, and similar d/p sensing lines, are also used to determine total core flow.

Investigation determined that a crack had developed in the socket weld/pipe interface on the underside of the pipe, in approximately the same location as the initial crack. Analysis of the cracked socket weld indicated that the weld itself was not defective. The weld was determined to have failed due to fatigue cracking caused by system vibration. In retrospect, the probable cause of the initial socket weld failure was the effect of the same fatigue phenomenon acting upon the imperfect weld, rather than an end-of-life failure of the imperfect weld, itself.

Continued investigation into the root cause of the occurrences determined that valves 1019A PC and 1019B PC [ISV;AB], which are immediately downstream of the cracked socket weld location, had been replaced during the 1983/1984 refueling outage. The replacement valves were heavier than the original valves by approximately 9 lbs. each (7.25 lbs vs 16 lbs). Design documentation completed at the time of the replacement indicated that system stresses would not be significantly higher due to the replacement valves. Justification for this conclusion was not provided with the design documentation, but, presumably, would have been based upon a static evaluation of the piping configuration. Subsequent investigation confirmed that the effect of the added weight on the system piping would not result in unacceptable static loading. When analyzed dynamically, however, the effect of the additional weight with normal system vibration induces motion in the cantilever-type configuration of sufficient magnitude to cause the observed fatigue failure in the socket weld area.

The pipe/elbow assembly was again replaced with a new assembly. A support was designed and installed between valves 1019A PC and 1019B PC to inhibit the dynamic forces which resulted in the previous failures. Following dye-penetrant examination of the welds, the sensing line was pressure tested and visually inspected during Plant heat-up on September 1, 1984. The design change process will be reviewed to determine whether current methods of technical justification and verification are adequate, or if enhancements are necessary.
