Northern States Power Company
Prairie Island Nuclear Generating Plant
1717 Wakonade Dr. East
Welch, Minnesota 55089

PRAIRIE ISLAND NUCLEAR GENERATING PLANT
Docket Nos. 50-282 License Nos. DPR-42
50-306 DPR-60

Request for Approval of Alternative to ASME Code Requirements

- Attachments:
1. Evaluation of Limiting Flaws for Structural Integrity in Canopy Seal Repairs at Prairie Island Nuclear Plants
 2. Summary of Camera Testing
 3. Control Rod Locations (Figure B5-2)

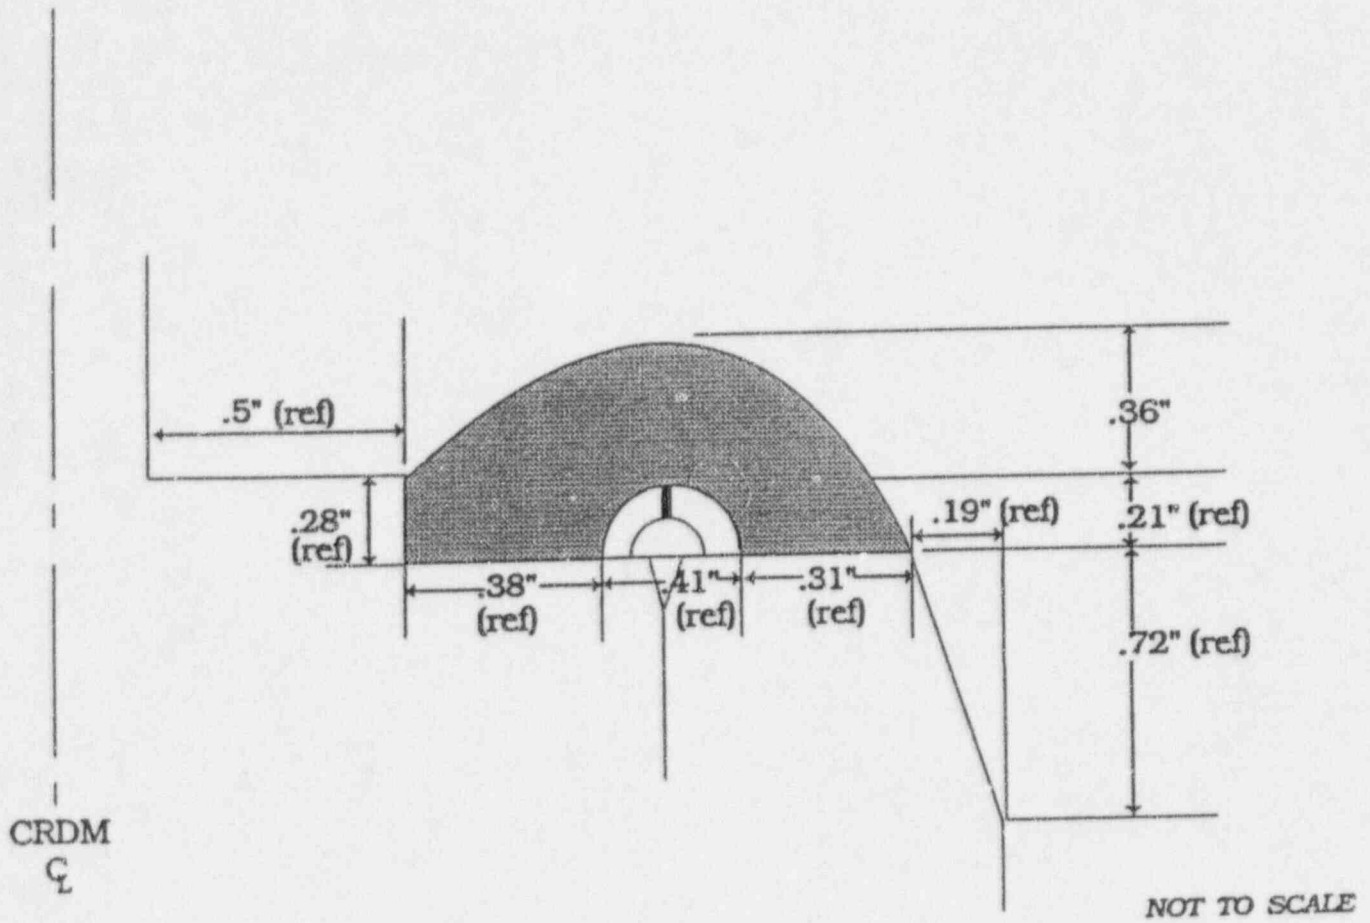
Figure 1. Canopy Seal Weld Overlay Design and Dimensions used in Analysis

The design geometry of the repair is illustrated in Figure 1. For the purpose of the present evaluation, the component was modeled as a pipe with outside radius equal to that of the latch housing (3.7 inches) and wall thickness equal to the overlay thickness in the vicinity of the latch housing outside surface (0.31 inches minimum), as shown on Figure 1. Through wall axial and circumferential flaws were evaluated. These geometries are considered to be reasonable representations of the actual design geometry. The model geometries are shown in Figure 2.

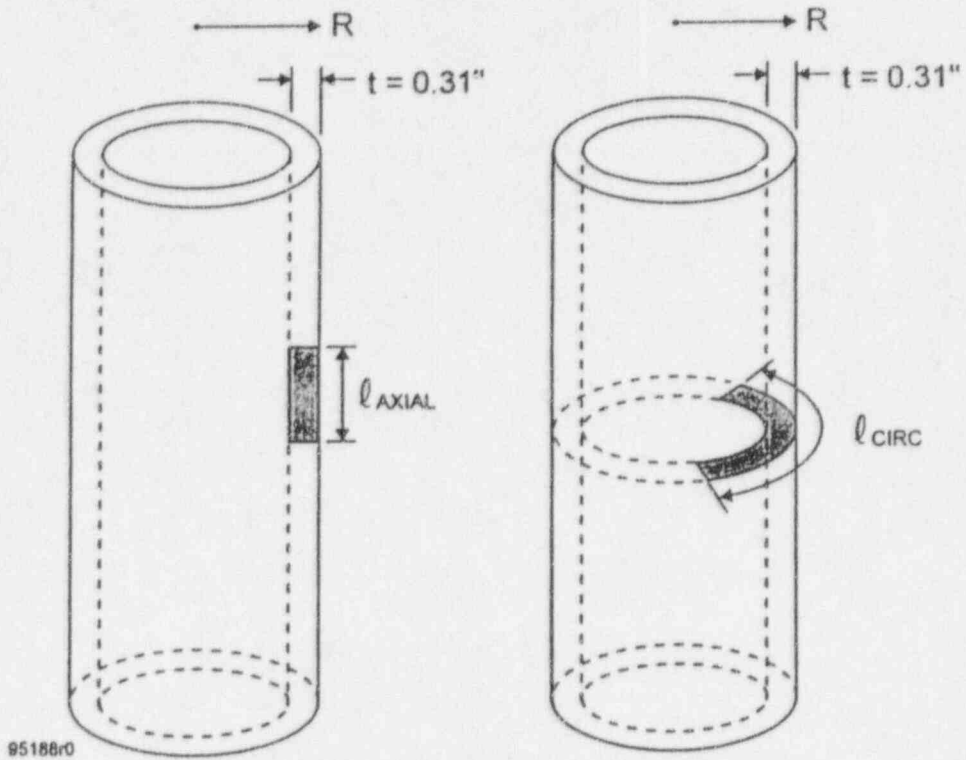
Figure 2. Modeled Geometries

$$R = \text{Outside Radius of Latch Housing} = \frac{7.386}{2}$$

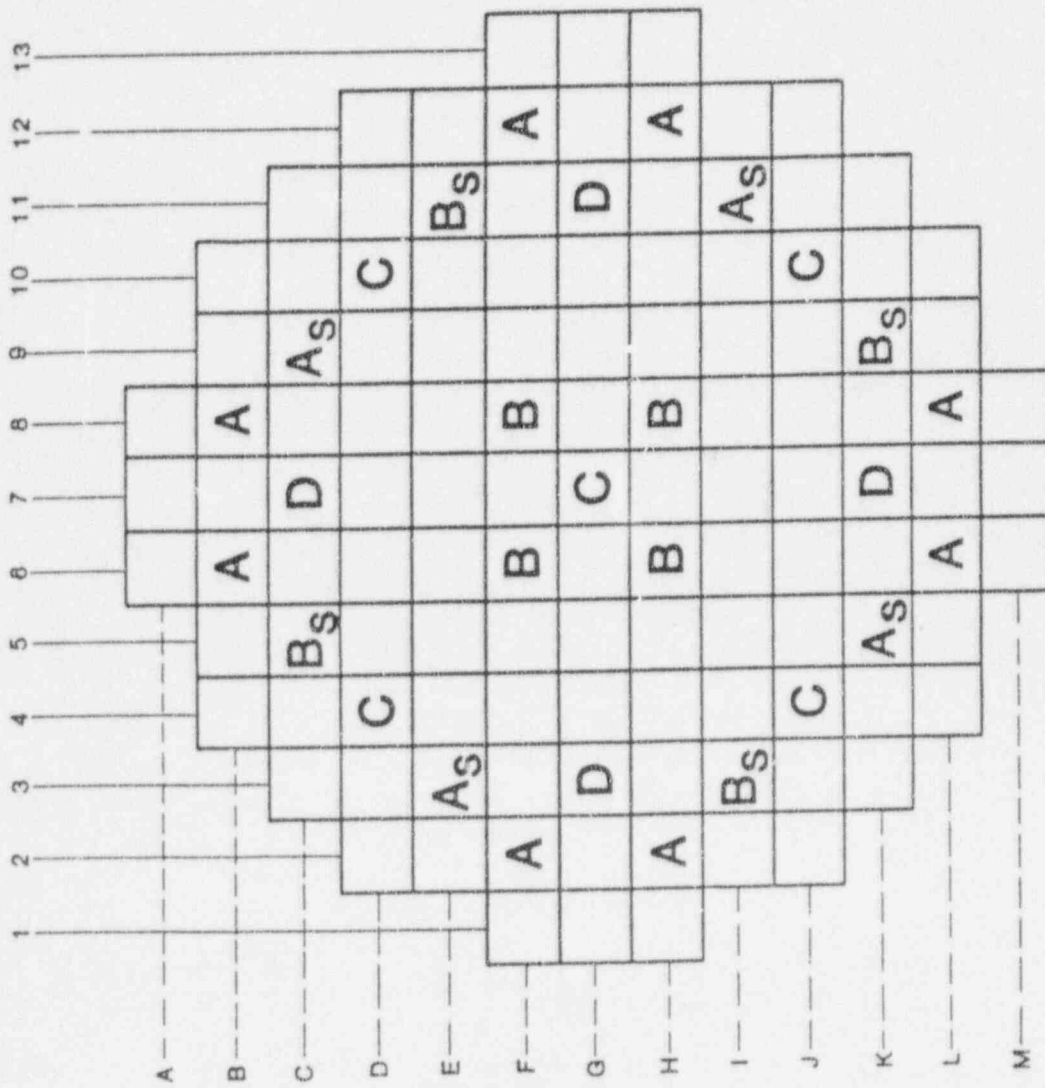
SYSTEM DESCRIPTION FIGURE B5-2

During reactor head assemblies during the current Unit 1 refueling shutdown, boric acid residue was noted at the base of the rod position indication stack at full length control rod drive mechanism (CRDM) for each of the following locations: H8, F6, and F8 (Attachment 3). The residue was confined to the upper coil housing on the CRDM stack; no boric acid residue was noted below the upper coil housing on the penetration or reactor vessel head insulation.
