UNITED STATES
NUCLEAR REGULATORY COMMISSION
WASHINGTON, D.C. 20555-0001

LICENSEE: Houston Lighting and Power Company (HL&P), et al.
FACILITY: South Texas Project, Units 1 and 2 (STP)
SUBJECT: SUMMARY OF JANUARY 18, 1996, MEETING ON THE UNIT 1 CONTROL ROD
INSERTION ANOMALY AND THE RESULTING ACTION PLANS

MEETING BETWEEN HL&P AND NRC ON CONTROL ROD ACTION PLANS

UNIT 1 CONTROL ROD INSERTION ANOMALY
TO
NRC

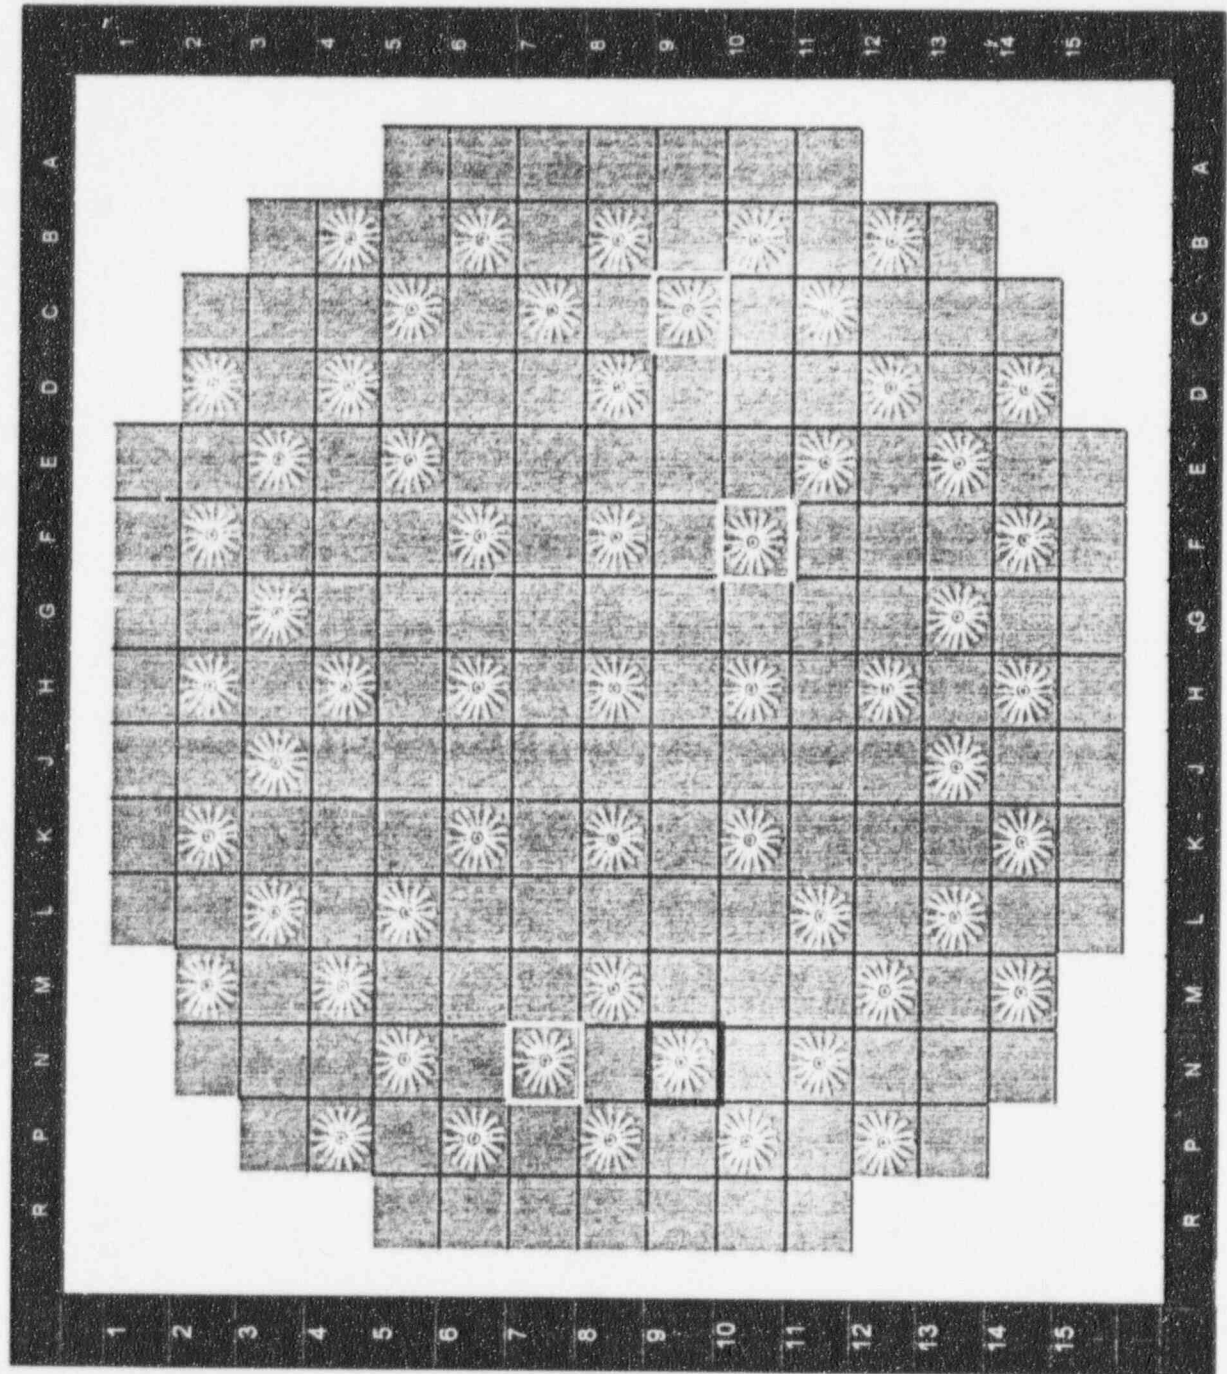
AFFECTED CORE LOCATIONS U1 C6

- December 18, 1995, Reactor Trip, three control rods stopped at six steps from the bottom
- Testing performed, one additional control rod stopped at six steps
- Affected control rods are over high burnup assemblies
- Performed safety evaluation which bounded current condition
- Monitoring plan to ensure conditions remain bounded by safety evaluation
- Plan established to determine cause and corrective action

- Unit 1 Cycle 6 reactor trip on 12/18/95
- 3 of 57 control rods not at rod bottom - DRPI indicated 6 steps from rod bottom
- Core locations F-10, C-9, and N-7
- N-7 DRPI indication changed to rod bottom within about 1 hour
- No indications from Loose Parts Monitoring System
- DRPI indication was correct

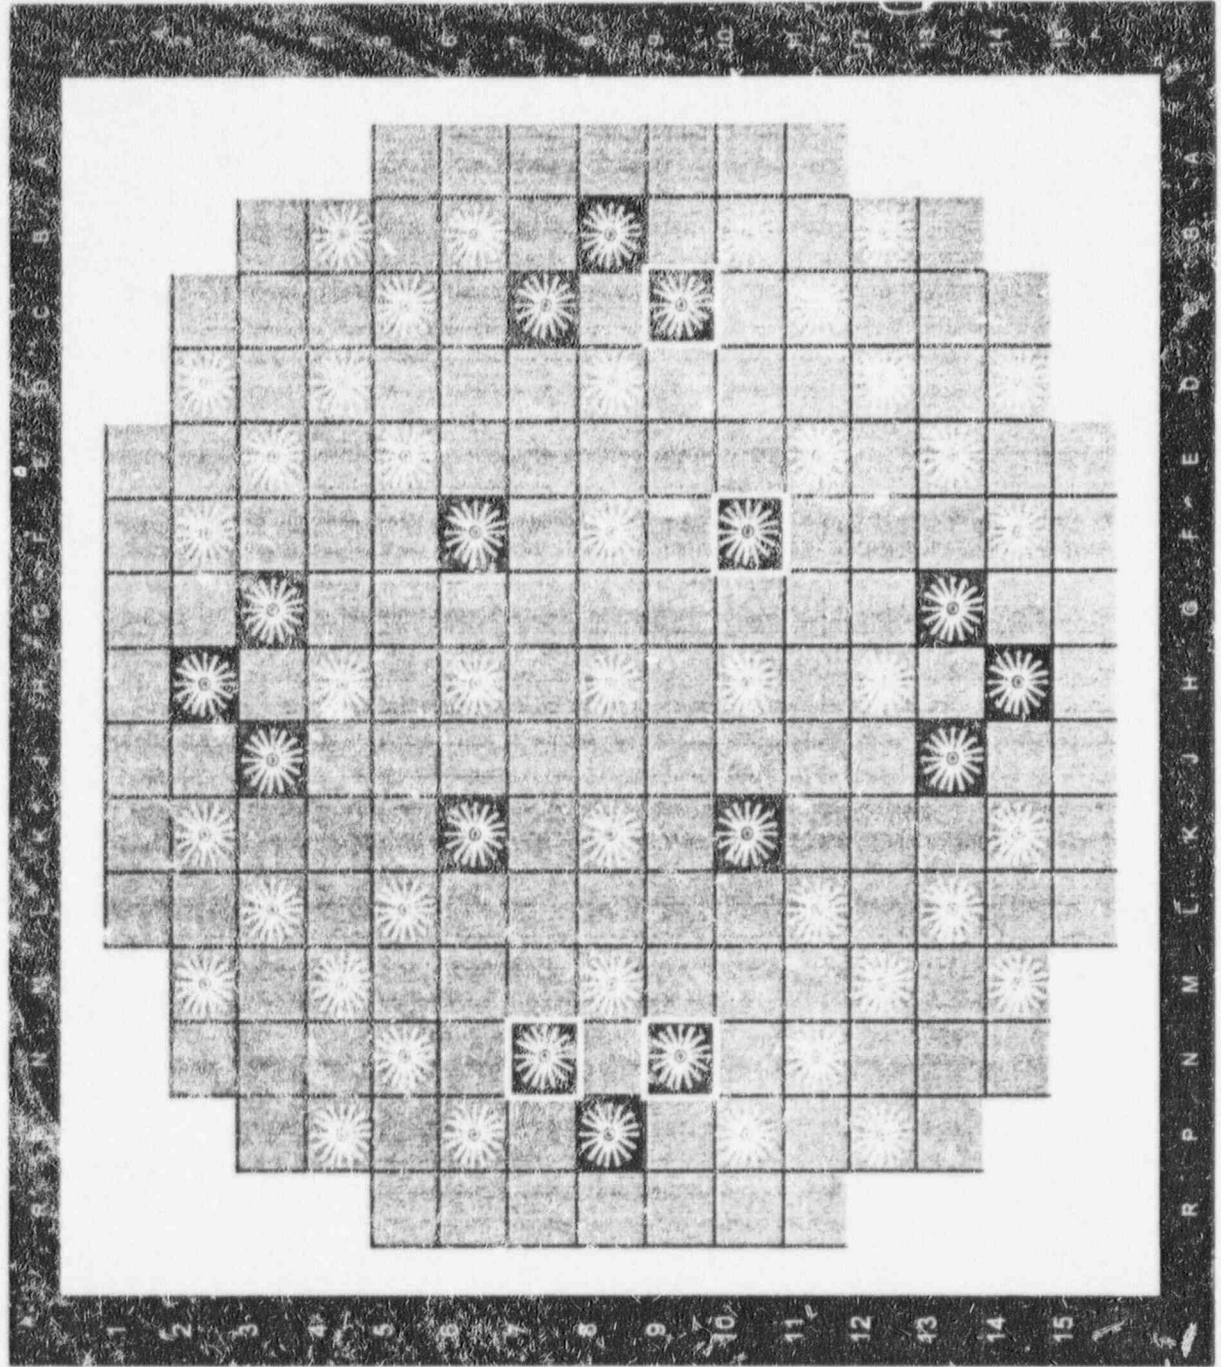
16 TESTED LOCATIONS U1 C6 - 12/19/95

- Hot, full flow rod drop timing
- Tested Control Bank C and Shutdown Bank B (16 RCCAs)
- Control rod drive mechanism currents monitored on 3 affected rods
- Same 3 rods indicated 6 steps from rod bottom after drops
- New rod, N-9, also stopped at 6 steps
- Both N-7 and N-9 went to rod bottom within about 1 hour
- No significant change in dashpot entry time
- Repeatable rod sticking at 6 steps
- F-10 and C-9 were manually inserted to rod bottom

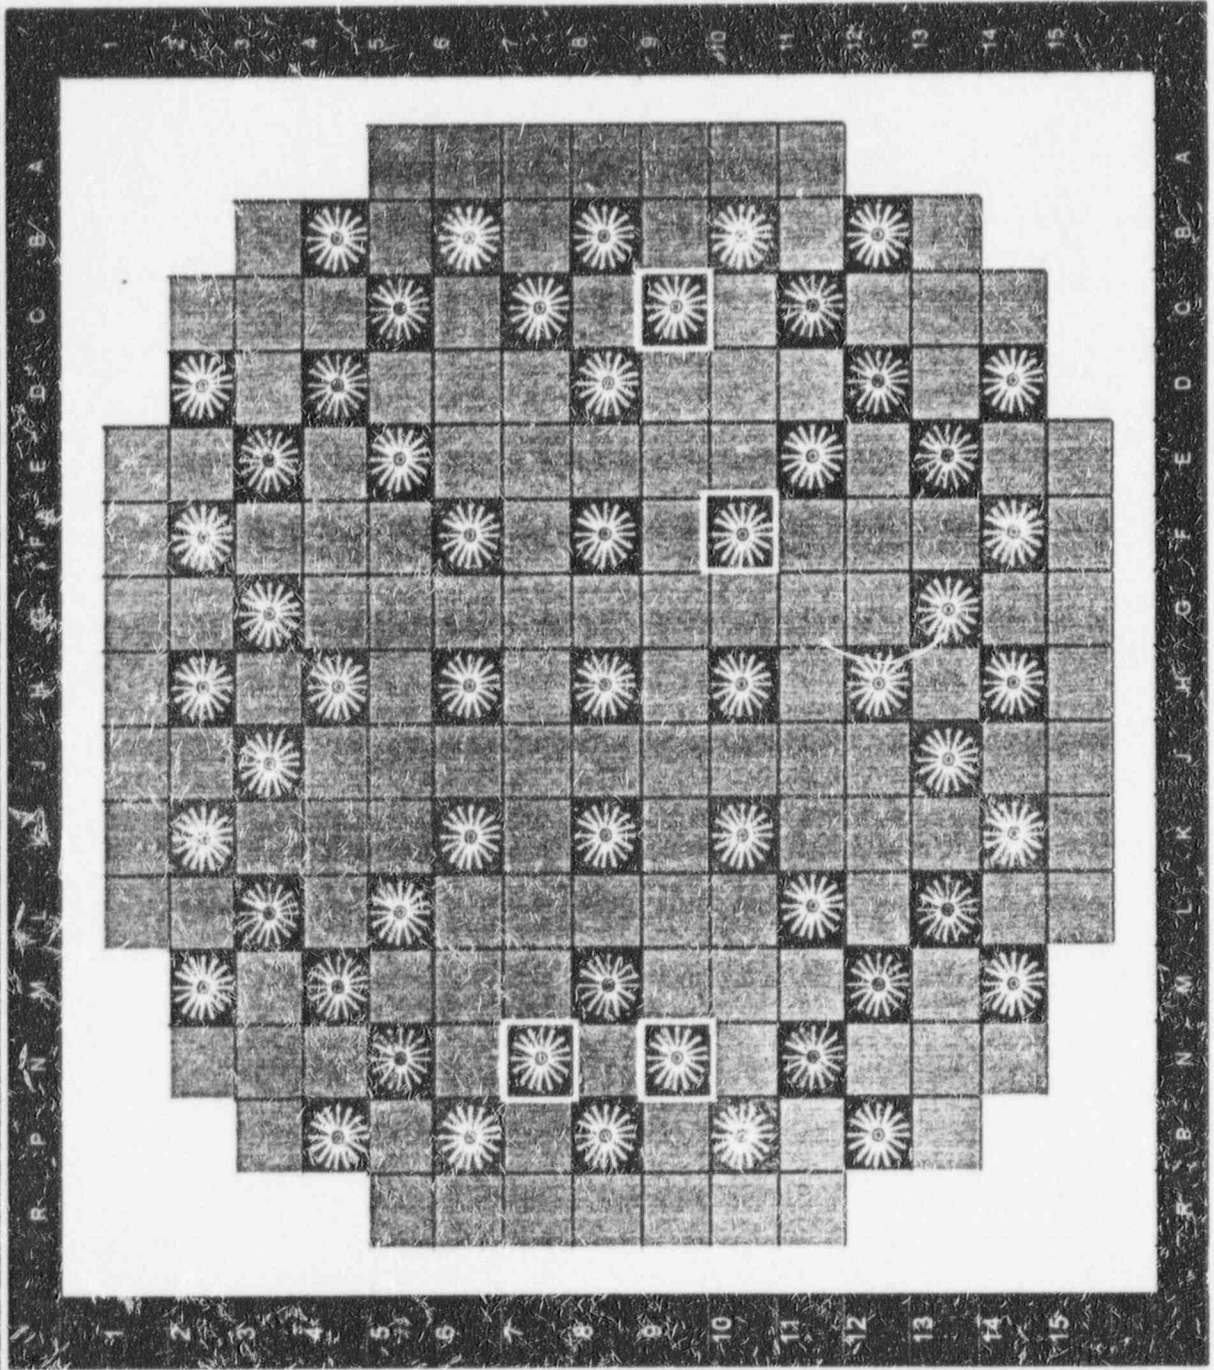
U1 C6 RODDED BURNUP DISTRIBUTION

Burnup ranges from about 9.8K to about 44K mwd/mtu

- Revise Unit 1 Cycle 7 loading pattern to minimize or eliminate high burnup fuel assemblies (> 40000 MWD/MTU at EOL) in rodded locations
- Evaluate performing RCCA testing
- Visually inspect affected Unit 1 fuel assemblies (scheduled for discharge) during 1RE06
- Complete further testing of affected Unit 1 fuel assemblies as soon as practical following 1RE06.
- Testing under consideration includes: drag testing of guide tubes, boroscopic examination of guide tubes, feeler gauge measurements in guide tubes, and assembly axial growth measurements.

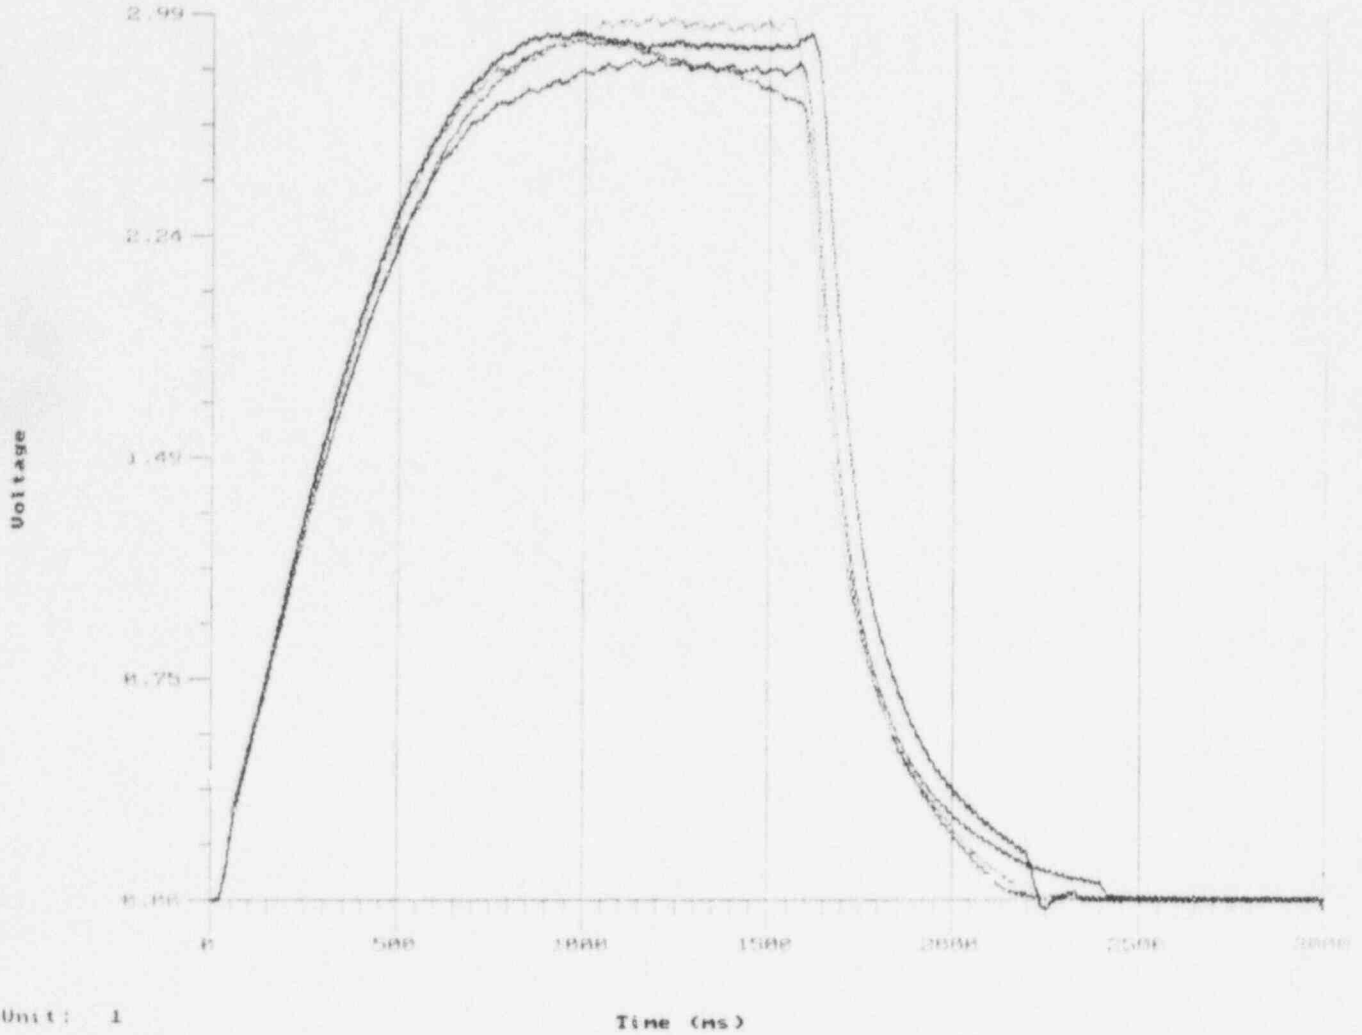
ROD DROP TRACES

Rod:	F10	K10	F6	K6
Drop:	1	1	1	1
File:	F1012951.RDA	K1012951.RDA	F612951.RDA	K612951.RDA
Dashpot:	1591	1501	1590	1613
TAround:	2736	2571	2705	2234
Temp:	568.0 Deg F	568.0 Deg F	568.0 Deg F	568.0 Deg F
Press:	2235.0 PSIG	2235.0 PSIG	2235.0 PSIG	2235.0 PSIG
Fl Rate:	100.0 %	100.0 %	100.0 %	100.0 %
Cycle:	6	6	6	6

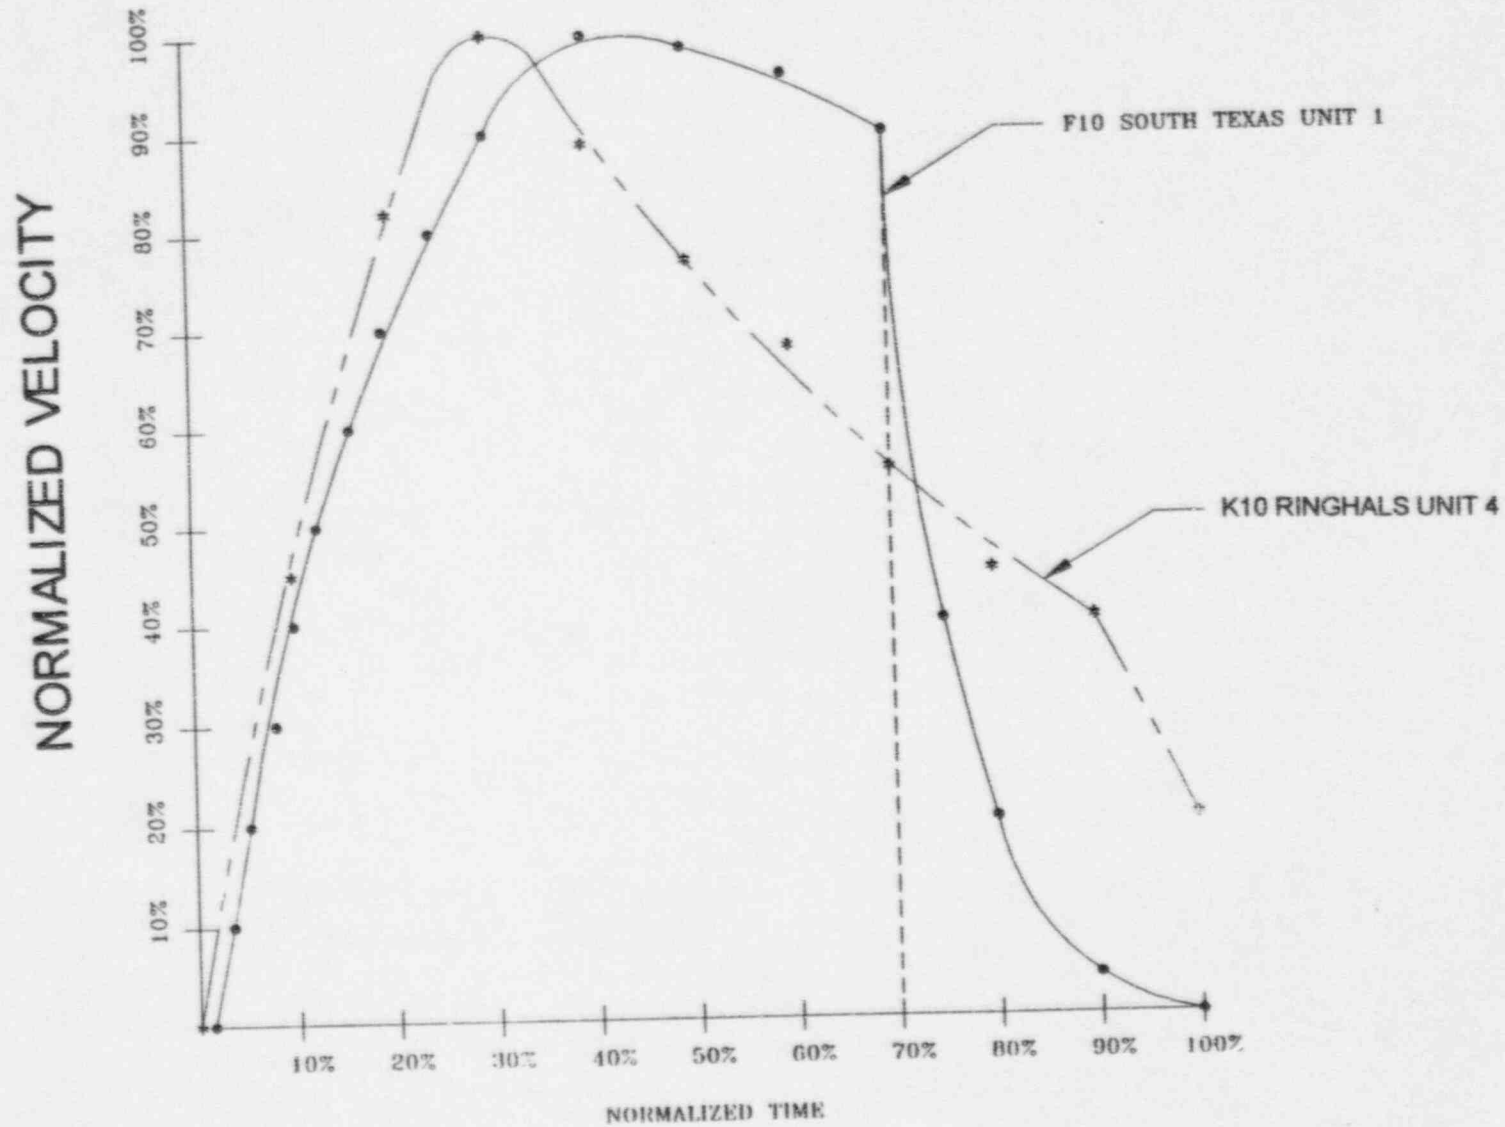
CONTROL ROD DROP CHARACTERISTICS

- Ringhals 4 (8/94)- 12' 17x17 Framagma fuel with burnup of 37,000 to 41,000 mwd/mtu
 - Rod stuck at 18 steps out; 4 rods stuck during subsequent testing
 - Rod drop testing showed rod speed affected well before dashpot
 - S-shaped bow observed in fuel under problem control rods
- Doel 3 (Fall 1994)- 12' 17x17 Siemens fuel with burnup of 37,000 mwd/mtu
 - Rod could not be fully inserted; moved freely in top half of travel
 - Fuel assembly was discharged; no exam of fuel or control rod
- French 1300 Mwe Plant (10/92) - 14' fuel, rod stuck at 7 steps; fuel assembly was bowed (25mm)
